Portico farmhouses of the Vistula Delta: architecture, current state and finite element modelling of timber roof truss under material and cross-section uncertainty

Tomasz Zybała¹, Katarzyna Szepietowska¹, Grzegorz Bukal², Izabela Lubowiecka¹

1) *Department of Structural Mechanics, Faculty of Civil and Environmental Engineering, Gdańsk University of Technology, Gdańsk, Poland*

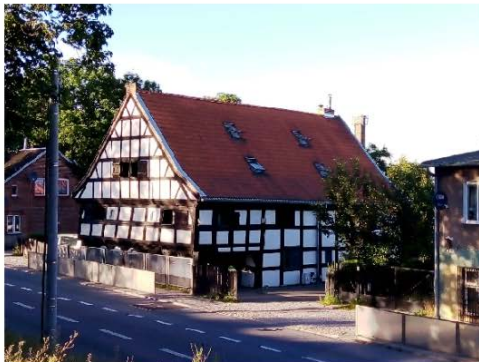
Figure 1. Three types of houses; a) 1, 2 – “I-type” house, 3; The portico houses in: b) Gdańsk Lipce c) Klecie d) Trutnowy e) Miłocin f) Nowa Kościelnica

Kloeppel (1924) differentiated three basic types of houses, (Figure 1a). It should be noted that the term *portico* should be treated somewhat conventionally here, and in some cases, the term *arcade* might be substantiated. In the building of the first and second type, the portico constituted the facade of the house, so we can call them I-type houses. The second type was in fact a result of the development of the I-type plan by adding a wing to the body of the house. Therefore, for this study they can also be classified as

The oldest preserved house in Lipce by Gdańsk (Germ. Guteherberge) was built ca 1600 (Kloepfel 1924 ; Bertram, Kloepfel, and La Baume 1924), (Figure 1b). The newest houses, retaining traditional style and proportions, come from the 1840 (Woede 1980).

by Gdańsk (Germ. Guteherberge) (Figure 1b), Klecie (Germ. Klettendorf) (Figure 1c), Trutnowy (Germ. Trutenau) (Figure 1d), Miłocin (Germ. Herzberg) (Figure 1e), Nowa Kościelnica (Germ. Neumünsterberg) (Figure 1f).

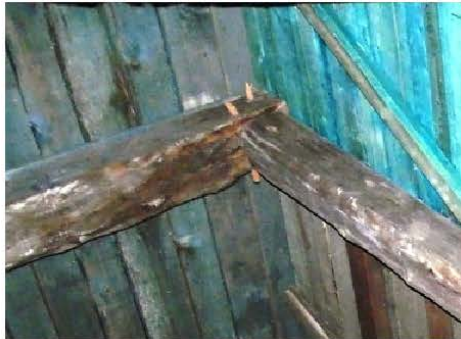
Figure 6. Traditional carpentry joints - current state: a) dovetail joint (Trutnowy) b) lap joint (Trutnowy) c) dovetail joint (Klecie) d) lap joint (Klecie) e) mortise and tenon (Nowa Kościelnica) f) lap joint (Nowa Kościelnica)

The dimensions of the roof truss components, the angle of inclination and the measure of used wood \bar{V} of all investigated houses are collected in Table 2. The axial spacing of the rafters varies from 11.0 m to 12.3 m depending on the house. The measure of used wood \bar{V} of the analysed houses ranges from 0.056 to 0.086 m³/m², the average value \bar{V} for all houses is 0.069 m³/m². The angle of the rafters varies from 46° to 49°, which gives the average value for the five analysed objects of 47.2°, approximately 47°. The number of trusses is from 12 to 19, most often there are 17. In houses in Klecie and Trutnowy rafters with collars are connected with a dovetail notch, in the house in Nowa Kościelnica are connected with mortise and tenon. At the roof ridge (houses in Trutnowy, Klecie and Nowa Kościelnica), rafters are connected using lap joint.
