## **Portico farmhouses of the Vistula Delta: architecture, current state and finite element modelling of timber roof truss under material and cross-section uncertainty**

**Abstract:** The article focuses on the oldest surviving I-type portico houses located in the Vistula Delta, which were built in the 17th and 18th centuries. The study describes the houses' origins, structure, details of roof structures and technical condition, and it also includes numerical modelling of a roof truss and its mechanical analysis. Numerical models of the roof trusses are defined and analysed by means of the finite element method. Global sensitivity analysis with the use of the polynomial chaos expansion method is used to study the influence of uncertainties in material properties of wood, such as Young's modulus and the friction coefficient, and also the beam cross-sectional height in the output of the numerical model of the structure. The outcomes show that uncertainty of beam height exerts the dominating influence on the maximum deflection of the roof truss hence accurate measurements of geometry are of great importance in the planning of conservation and renovation of such historic structures.

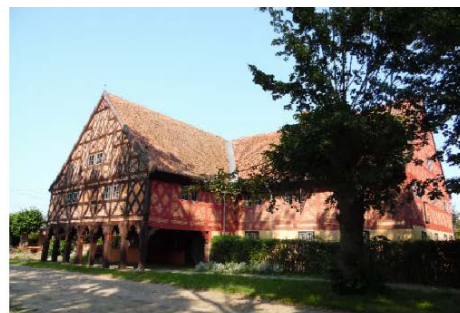
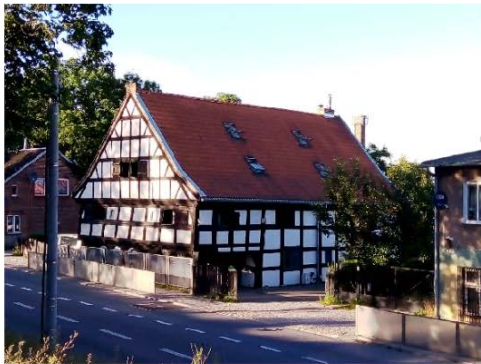
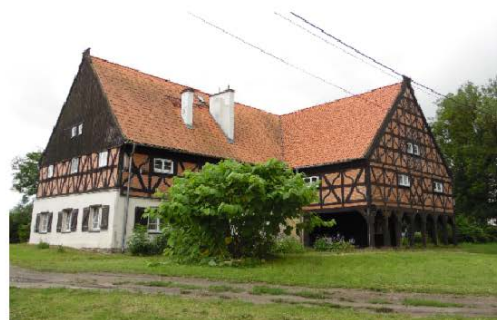
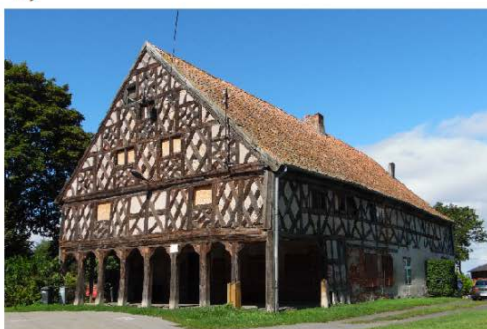
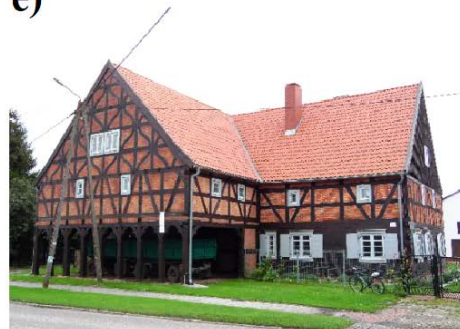
Figure 1. Three types of houses; a) 1, 2 – “I-type” house, 3; The portico houses in: b) Gdańsk Lipce c) Klecie d) Trutnowy e) Miłocin f) Nowa Kościelnica

Kloeppel (1924) differentiated three basic types of houses, (Figure 1a). It should be noted that the term *portico* should be treated somewhat conventionally here, and in some cases, the term *arcade* might be substantiated. In the building of the first and second type, the portico constituted the facade of the house, so we can call them I-type houses. The second type was in fact a result of the development of the I-type plan by adding a wing to the body of the house. Therefore, for this study they can also be classified as

The oldest preserved house in Lipce by Gdańsk (Germ. Guteherberge) was built ca 1600 (Kloepfel 1924 ; Bertram, Kloepfel, and La Baume 1924), (Figure 1b). The newest houses, retaining traditional style and proportions, come from the 1840 (Woede 1980).

by Gdańsk (Germ. Guteherberge) (Figure 1b), Klecie (Germ. Klettendorf) (Figure 1c), Trutnowy (Germ. Trutenau) (Figure 1d), Miłocin (Germ. Herzberg) (Figure 1e), Nowa Kościelnica (Germ. Neumünsterberg) (Figure 1f).

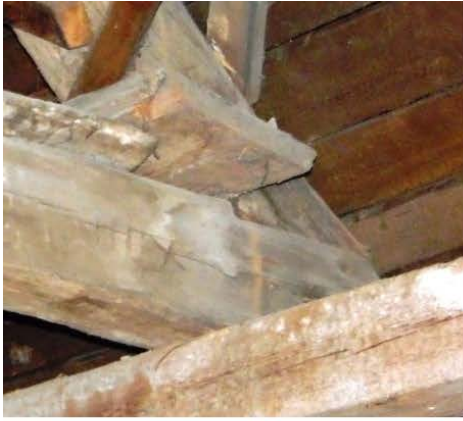
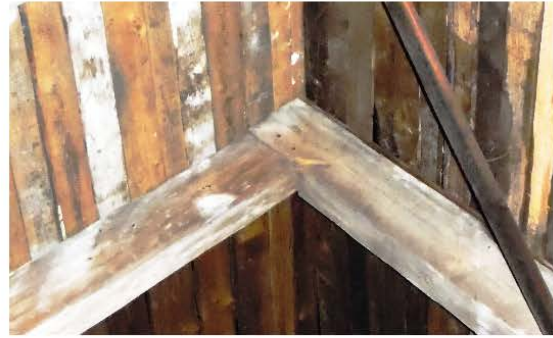
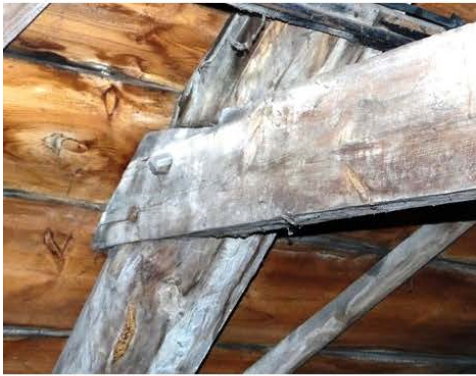
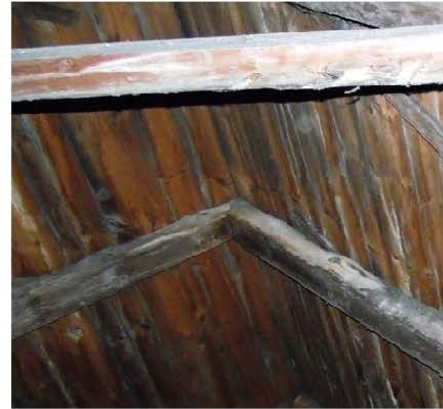
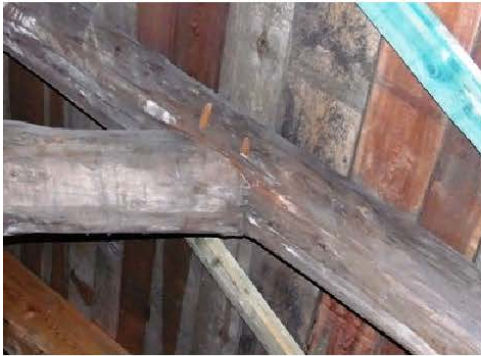
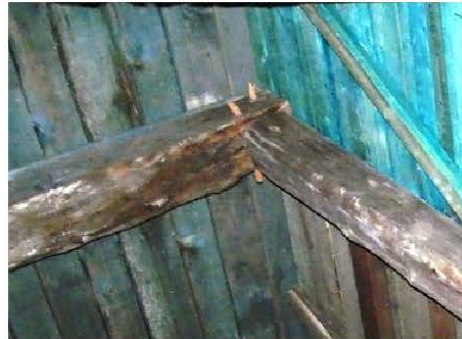
Figure 6. Traditional carpentry joints - current state: a) dovetail joint (Trutnowy) b) lap joint (Trutnowy) c) dovetail joint (Klecie) d) lap joint (Klecie) e) mortise and tenon (Nowa Kościelnica) f) lap joint (Nowa Kościelnica)

The dimensions of the roof truss components, the angle of inclination and the measure of used wood  $\bar{V}$  of all investigated houses are collected in Table 2. The axial spacing of the rafters varies from 11.0 m to 12.3 m depending on the house. The measure of used wood  $\bar{V}$  of the analysed houses ranges from 0.056 to 0.086 m<sup>3</sup>/m<sup>2</sup>, the average value  $\bar{V}$  for all houses is 0.069 m<sup>3</sup>/m<sup>2</sup>. The angle of the rafters varies from 46° to 49°, which gives the average value for the five analysed objects of 47.2°, approximately 47°. The number of trusses is from 12 to 19, most often there are 17. In houses in Klecie and Trutnowy rafters with collars are connected with a dovetail notch, in the house in Nowa Kościelnica are connected with mortise and tenon. At the roof ridge (houses in Trutnowy, Klecie and Nowa Kościelnica), rafters are connected using lap joint.

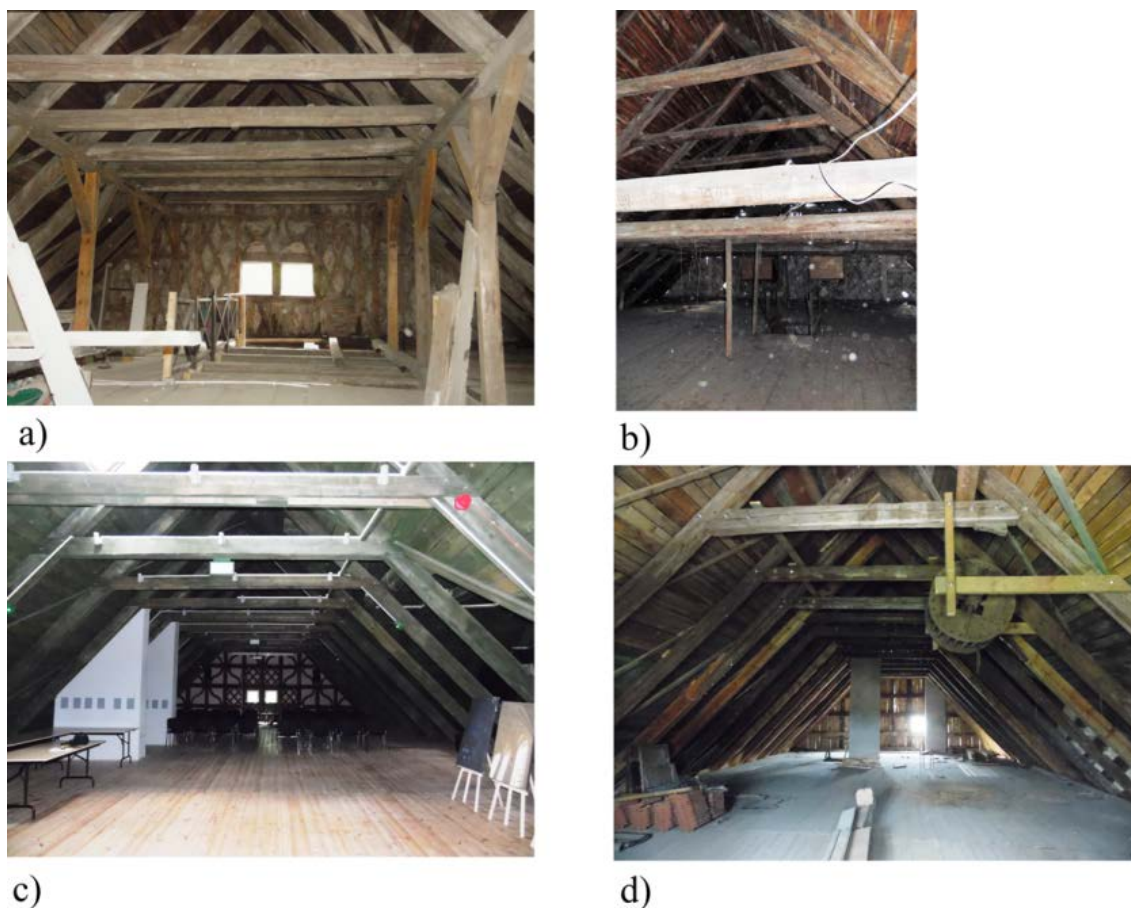
Figure 7. The timber roof truss – current state: a) Trutnowy b) Klecie c) Miłocin  
d) Nowa Kościelnica

It is worth noting the good technical condition of the roof structures in the houses analysed from the 17th and 18th centuries. This is caused by several factors. Homeowners make repairs systematically. In all buildings, the roof coverings are raintight, the attics have gravity ventilation (constant air circulation maintains the correct moisture of the wood), and there are no additional loads. This situation augurs well for the proper preservation of the historical structures in centuries to come. Such a way of maintenance is consistent with the principles of monument conservation and may be used in all wooden roof structures.
