Imaging of Increasing Damage in Steel Plates Using Lamb Waves and Ultrasound Computed Tomography

Abstract: This paper concerns the inspection of steel plates, with particular emphasis on the assessment of increasing damage. Non-destructive tests were performed on four plates, one of which was undamaged, while the remaining three had defects in the form of circular holes with diameters of 2, 5 and 10 cm. Guided Lamb waves were used in the research, and the image reconstruction was performed using ultrasound computed tomography. The damage size was estimated by tracking the real course of rays and densifying the pixel grid into which the object was divided. The results showed the great potential of ultrasound tomography in detecting defects in steel elements, together with the possibility of estimating damage size.

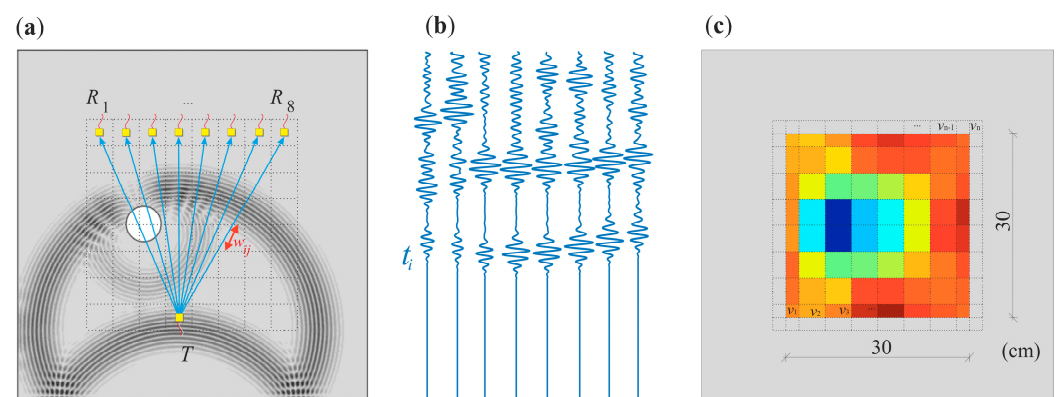
Figure 1. Schematic diagram of velocity reconstruction using ultrasound tomography: (a) plate with indicated receivers (R), transmission (T) points and simulated wave field; (b) guided wave propagation time signals; (c) ultrasound tomography map.

Ultrasound tomography imaging allows recreating the internal structure of an examined object using the properties of elastic waves. A schematic process of performing ultrasound tomography is shown in Figure 1. The first step is to divide the test sample into cells called pixels. Each one of them constitutes a discrete area in the tested element. Such a division is shown with a dashed line in Figure 1a. Then, after applying appropriate algorithms, each pixel takes a value representing the speed of the ultrasonic wave propagated through this area.

Image reconstruction is based on information from ultrasound wave signals propagating from transmitting points (T) to receiving points (R). This information may be, for example, the time of flight (TOF), measured along with the multiple ray paths, determined after appropriate signal processing [34–36]. Each obstacle in the path of the travelling wave changes the propagation time. Among them, we can distinguish defects that delay the wave reaching the receiver, such as air voids or cracks, and those that decreased total velocity along all rays passing through these inclusions. The latter include inclusions made of materials whose propagation velocity is higher than in the surrounding medium. Based on the time of flight of the wave, with the known geometry of the tested object, it is possible to determine wave propagation speed, correlated with the mass density, modulus of elasticity, and Poisson's ratio characteristic for a given material.

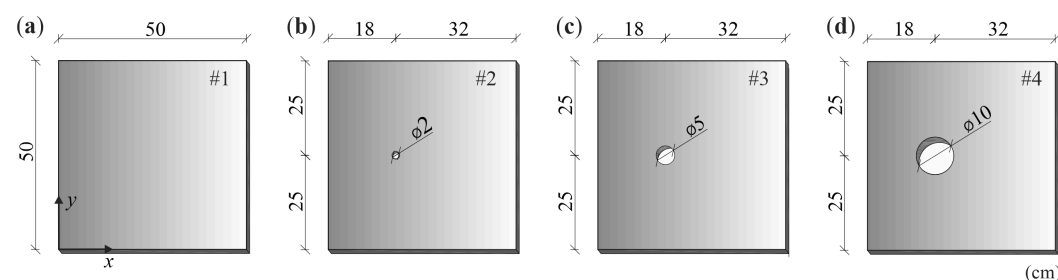
Figure 2. The geometry of the tested plates: (a) plate without damage (#1); (b–d) plates with surface damage (#2–#4).

The tests were carried out on four steel plates with dimensions of 50 cm \times 50 cm and 3 mm thickness. A reference model was the first element without damage (plate #1). The other three plates contained a circular hole of variable diameter: 2 cm (plate #2), 5 cm (plate #3) and 10 cm (plate #4), which represented damage of a surface type. Holes were made through the entire thickness of the plate. The centres of all holes were placed symmetrically in the y -axis direction and at a distance of 18 cm from the outer edge of the plate in the x -axis direction. The geometry of the test models is shown in Figure 2. Photographs of the plates used for the experimental tests are presented in Figure 3.

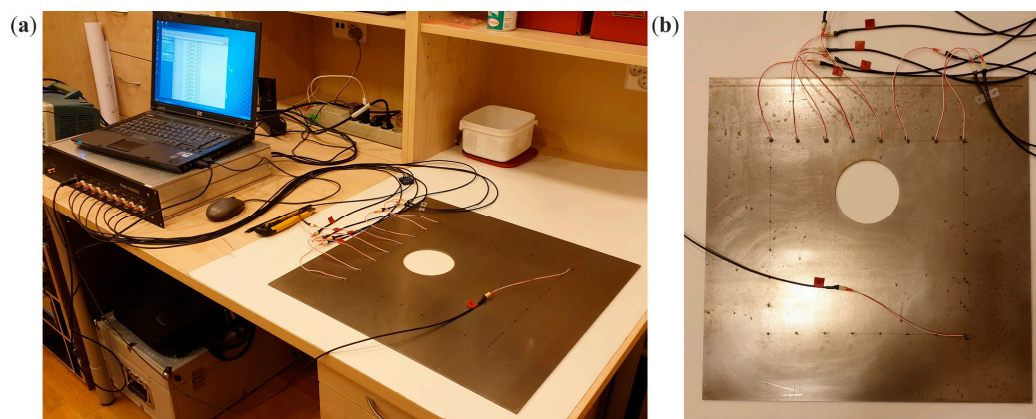
Figure 4. Experimental setup (a) and view on the steel plate with piezoelectric transducers (b).

Experimental tests of the propagation of Lamb waves in the steel plates were performed using a system for generation and registration of ultrasonic waves, the PAQ-16000D system (EC Electronics, Krakow, Poland). The experimental setup is shown in Figure 4. For both transmitting and receiving Lamb wave signals, plate piezoelectric transducers, NAC2024 (Noliac, Kvistgaard, Denmark), were applied. The excitation was a wave packet with a central frequency of 150 kHz, consisting of five sinusoid cycles modulated with the Hann window.

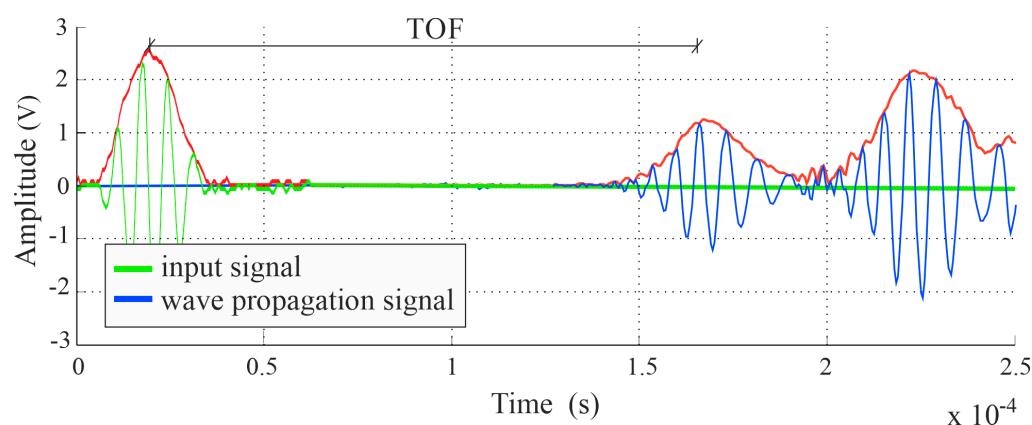
Figure 8. Determination of the time of flight (TOF) between transmitters and receivers.

The scheme of determining the time of flight (TOF) is shown in Figure 8. The estimation of this value is based on the first wave packet. The wave propagation time was established through the peak-to-peak method and was the difference between the peak value of the first wave pack of the output signal and the peak value of the input signal. The Hilbert transform was employed to create the signal envelope, which enabled the identification of peaks.

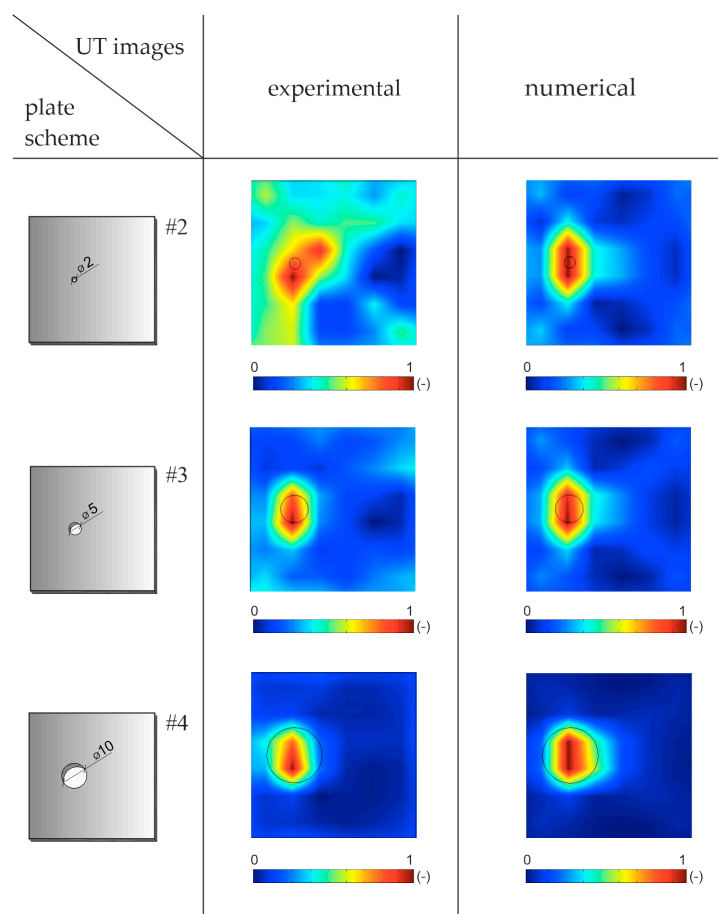
Figure 11. Ultrasonic tomography (UT) maps in plates with surface damage with the reference to the undamaged plate using TOF differences.

Figure 11 shows the tomographic velocity maps obtained based on differences in wave propagation TOF between the reference plate and the plate with growing damage. Each map was made on a scale from 0 to 1, where 1 indicates the highest difference between reference and current state, and 0 indicates their full compatibility. The location of the circular hole (Figure 11) was detected on the numerical images as regions with a reduced speed of wave propagation. These maps clearly indicate the location of the holes; however, it is not possible to precisely determine their size. This is due to the number of pixels into which the element was divided, as they define the image resolution. Regardless of the hole diameter, each defect lies on a combination of at least two pixels (see Figure 12). This area is indicated on tomography maps as a place with a reduced propagation velocity of ultrasonic waves. In the case of the UT images reconstructed for experimental signals, it can be noticed that they made it possible to determine the location of defects, regardless of their size. At the same time, it was not possible to assess the damage size, as in the case of the numerical results.

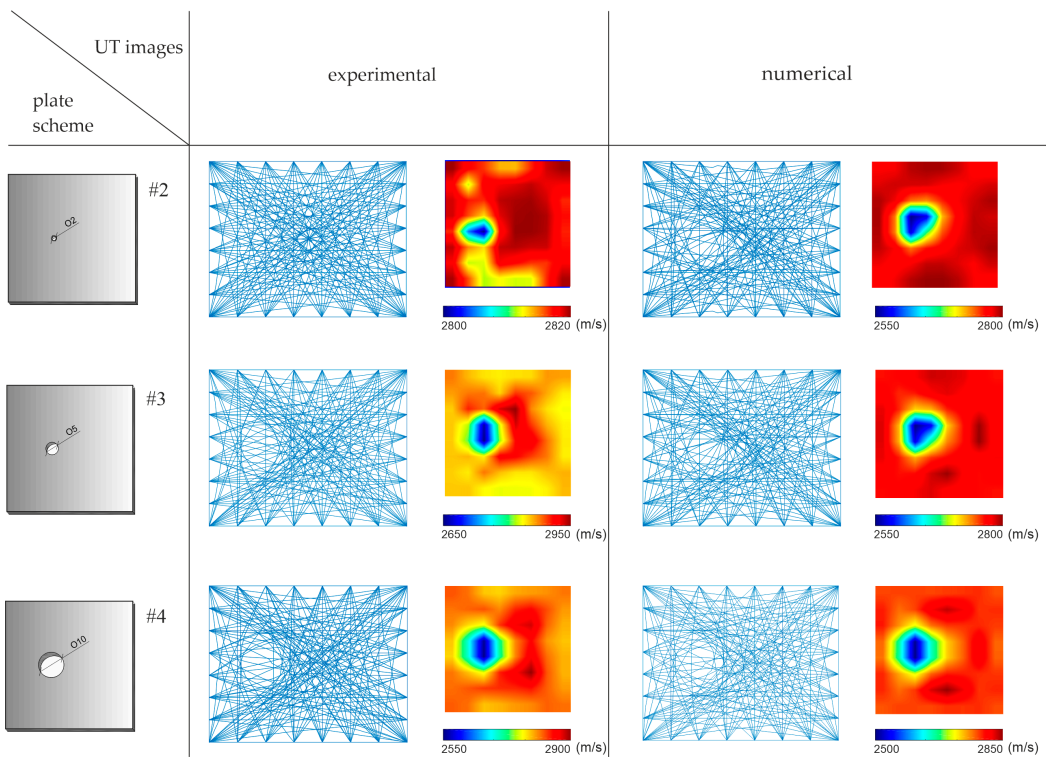
Figure 13. Ultrasonic tomography (UT) maps using direct travel time measurements with curved paths.

Figures 13 and 14 present experimental and numerical tomography maps created using the curved rays determined by the hybrid method. The analysis was carried out for the time of flight measured directly from transmitters to receivers (Figure 13) and by comparing the results between the current and reference state (Figure 14). The first step of the hybrid method is the preparation of a tomographic map for straight rays from transmitters to receivers. These maps are prepared both for the time of flight measured directly and for the differences in signals between the current and reference model. It is the starting point for which further ray bending iterations are carried out [52].

The tomographic velocity maps made on the basis of direct measurements (Figure 13) clearly indicate the location of the defects. They are visible as areas with smaller values of wave propagation velocity. Each of the tomographic images has its own individual scale, with values ranging from minimum to maximum velocity. Maps made for straight paths give satisfactory results. Simultaneously, the use of a hybrid method, combining the network method and the ray bending method, improved the results. In this case, the defect area was more concentrated. However, it was difficult to assess the extent of the damage based on these maps. Analysis of traced rays showed that the paths determined by the hybrid method bypassed the area of the defects.

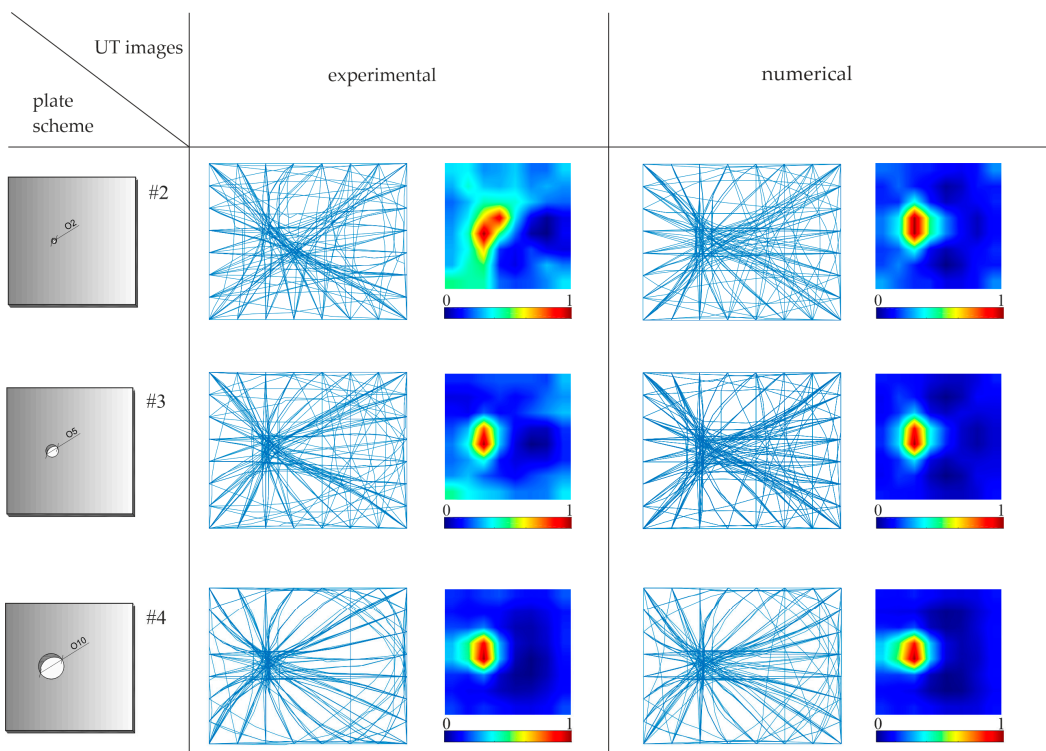
Figure 14. Ultrasonic tomography (UT) maps using the method of signal differences with curved paths.

Figure 14 shows tomographic velocity maps based on the comparison of the TOF between the undamaged plate and plates with growing defects. Values in the map cover the range from 0 to 1, where 1 indicates the highest measured difference between the map for undamaged and defective pieces, and 0 indicates their full compatibility. The circular

hole in each plate is shown as an increased value, which means a significant difference in wave propagation velocity in this area. Curved rays are concentrated within the defect. In this case, the maps are similar to those prepared with the use of straight rays. However, the damaged area is only a little more concentrated. In this case, it was also impossible to estimate the damage size as in the case of straight rays.

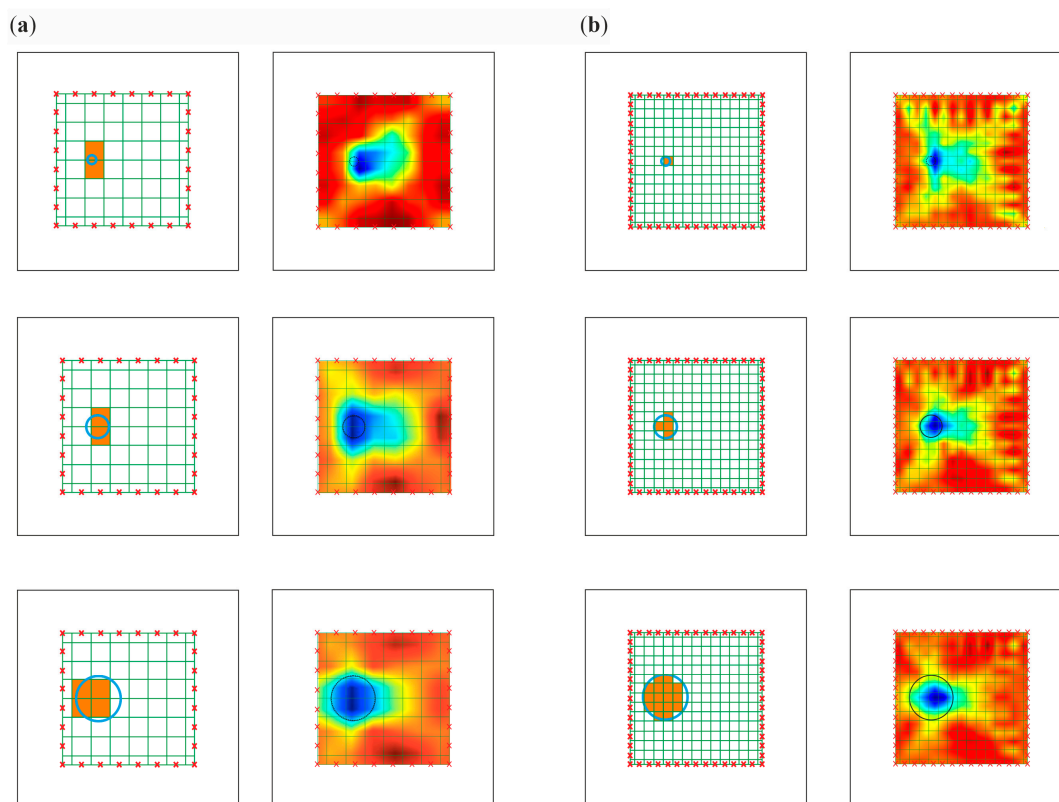
Figure 15. Pixel grid for the direct travel time measurement method: (a) division into 64 pixels; (b) division into 225 pixels.

In order to improve the identification of the size of damage, the pixel mesh was refined. The split of each edge was increased from 8 to 15 elements, which gave a total number of 225 pixels. The dimension of a single pixel was $2.15\text{ cm} \times 2.15\text{ cm}$. The impact of the density grid was assessed for data obtained from numerical simulations. Figures 15 and 16 show the tomography maps prepared for the elements divided into 64 and 225 pixels, respectively, using direct measurement of time of flight and difference in the TOF between the current state and the reference state. Orange colour marks the pixels for which the damage covers more than half of the area. In the case of a 64-cell mesh, the damage was concentrated within two pixels. The exception was damage with a diameter of 10 cm, which occupied 4 pixels. More significant differences in the number of pixels occupied by the damage are visible when the mesh was densified to 225 pixels.

The maps in Figures 15a and 16a concern models divided into 64 pixels. The tomograms are very similar to each other, regardless of the damage size. The images were enhanced significantly by densifying the pixel grid (Figures 15b and 16b). It was possible to estimate the damage size for such prepared tomograms. The size of the area with a lower velocities of wave propagation on these maps increased with the size of the defect.

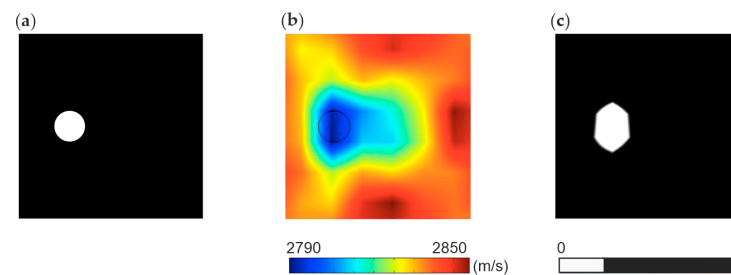
Figure 17. Error coefficient values for maps with reduced spectrum based on direct travel time measurement method: (a) reference model with a reduced spectrum, (b) topographic map with a full spectrum, (c) tomographic map with a reduced spectrum.

The accuracy of the tomographic reconstruction was quantified by using an error coefficient comparing the reference image with the obtained tomographic maps. Each of the prepared tomographic maps was replaced by a simplified model with a reduced spectrum, indicating high and low velocities as well as large and small differences. In the case of direct measurement, pixels with velocities below the 25th percentile of the maximum scale value are considered to be low-velocity indications and are assigned a value of 0, while others are assigned a value of 1. An example of spectrum reduction for direct measurement is shown in Figure 17. In the case of maps based on signal differences for an undamaged structure and a damaged structure, pixels with a difference above the 75th percentile of differences in a scale are assigned a value of 0, and the remaining pixels are assigned a value of 1.
