Article

Imaging of Increasing Damage in Steel Plates Using Lamb Waves and Ultrasound Computed Tomography

Abstract: This paper concerns the inspection of steel plates, with particular emphasis on the assessment of increasing damage. Non-destructive tests were performed on four plates, one of which was undamaged, while the remaining three had defects in the form of circular holes with diameters of 2, 5 and 10 cm. Guided Lamb waves were used in the research, and the image reconstruction was performed using ultrasound computed tomography. The damage size was estimated by tracking the real course of rays and densifying the pixel grid into which the object was divided. The results showed the great potential of ultrasound tomography in detecting defects in steel elements, together with the possibility of estimating damage size.

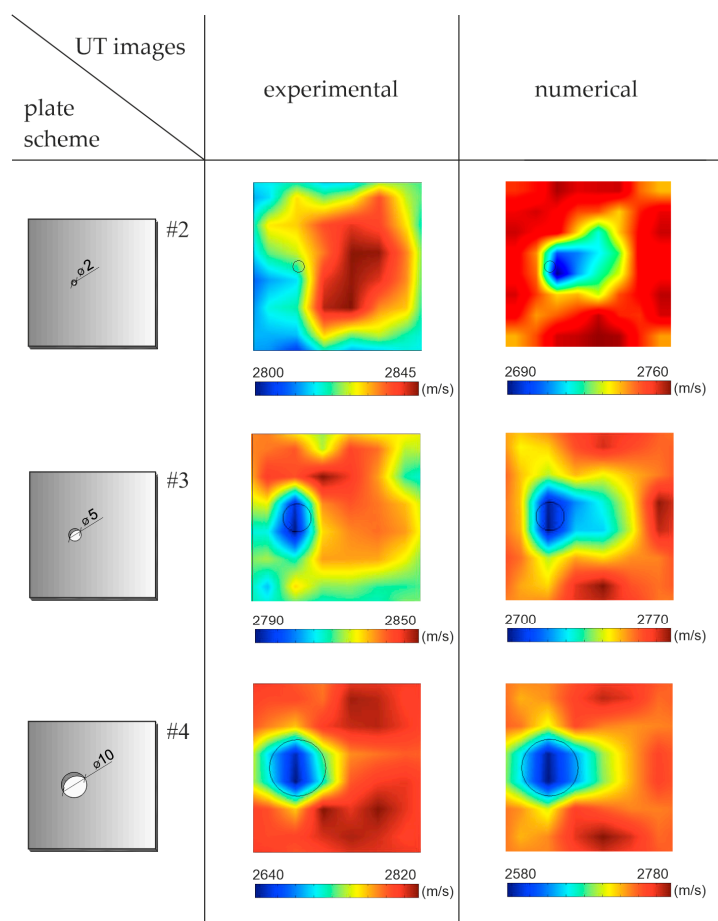
**Figure 9.** Ultrasonic tomography (UT) velocity maps using direct wave transition in plates with surface damage.

The ultrasonic tomography maps are illustrated in Figure 9. The first column shows the plate scheme; the next two present the tomographic maps based on experimental and numerical signals, respectively. The tomograms are constructed, based on the direct measurement of the wave travel time, which means that the results were not compared with the results obtained for the undamaged plate. Each of the performed tomograms is presented separately, ranging from the minimum to the maximum speed. The maps present results for all considered plates, with the increasing surface damage in the form of holes with a diameter of 2, 5 and 10 cm. The defect with a diameter of 2 cm was properly imagined only for data obtained from numerical tests. On the other hand, the holes with a diameter of 5 and 10 cm were successfully detected in both experimental and numerical results. The locations of this damage are marked as areas with a reduced speed in relation to the surrounding material. However, the size of the holes was difficult to estimate accurately.
