Research paper

Risk assessment for tram traffic on tramway bridges

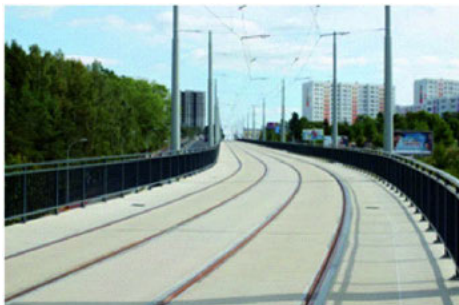
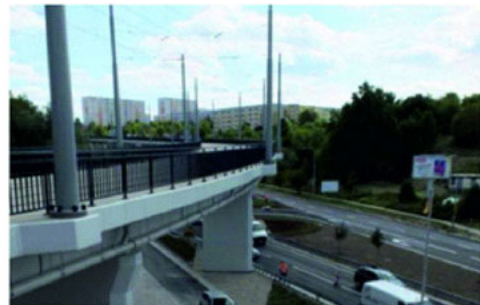
Fig. 4. View of the tramway bridge in Rakoczego St., Gdansk. Source: press materials, trójmiasto.pl

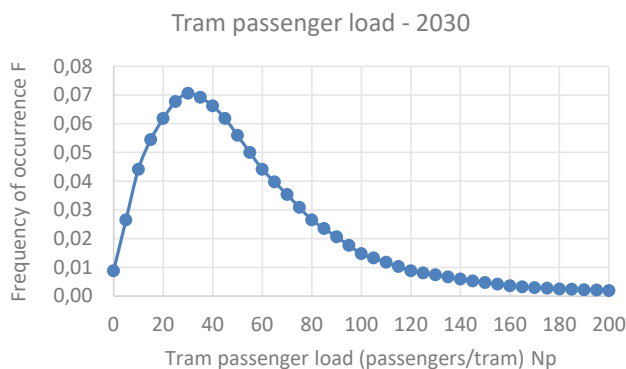
Probability of a hazardous event. Further analyses used tram passenger load data which were developed on the basis of previous research by the authors. Next, tram traffic forecasts on the analysed line were developed for 2030 and the average daily distribution of tram passenger loads was determined (Fig. 8).

Fig. 8. Distribution of the daily tram passenger load on the analysed section of the line – forecast for 2030 [10]

Current research shows that at present the average tram passenger load is about 3 passengers on one tram journey with app. 20 passengers as the maximum value. Forecasts suggest a large increase in the number of passengers with the average passenger load at 54 passengers and the maximum value at up to 200 passengers per tram journey on the analysed section.
