## Research paper

# Risk assessment for tram traffic on tramway bridges

In September 2015 a tram line was opened along Rakoczego Street in Gdansk. It connects Morena (a district of Gdansk) with the Pomeranian Metropolitan Railway's (PKM) Bretowo station. On a section of approx. 1.0 km the line runs along a longitudinal decline with varying gradients from 0 to 5%. At 0.3 km from the PKM stop, the line runs along a horizontal curve with a radius of  $R = 180$  m. The tram line is connected to the PKM stop by a 362.1 m double-track overpass (Figures 1–4) with a gradient of up to 5%. It stands on thirteen spans, the highest

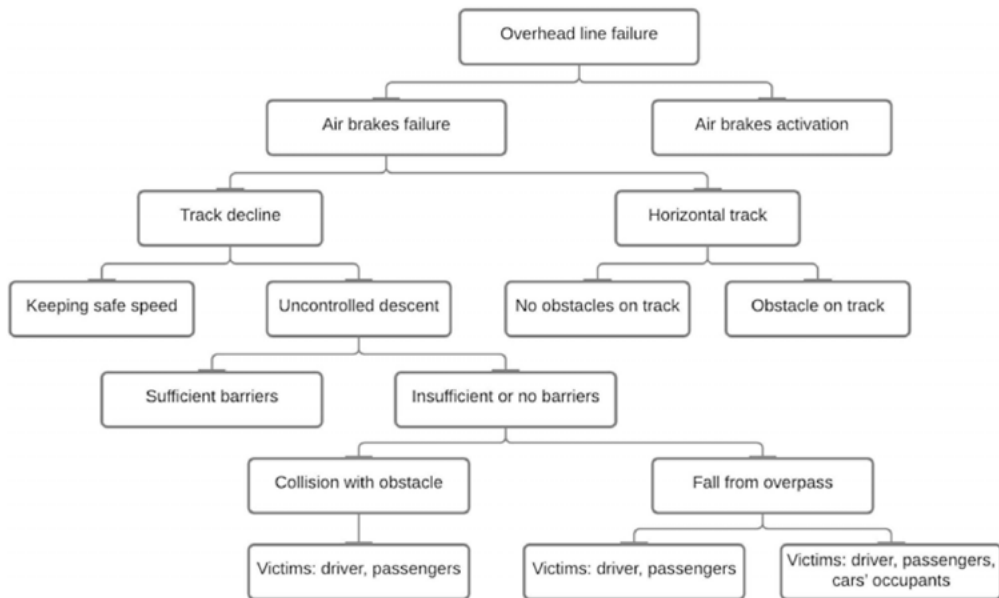
Fig. 5. The cause and effect event sequence during the failure of an overhead contact line – event tree [10]

Three methods were used to identify the risk of hazards: the event tree method, fault tree method and Bow–Tie method [6, 9, 14, 15, 21]. Fig. 5 shows a diagram of the cause and effect event sequence during the failure of an overhead line.

The cause and effect sequence of events presented in the diagram shows that a failure of the overhead contact line may be the initiating dangerous event on the analysed section of tram tracks located on the overpass. Failure of a tram overhead contact line may cause the vehicle to come to a stop slowly when it is on a flat section of the track. However, where a tram is on a section of the track located on a longitudinal decline (during a power failure), the tram car may start to roll (unable to start in-service braking) in a controlled manner (with the possibility of safety or emergency braking) or uncontrolled manner (unable to engage any braking, e.g. failure or deactivation of the braking system).
