Fatigue fracture morphology of AISI H13 steel obtained by additive manufacturing

Wojciech Macek · Rui F. Martins · Ricardo Branco · Zbigniew Marciniak · Mirosław Szala · Sebastian Wroński

Received: 18 October 2021 / Accepted: 10 December 2021
© The Author(s) 2022

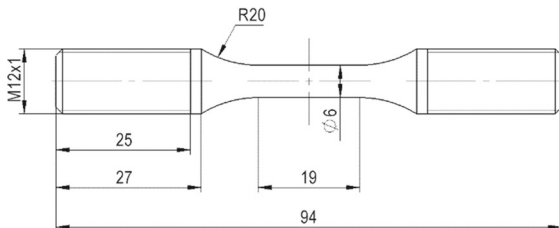
**Fig. 1** Specimen geometry used in the fatigue campaign (units: mm)

The H13 steel specimens were manufactured with the usage of a SLM Solutions SLM 125 industrial 3D printer and commercial powder. SLM additive process parameters used in the fabrication of the tested specimens are given according to our previous study (Garcias et al. 2021), with energy densities ranging from 92.59 to 111.11 J/mm³, and laser speeds of 300 and 250 mm/s, respectively. The metallic powder used in the specimens had dimensions between 10 and 45 µm, whose chemical composition is described in Table 1. The specimens for fatigue testing were printed in the vertical direction, according to the geometry exhibited in Fig. 1, and were not subjected to any heat

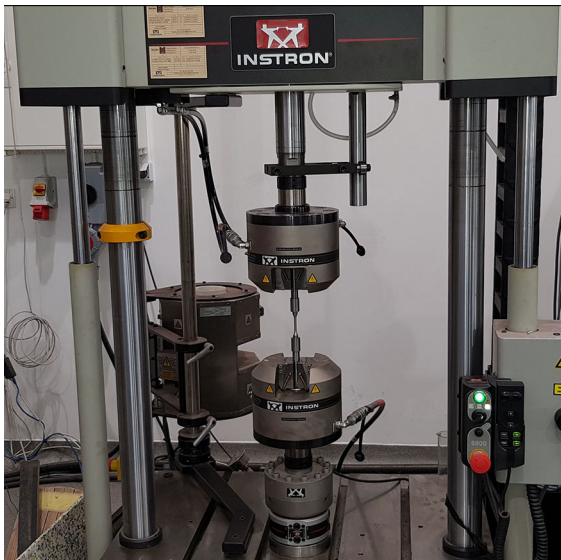
**Fig. 2** Servo-hydraulic machine used to carry out the fatigue tests

The H13 specimens produced by SLM were tested using an Instron 8802 fatigue machine, with a maximum load cell of 100 kN, under uniaxial conditions (see Fig. 2). The tests were performed at a load ratio $R = 0.2$ with a frequency of 1 Hz for the highest load values, 2 Hz for the intermediate load levels, and 5 Hz for the load level at which it was expected to reach infinite life. All tests were carried out at room temperature. Two specimens were used for each load level, for at least four different stress levels in the finite life region. Test pieces that reached two million cycles were considered infinite life (run out). The nominal stress levels are presented, inter alia, in Table 2, together with the results of surface topography measurements.

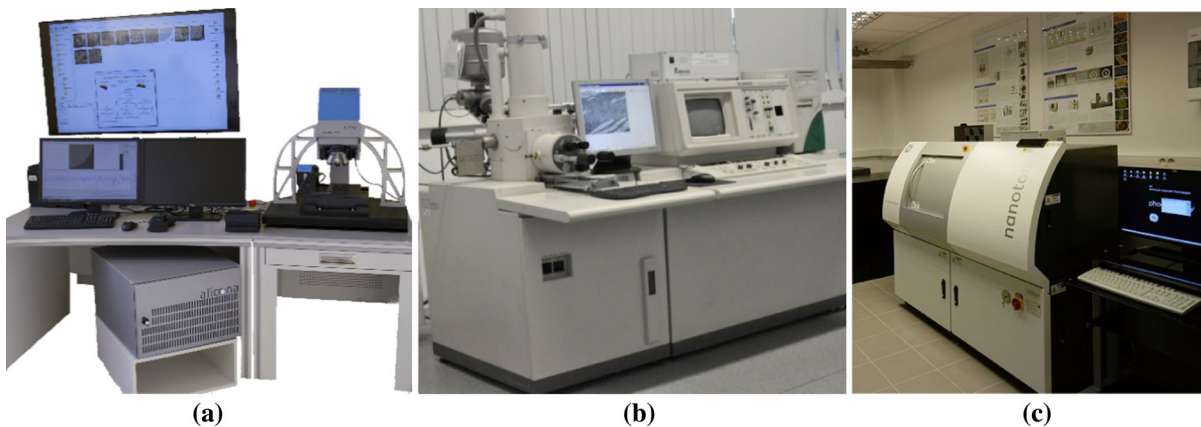
Fig. 3 **a** Infinite focus IF G4 measurement device used in surface metrology, **b** phenom desktop scanning electron microscope (SEM), **c** micro-CT scanner Nanotom 180N

Topographic measurements of the fracture surfaces were performed with an Alicona G4 optical profilometer using focus-variation technology with a $\times 10$ lens (see Fig. 3a). Due to the restricted field of view, eight rows and seven columns were stitched together to map the entire fracture surface area. The fracture surface maps were processed with MountainsMap® software for quantitative analysis and visualisation. A similar configuration of equipment and software for surface analysis was used in the works (Allum et al. 2020; Kahlin et al. 2020). Additionally, the fractures of the fatigue specimens were also observed under specific magnification using a Phenom desktop Scanning Electron Microscope (SEM) as described elsewhere (Żebrowski et al. 2019) (see Fig. 3b).

The microtomography measurements presented in this paper were performed using a Nanotom 180 N device (see Fig. 3c) produced by GE Sensing & Inspection Technologies phoenix X-ray GmbH. The machine is equipped with nanofocus X-ray tube with maximum 180 kV voltage. The tomograms were registered on Hamamatsu 2300 2300 pixel detector. The reconstruction of measured objects was done with the aid of proprietary GE software datosX ver. 2.1.0 with use of Feldkamp algorithm for cone beam X-ray CT (Feldkamp et al. 1984). The post reconstruction

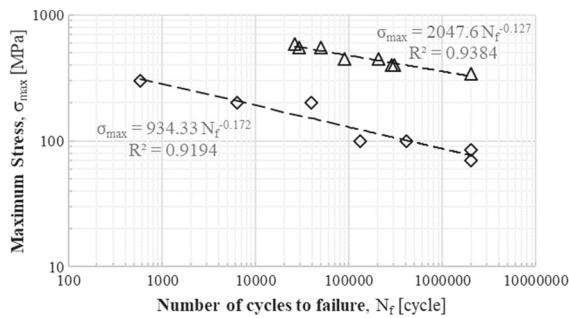
Fig. 4 SN diagrams (σ_{\max} vs. N_f) for AISI H13 by SLM (diamonds) and conventional manufacture (triangles). Load ratio, $R = 0.2$. Fatigue results of the conventional manufactured specimens were taken from the reference Garcias et al. (2021)

Fatigue results in form of S–N curves for both the additively manufactured and conventional specimens are shown in Fig. 4. Overall, the maximum applied stress can be successfully related to the number of cycles to failure via power functions. As can be seen, the fitted curves present high correlation coefficients. In the case of the SLM samples, the scatter is higher, which can be explained by the specificities of the manufacturing process which is more susceptible to defects. Besides, the details about the fatigue loads and fatigue lives as well as the fracture surface topography measurements are presented in Table 2. The maximum and minimum values of individual fracture surface parameters are marked in green and yellow,

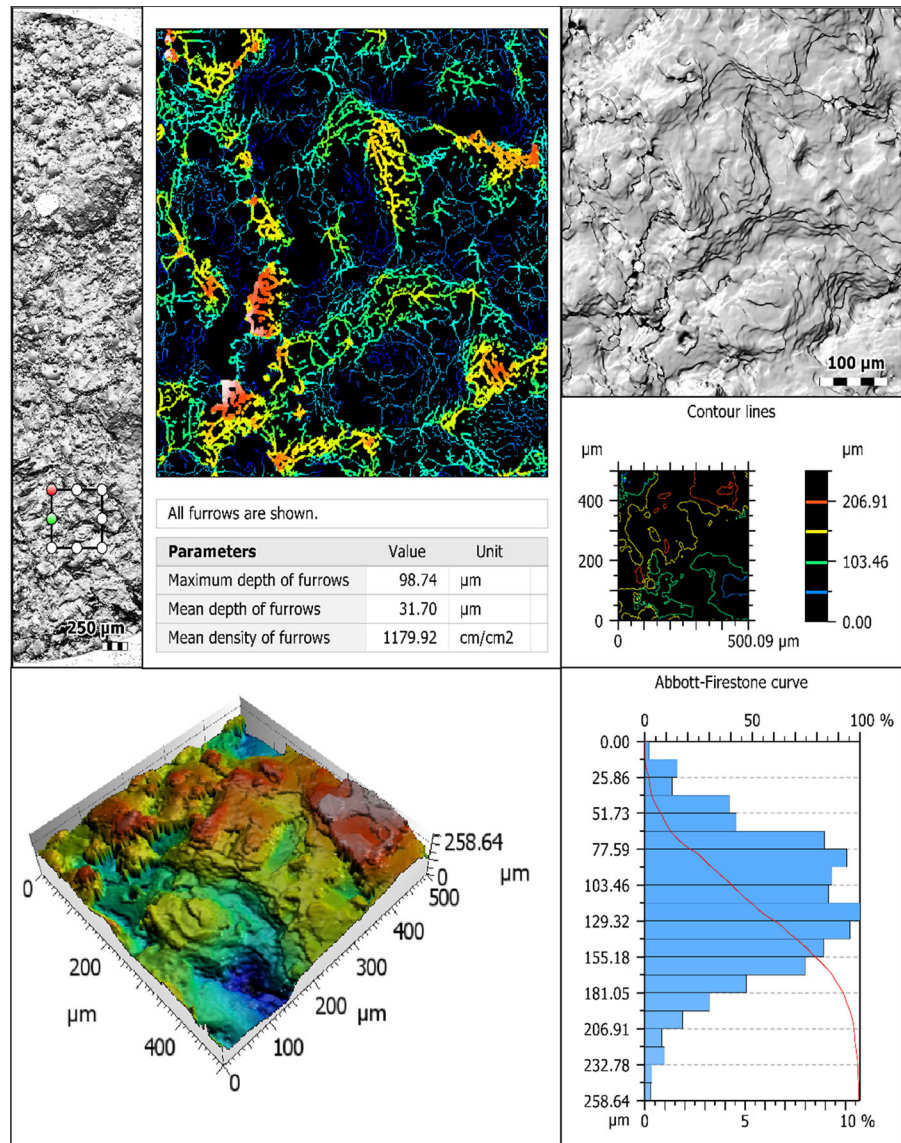
Fig. 5 Visualization of exemplary fracture area with the furrows, contour lines, and depth histogram

As shown in Fig. 5, there are specific dissidences between the different fracture zones. In Fig. 5 are also shown the depth histograms related to the analyzed example fracture surface. The depth histogram represents the distribution density of the surface data points. The horizontal axis is depicted in percent of the total number and the vertical one in depths, followed by the Abbott-Firestone (Abbott and Firestone 1933; Deepak Lawrence et al. 2014) curve shown in red. Also, the Furrows plot displays all furrows and results for maximum furrow depth, mean furrow depth, and furrows' mean density. The contour lines reveal that in all areas of the fracture, the peaks and valleys form a collection of irregular geometries in different subregions of the measured samples. However, given the promising results, especially for fatigue and fracture investigations, the authors decided to employ the total fracture surface method used by Macek et al. (2021a).

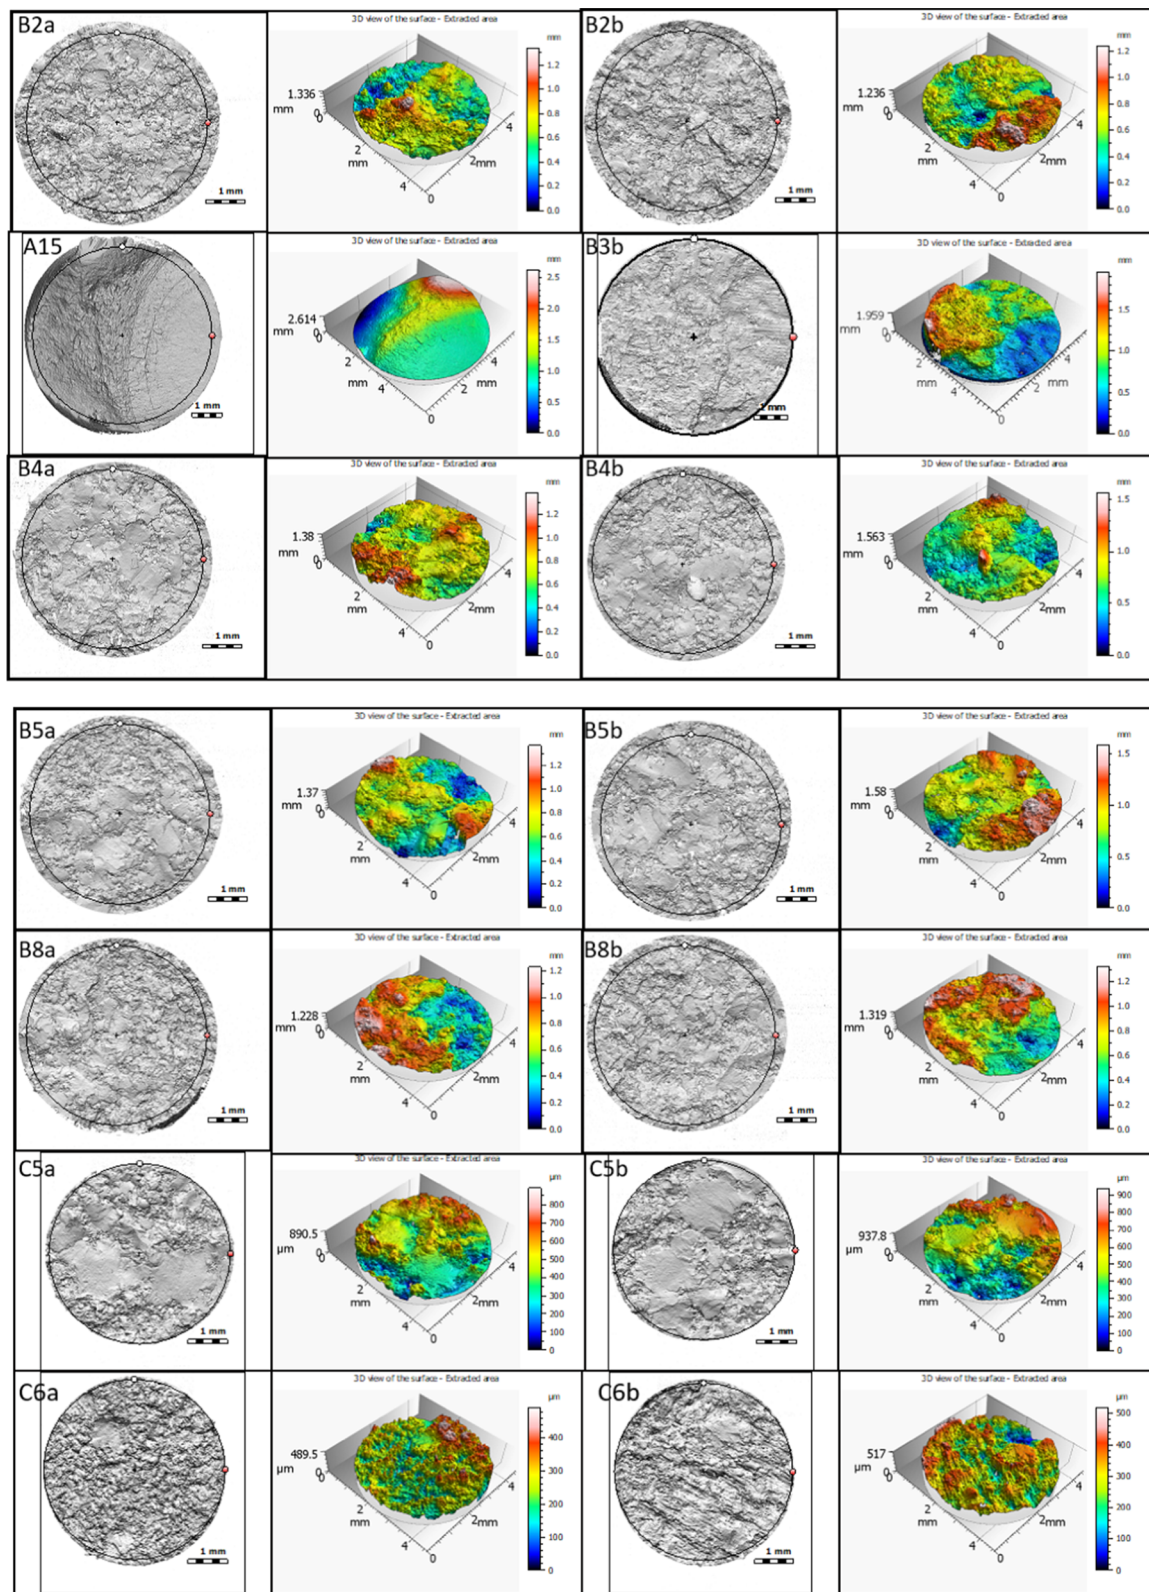
Fig. 6 Fracture surfaces in pseudo-color views

Figure 6 shows fracture surfaces of specimens obtained after fatigue test received with the Infinite-Focus IF G4 variable focal length microscope. The whole current surface was reduced to eliminate the final break, discontinuities, and non-sampling areas. Regions of interest are also presented in isometric views. SLM specimens are denoted with B and C

letters, while A15 specimen represents the fracture surface of a conventional manufactured specimen subjected to fatigue loading. The pseudo-color views of the SLM-based specimens are more random than those of the conventional one. In the latter case, the changes are more uniform and progressive along the entire surface. This fact is predictable, because the additively manufactured samples, due to the nature of the fabrication process, contain more defects disperse throughout the fracture surface, which affects the fracture topology.

Fractographic analysis of conventionally manufactured H13 steel (specimen A15) and SLM specimens' fractures given in Fig. 6 allows to state that SLM additive manufactured samples do not exhibit classic fatigue fracture surfaces usually showing initiation, crack propagation and catastrophic rupture areas, likewise specimen A15 of Fig. 6. It derives mainly from the fact that additively manufactured metallic structure has a much more complex structure consisting of fully melted material and unmelted powder particles and pores which influences the fatigue properties and fracture structure. The effect of porosity on fatigue response is clear by comparing, for instance, both the C5 and C6 specimens, which were tested under the same stress loading conditions (see Table 2). Nevertheless, the former exhibited a fatigue life 10 times higher than the latter. A closed analysis of Fig. 18 shows that the average porosity of the C6 specimens is higher than that of the C5 specimen. However, if we compare the average pore diameters, the former has higher values and closer to the surface which eases the fatigue crack initiation process.

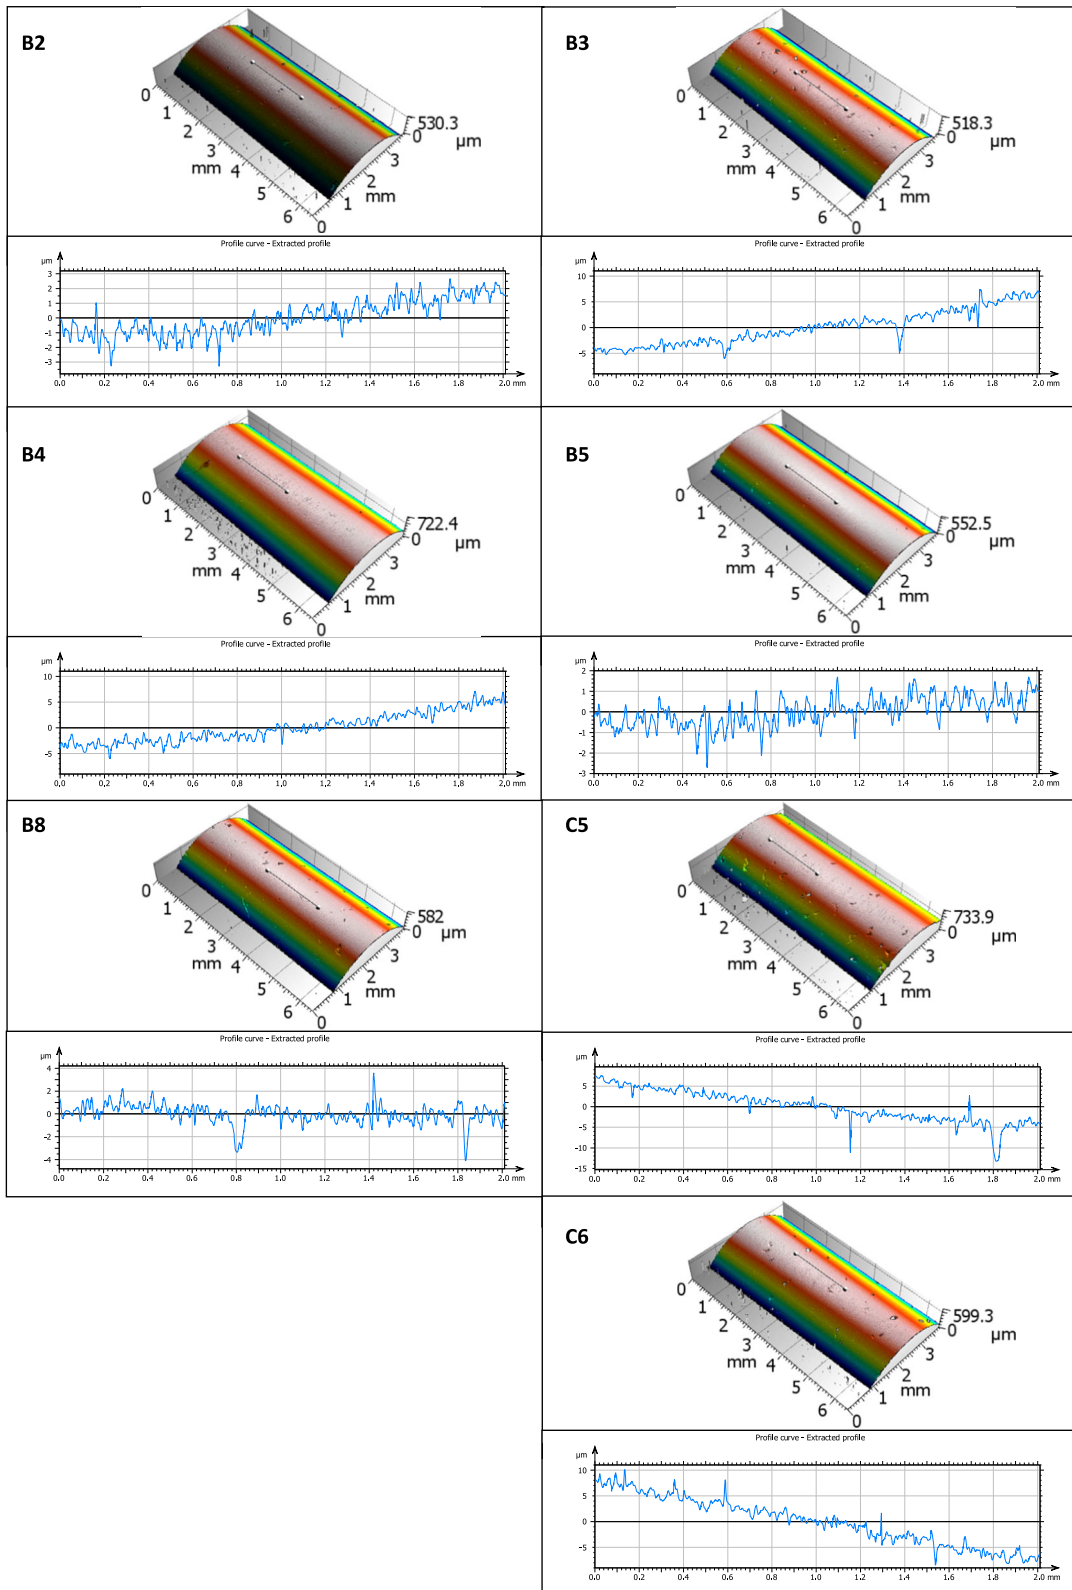
Fig. 7 Side surface profile of the specimen, measured before the fatigue tests

The side surface profile of the specimen R-parameters does not correlate with the load values, which results from the large irregularity of the valley distribution on the specimen surface and the randomness of the applied measurement profile. Therefore, the profile results, measured as in Fig. 7, will not be used for further analyses. The surface parameters of fatigue fractures, as shown in Fig. 6, will be analysed further, especially in combination with the loads.

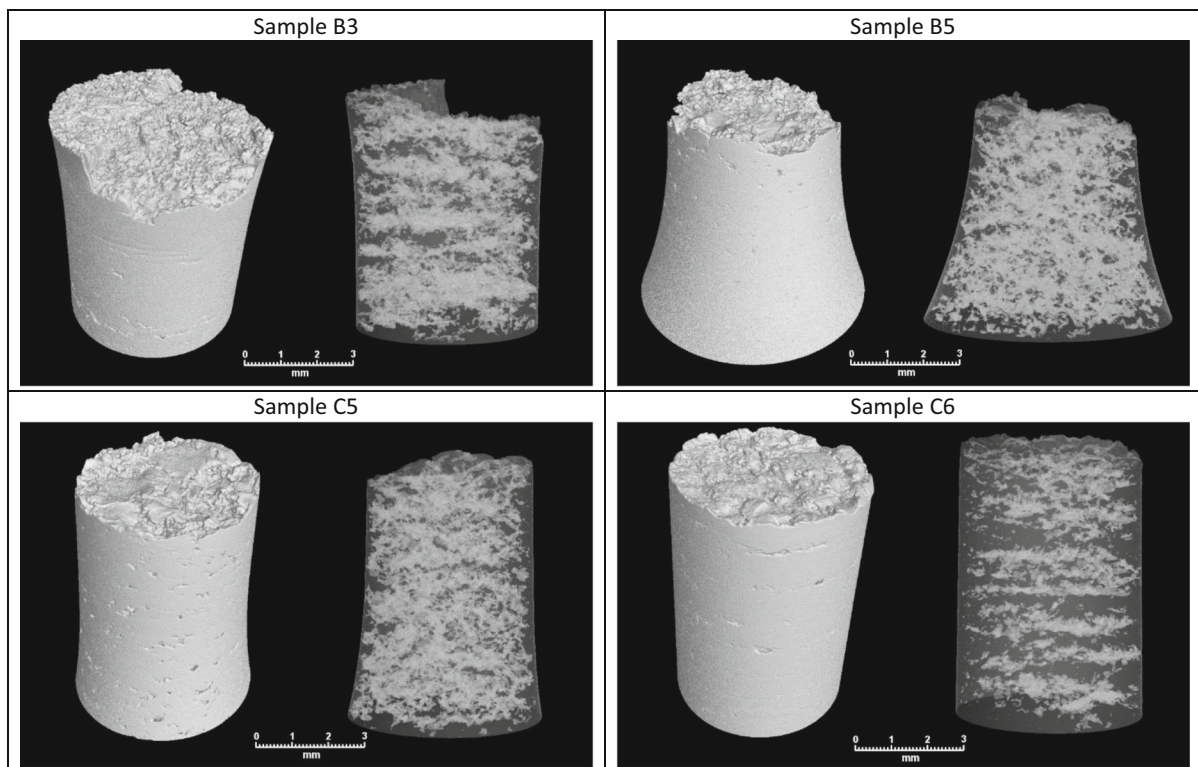
Fig. 8 Three-dimensional micro tomography visualizations of samples B3, B5, C5 and C6

Figure 8 shows typical three-dimensional visualizations of the tested samples. For each of them, a model was presented using the isosurface function (presenting the surface of the examined object) and a model using the transparence function, which enables visualization of the spatial distribution of pores inside the sample volume. As the data show, the fracture plane for samples B3 and B5 has a much more irregular shape than that of the samples C5 and C6. There is a clear step in sample B3. When we analyze the spatial distribution of pores, it can be seen that it is quite homogeneous for samples B5 and C5. In turn, for samples B3 and C6, it can be seen that porosity after mechanical loading changes along the length of the sample. The variation in porosity shows a certain periodicity.

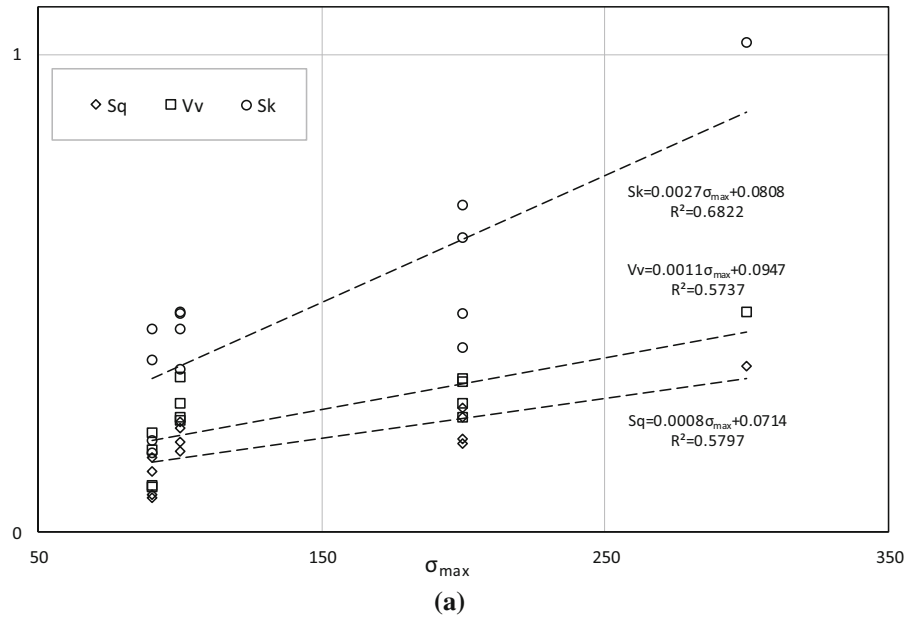
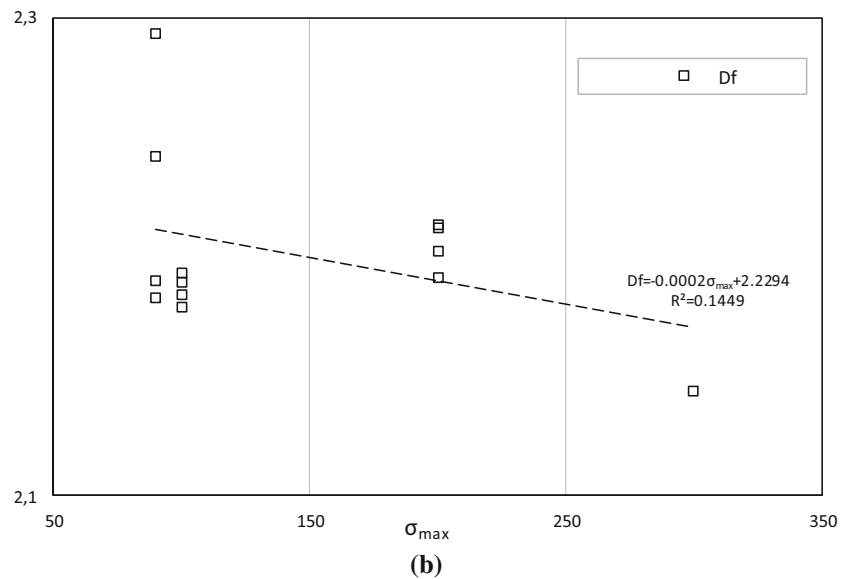
Fig. 9 Maximum stress σ_{max} vs. fracture surface measurement for: **a** Sq, Vv, Sk; and **b** fractal dimension Df

Figures 9 and 10 show, respectively, the relationship between the fatigue loading and the fracture surface parameters, and the relationship between the fatigue life and the fracture surface parameters for the AISI H13 SLM steel specimens.

The analysis of the fracture surfaces based on the entire fracture surface method using the selected surface topography parameters (see Fig. 9a) confirmed that surface parameters values grow with fatigue loadings for both surface parameters S_q

(Eq. 1) and S_k and volume parameter V_v (Eq. 2). The opposite situation was noted for the fractal dimension D_f (see Fig. 9b). The research results also indicate a strong influence of the maximum stress σ_{\max} in the fracture surface roughness, but most for the results characterized by the parameter core height, S_k . The proportion of the variance for a dependent variable, expressed as R^2 , is approximately 0.68. The fractal dimension D_f is also consistent for the linear approximation, but the proportion of the R^2 is only 0.15. Fatigue test results N_f compared with the analysed fracture surface parameters (see Fig. 10) do not show unequivocal relationships.

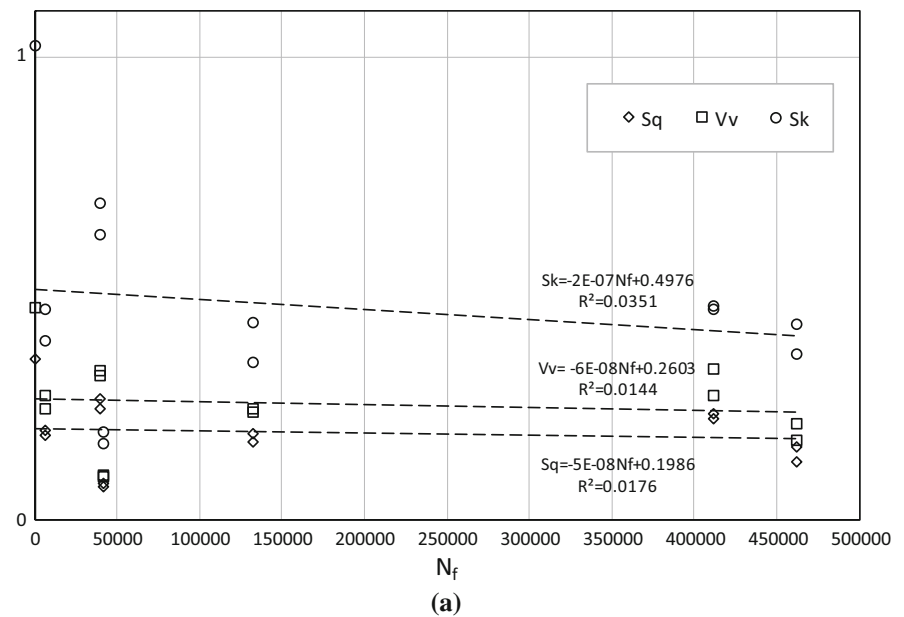
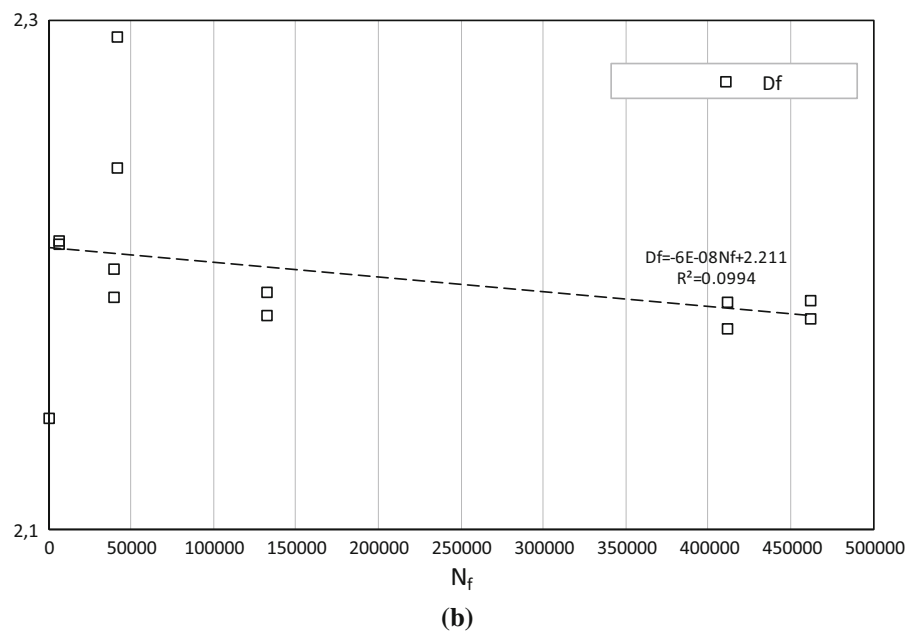
Fig. 10 Fatigue life N_f vs. fracture surface parameters, for: **a** S_q , V_v , S_k ; and **b** fractal dimension D_f

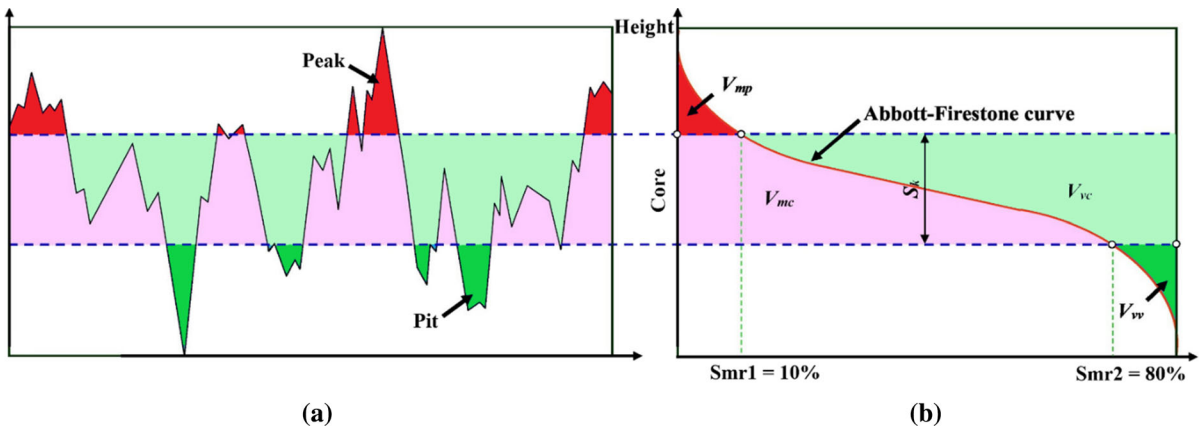
Fig. 11 Graphical presentation of the functional (volume) parameters: **a** an exemplary surface profile; **b** functional (volume) parameters of Abbott–Firestone curve according to ISO 25178. Adopted from (Macek 2021)

S_q (Eq. 1) is the root mean square height, while void volume V_v calculated for a material ratios S_{mr} , by integrating the volume enclosed above the surface and below a horizontal cutting plane (Eq. 2). Graphical illustration of the functional (volume) parameters is presented in Fig. 11.

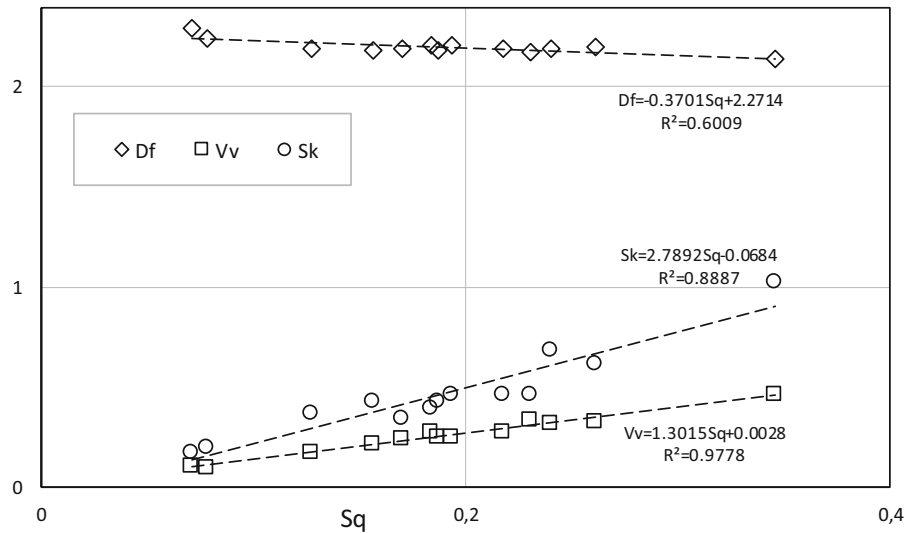
Fig. 12 Relationship between fractal dimension D_f , void volume V_v , core roughness depth S_k and root average square height S_q values for the SLM specimens

A comparison was made for the fractal dimension D_f , void volume V_v , core roughness depth S_k and root average square height S_q values (see Fig. 12) of the additively manufactured specimens subjected to fatigue loading. Overall, there is a very good correlation between these variables, and the data can be successfully fitted using linear functions for all cases. V_v shows the highest compliance with S_q ($R^2 = 0.98$), which results from the method of calculating both parameters.

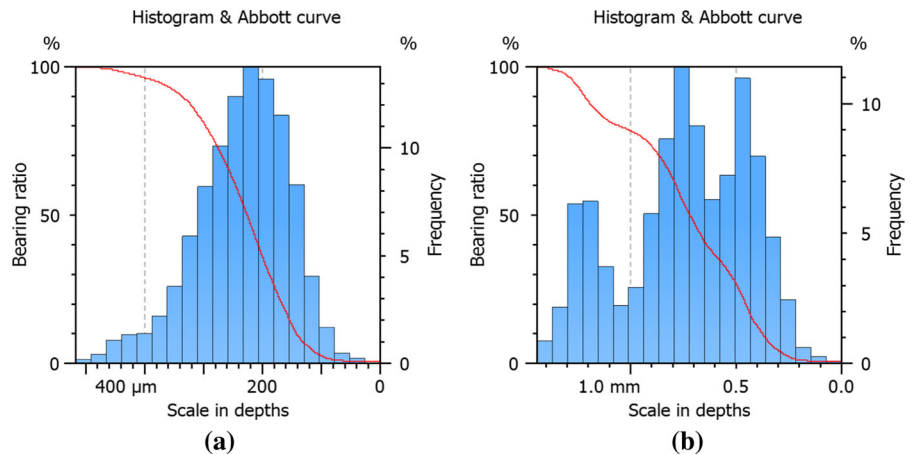
Fig. 13 The depth histograms of the fracture surfaces: **a** minimum S_q value (specimen C6a); and **b** maximum S_q value (specimen B3b). The vertical axis represents the bearing ratio [%], and the horizontal axis represents the depths (measurement unit)

histogram distribution is more even. This occurs because the largest measured Sq value (specimen B3b) has the lowest depth distribution value (about 13%). On the other hand, the lowest Sq value, occurring for the C6a specimen, generates the highest percentages, amounting to approximately 15%.

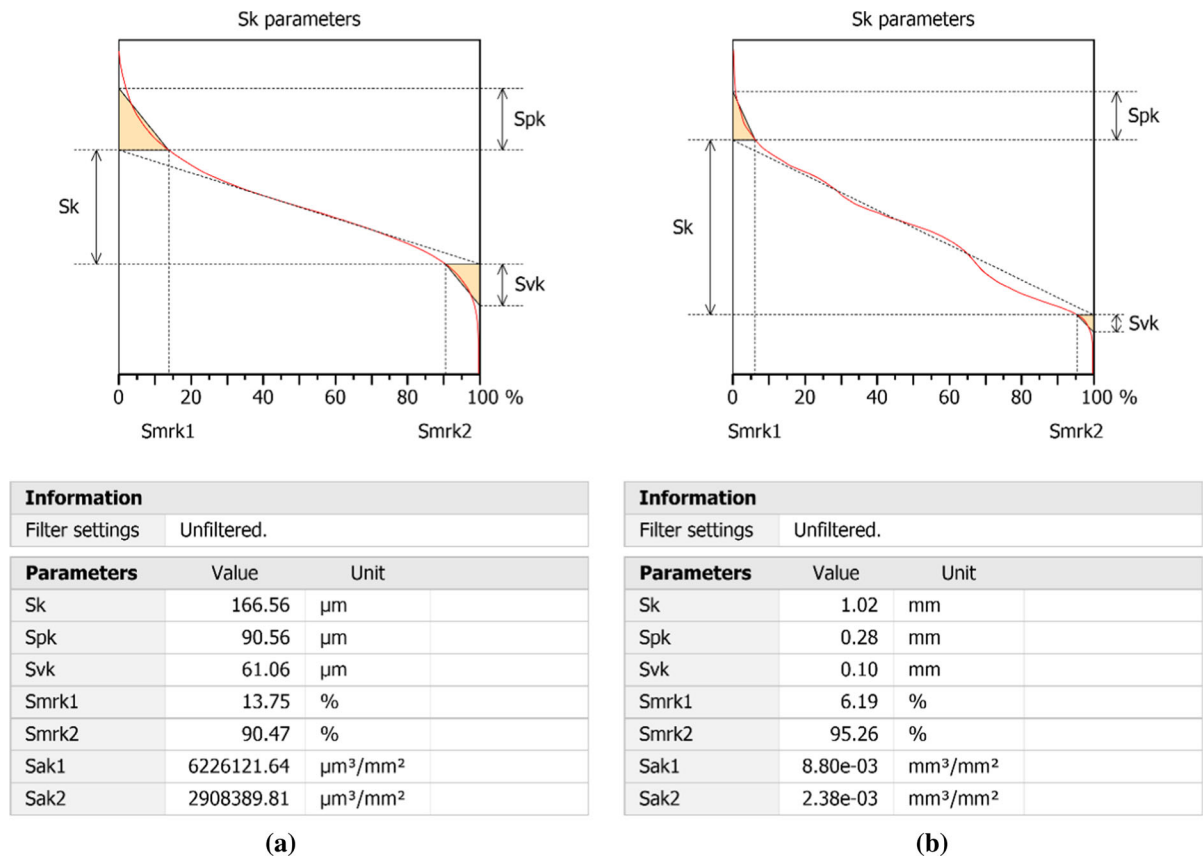
Fig. 14 Representation of functional (stratified) parameters in Abbott-Firestone curve for the specimen: **a** C6a; and **b** B3b

and valleys removed. From Figs. 9a and 14, we conclude that S_k increases with stress level. For example, an increase in the mean stress level σ_m from 54 to 180 MPa results in an increase in S_k from 0.17 to 1.02 mm (500% increase).

respectively. Reduced peak height Spk is the height difference between the Abbott-Firestone curve and the equivalent line at 0% material ratio. Spk parameter expresses the average of peak heights above the core surface. In Fig. 14, we can see that for a specimen with a minimum Sk (specimen C6a), Spk occurs at $Smrk1 = 13.75\%$ and takes a small value ($90.1 \mu\text{m}$), with $Svk = 61 \mu\text{m}$. In addition, for the maximum Sk (specimen B3b), Spk occurs at $Smrk1 = 6.19\%$, and Svk is relatively low (0.1 mm) with $Smrk2$ being over 95% .

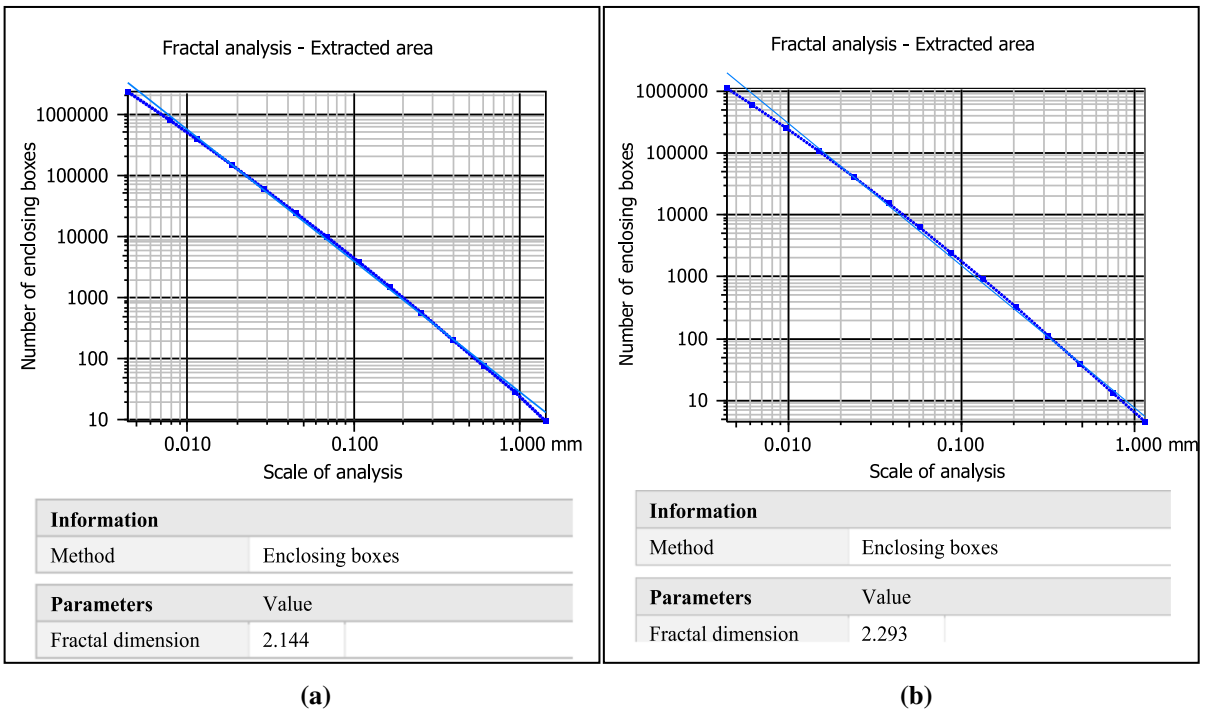
Fig. 16 The fractal dimensions D_f with slope values and coefficients of correlation R^2 determined by the enclosing boxes method for analysed cases: **a** minimum D_f value (specimen B3b); **b** maximum D_f value (specimen C6a)

The fractal dimension D_f was calculated using the enclosing boxes method (EBM) from the extracted final fracture surface areas. The EBM divides the profile into smaller sections with a width ε and calculates the field A_ε of all fields covering the entire profile. This is an iterative procedure in which the width of the field is changed to plot, $\ln(A_\varepsilon)/\ln(\varepsilon)$.

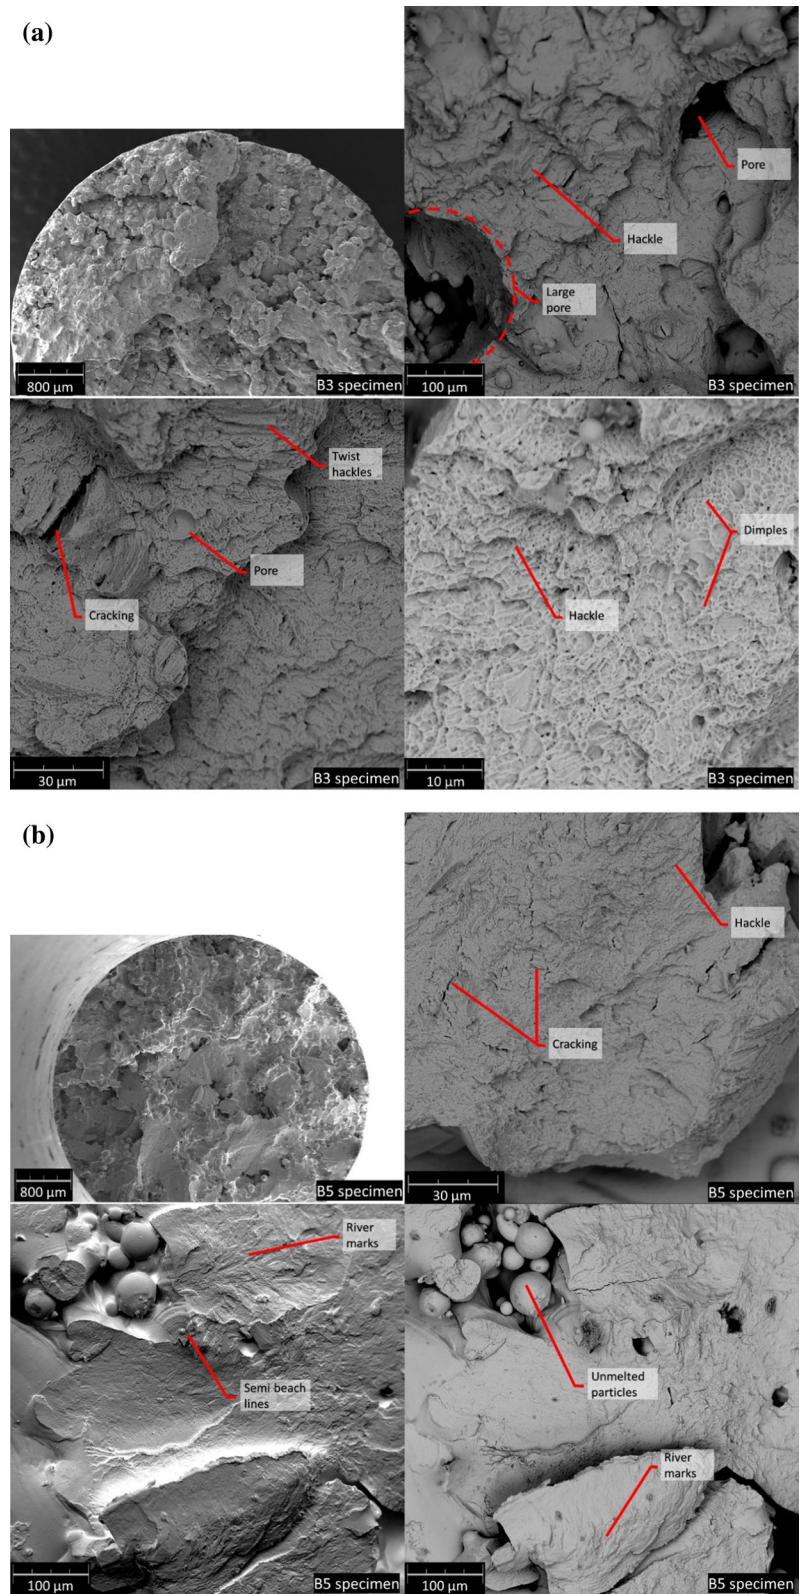
Fig. 17 The fracture morphology: **a** specimen fractured at high stress level, B3; **b** fracture of low stress level, B5 (SEM, BSE and topographic modes)

Comparison of fracture surfaces obtained for different fatigue testing conditions, observed using SEM is presented in Fig. 17, while the variability of porosity and pore size along the sample axis, after mechanical loading revealed using Micro-CT, is shown in Fig. 18.

Another interesting outcome is that the average pore size observed by SEM in the fractured surfaces, see Fig. 17, is in the range of pore diameter estimated by Micro-CT (Fig. 18) and it varies from 0.08 to 0.15 mm. There are also oscillations that are correlated with changes in porosity, which proves that the pore distribution is heterogeneous along the sample—in areas with high porosity, the pores are larger than in areas with less porosity, see Fig. 8. In the C5 sample, the mean value of the porosity increased to the value of about 12%. Also visible are oscillations with a slightly smaller amplitude than in sample C6. On the other hand, the mean value of the pore size increased slightly; however, it shows much smaller oscillations than in the C6 sample. This proves that the average pore size along the sample axis is practically constant after a greater number of cycles. It can therefore be concluded that the greater number of cycles resulted in an increase in porosity and in the uniformity of the pore size. Interior porosity is visualised in Fig. 8 and can be read from the fracture surface observed via SEM, Fig. 17. Therefore, Fig. 17a shows coarser pores than those observed in the case of samples damaged with lower stresses, see Fig. 17b. Moreover, SEM fractographic investigations confirm that the samples tested with the high loading level, likewise B3 specimen (see Fig. 17a), present the rougher fracture

surface than those tested with lower loadings, likewise specimen B5 (see Fig. 17b). High load-tested specimens present the rough fracture surfaces in which dimples are visible. On the other hand, the higher number of cycles to failure N_f results in the presence of semi beach lines and the predominant fracture mechanism is transgranular fracture mode with the presence of cleavage fracture with river patterns. Moreover, the microstructure of SLM manufactured specimens affects crack propagation. The component porosity and unmelted powder particles act as internal notch and facilitate fatigue damage. These structural features originate from fatigue cracking and the fracture makings; likewise, hackles and cracks are visible.
