Fatigue fracture morphology of AISI H13 steel obtained by additive manufacturing

Abstract The paper focuses on researching the effect of fatigue loading on metallic structure, lifetime, and fracture surface topographies in AISI H13 steel specimens obtained by selective laser melting (SLM). The topography of the fracture surfaces was measured over their entire area, according to the entire total area method, with an optical three-dimensional surface measurement system. The fatigue results of the SLM 3D printed steel specimens were compared with those reported for conventionally manufactured 13H steel. The investigation also considers the roughness of the specimens' side surface. Moreover, the fractographic

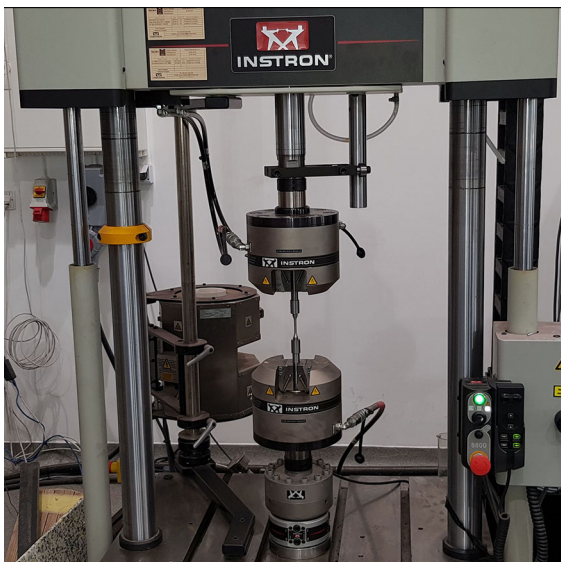
**Fig. 2** Servo-hydraulic machine used to carry out the fatigue tests

The H13 specimens produced by SLM were tested using an Instron 8802 fatigue machine, with a maximum load cell of 100 kN, under uniaxial conditions (see Fig. 2). The tests were performed at a load ratio $R = 0.2$ with a frequency of 1 Hz for the highest load values, 2 Hz for the intermediate load levels, and 5 Hz for the load level at which it was expected to reach infinite life. All tests were carried out at room temperature. Two specimens were used for each load level, for at least four different stress levels in the finite life region. Test pieces that reached two million cycles were considered infinite life (run out). The nominal stress levels are presented, inter alia, in Table 2, together with the results of surface topography measurements.

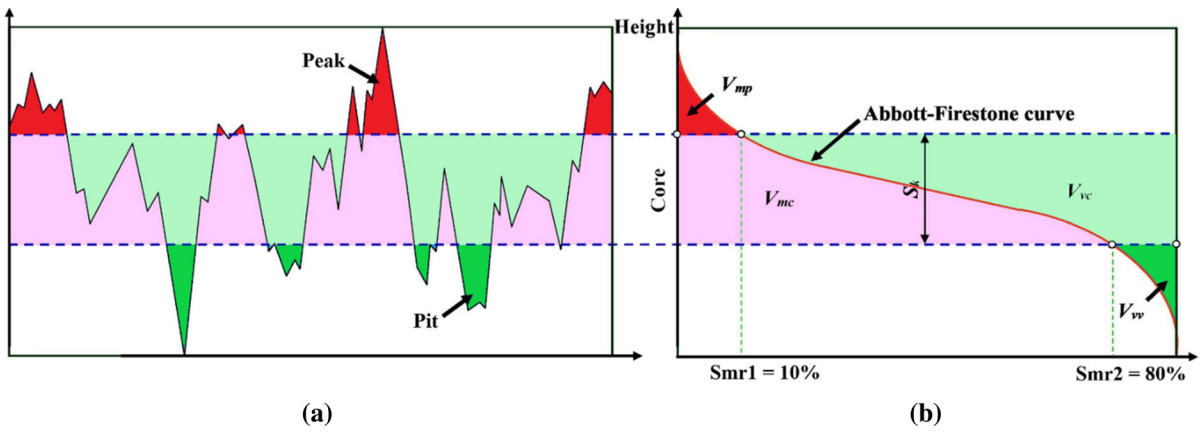
Fig. 11 Graphical presentation of the functional (volume) parameters: **a** an exemplary surface profile; **b** functional (volume) parameters of Abbott–Firestone curve according to ISO 25178. Adopted from (Macek 2021)

S_q (Eq. 1) is the root mean square height, while void volume V_v calculated for a material ratios S_{mr} , by integrating the volume enclosed above the surface and below a horizontal cutting plane (Eq. 2). Graphical illustration of the functional (volume) parameters is presented in Fig. 11.
