# Influence of PWHT Parameters on the Mechanical Properties and Microstructural Behavior of Multi-Pass GTAW Joints of P92 Steel

**Abstract:** The 9% Cr steels were developed for ultra-supercritical (USC) power plants to meet the requirements of high operating temperature and pressure. These steels are produced to operate at high temperatures where impact toughness is not a concern; however, it becomes important for the welded joints to have good impact toughness at room temperature for manufacturing. The present work investigates the effect of the post-weld heat treatment (PWHT) parameters, i.e., temperature and time, on the impact toughness of multi-pass gas tungsten arc welded (GTAW) joints of ferritic/martensitic grade P92 steel. The microstructural evolution in welded joints given varying post-weld temperatures and times was studied. The lath martensitic structure of the weld metal for the as-welded joints resulted in high hardness and low impact toughness. The weld fusion zone toughness was 12 J, which was lower than the minimum specified values of 41 J (ASME standards) and 47 J (EN ISO 3580:2017). The PWHT temperature and time were found to have a significant effect on the i

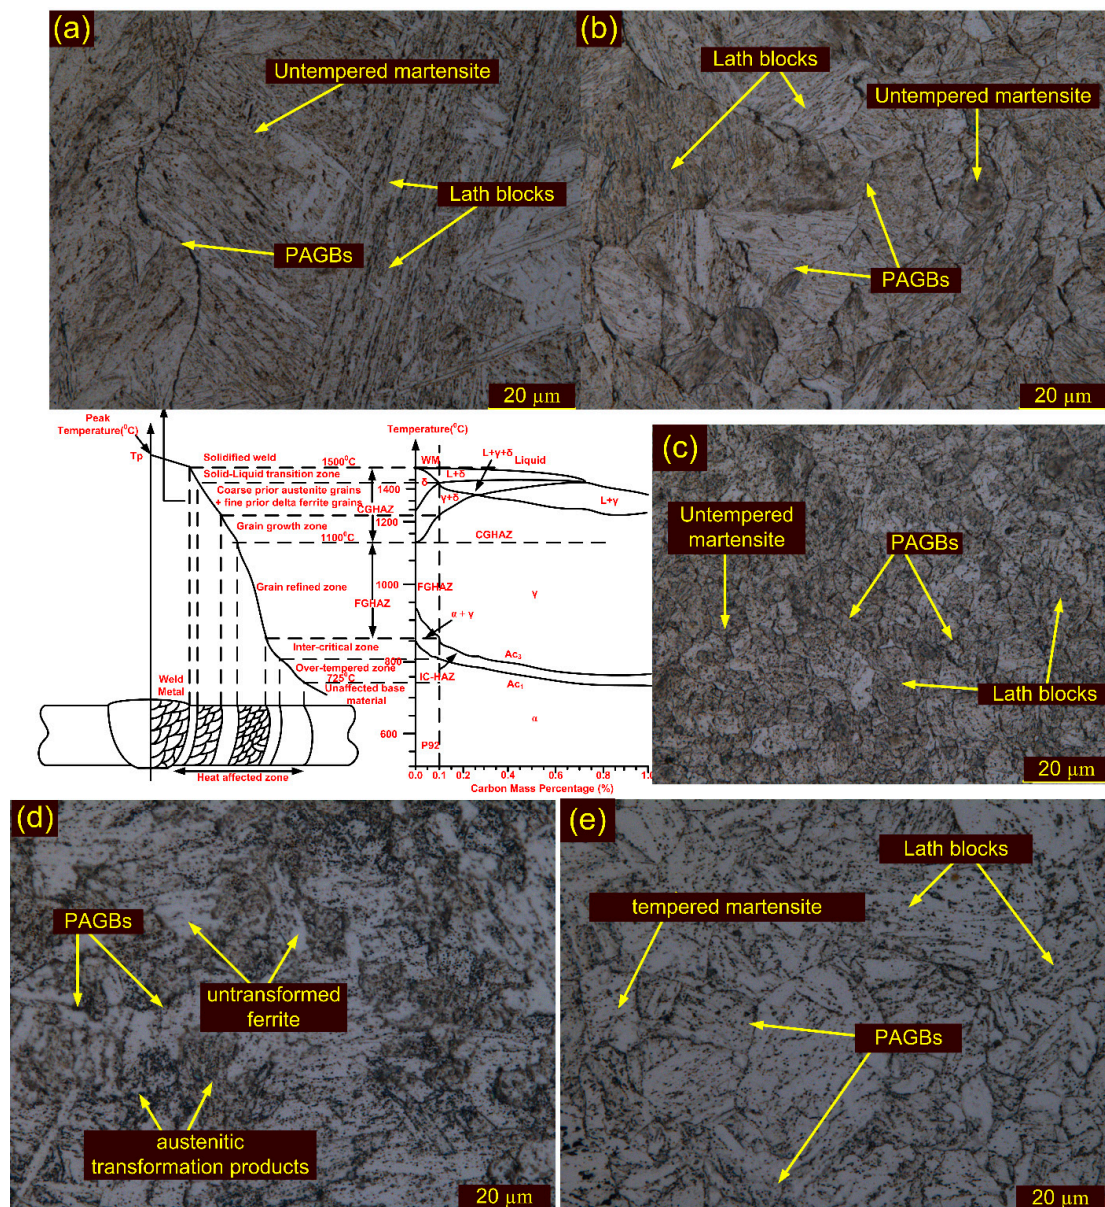
**Figure 5.** Fe–C diagram showing the formation of various zones in P92 weldments corresponding to different peak temperatures, and optical images of weldments: (a) WFZ, (b) CGHAZ, (c) FGHAZ, (d) ICHAZ, (e) SCHAZ.

The effect of the welding thermal cycle on microstructural evolution along weldments is depicted in a systematic Fe–Fe<sub>3</sub>C phase diagram (Figure 5). Figure 5 also presents the peak temperature experienced by each sub-zone and the corresponding optical micrographs. The microstructural evolution strongly influences the variation in mechanical properties along the sub-zones during the welding thermal cycle [58]. Zhang et al. [50] had reported the lower critical temperature ( $A_{c1}$ ) and upper critical temperature ( $A_{c3}$ ) for P92 steel to be 835–845 °C and 920–930 °C, respectively. The peak temperature experienced by the region varied as it moved away from the fusion boundary toward the BM. The weldment could be divided into five sub-zones on the basis of  $A_{c1}$ ,  $A_{c3}$  and peak temperature (Figure 5). The sub-zones will be referred to as the weld fusion zone (WFZ), coarse-grained HAZ (CGHAZ), fine-grained HAZ (FGHAZ), inter-critical HAZ (ICHAZ) and sub-critical HAZ (SCHAZ) [59].

The micrograph of the WFZ consists of a typical columnar lath martensitic microstructure. The lath blocks and packet boundaries are seen very clearly in Figure 5a. The SEM image corresponding to the WFZ shows the complete dissolution of the precipitates, as the temperature was much higher than the melting temperature. The lath blocks of different orientations within the lath packets are marked in Figure 6a–c. The WFZ of P92 steel is more prone to  $\delta$  ferrite formation because of the presence of Cr, W and Mo [60]. Based on the chemical composition of the WFZ (Table 1), various empirical relationships, i.e., the ferrite factor ( $K_{ff}$ ), have been suggested for evaluating  $\delta$  ferrite formation. Schneider’s formula is the method most commonly used to predict the formation of  $\delta$  ferrite [61]. The  $K_{ff}$  and  $Cr_{eq}$  are used to estimate ferrite formation and are listed in Equations (3) and (4):

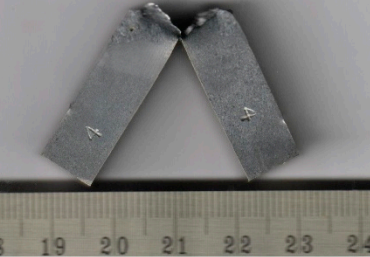
**Figure 18.** Impact test results for AW and heat-treated joints showing impact toughness values and impact specimens before and after fracturing.

For the rest of the weldment conditions, impact toughness was measured for the WFZ only and the results are presented in Figure 18. T1 improved impact toughness significantly, as it imparted ductility to the WFZ by tempering the martensite. However, impact toughness still measured lower than the minimum accepted value of 47 J. After T2, i.e., at a constant temperature with increased PWHT time from 90 min to 120 min, impact toughness was 68 J, close to the recommended value of 47 J. The increase in impact toughness was attributed to the tempering reaction. Tempering of martensite imparts softening to the martensitic matrix via a reduction in dislocation density, breakup of lath and evolution of precipitates. In both T1 and T2 treatment, a complete fracture of the test specimen occurred, which ensured that the mixed-mode fracture was dominated by a cleavage area or brittle fracture. With the increase in PWHT temperature, i.e., from 760 °C (T1) to 780 °C (HT1) for a constant PWHT duration of 90 min, impact toughness increased from 45 J to 70 J and achieved the minimum landmark of 47 J. That result might be due to adequate tempering of the martensite. The impact test results for HT2 showed the highest impact toughness value of 124 J (Figure 18). The test specimen for HT2 also showed yielding before fracture, as given in Figure 18. A great impact of PWHT parameters on the impact toughness of Cr–Mo steel welded joints was also reported by Pandey and Mahapatra [69]. From the impact test results, it can be recommended to either perform PWHT at 760 °C for 120 min (T2) or at 780 °C for 90 min (HT1). T1 resulted in poor impact toughness while HT2 needed a higher cost than HT1.

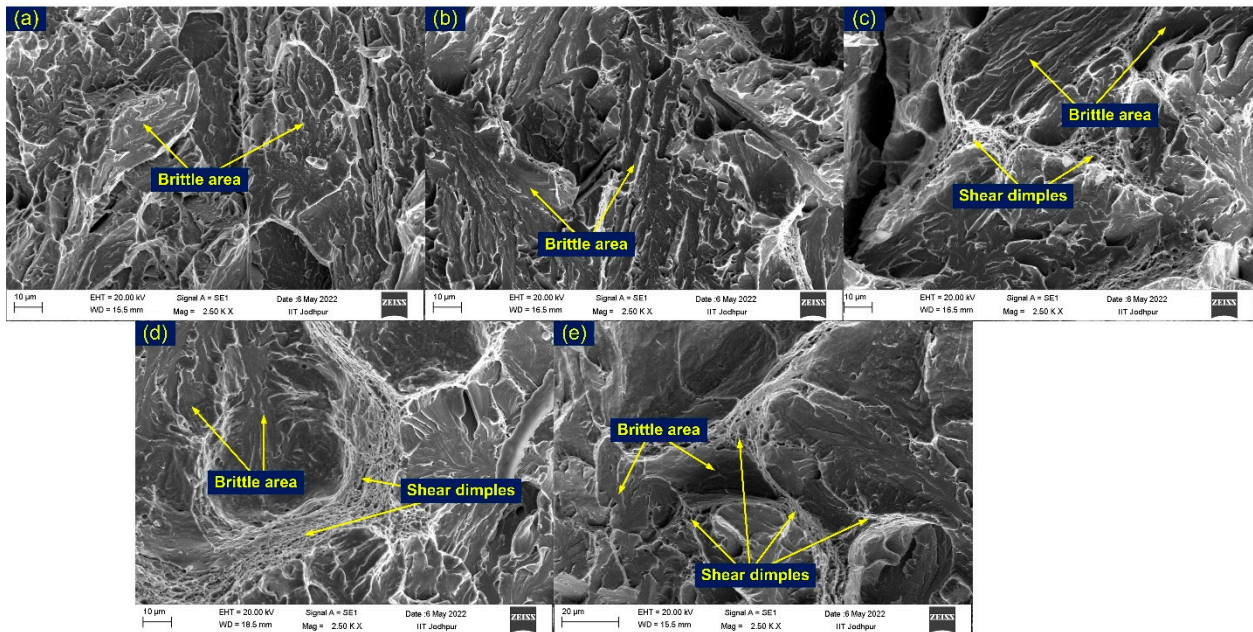
Figure 19. SEM image of fractured impact tested specimens: (a) AW, (b) T1, (c) T2, (d) HT1, (e) HT2.

SEM micrographs of the impact-tested fractured specimens are presented in Figure 19. The appearance of the fracture surface for AW and T1 specimens supports the impact test

results, as in both cases the fracture was dominated by a brittle area (Figure 19a,b). The fracture surface shows the typical characteristics of a cleavage area and river patterns. In T2, both dimples and a cleavage area appeared at the fracture surface; however, the fracture mode was dominated by the brittle area (Figure 19c). In HT1 (Figure 19d) and HT2 (Figure 19e), both cleavage and shear dimples are seen; however, the major portion was represented by the brittle area.
