# Mechanical and physical assessment of epoxy, mineral, solvent-based, and water-soluble coating materials

Ginneth Patricia Millán Ramírez<sup>✉</sup>, Hubert Byliński & Maciej Niedostatkiewicz

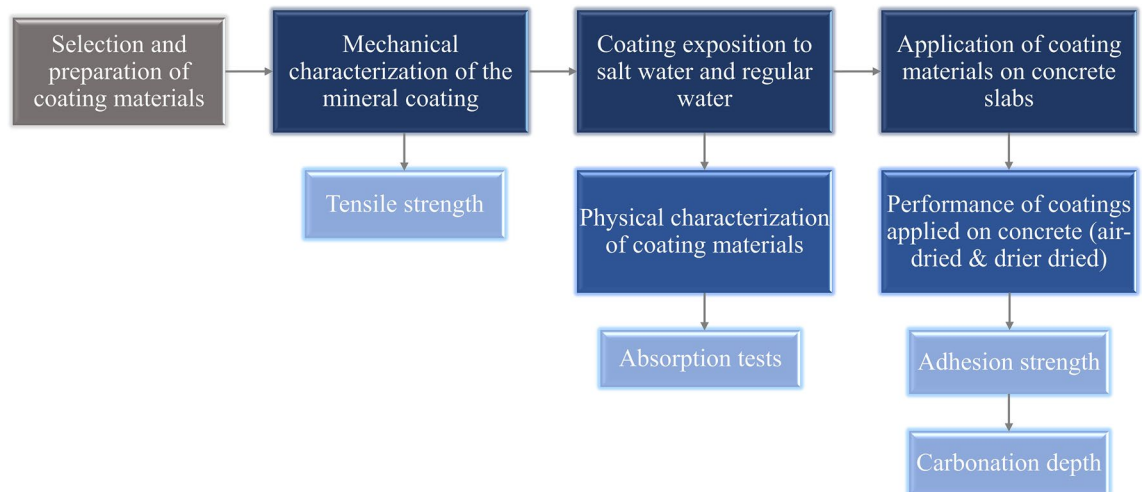
**Figure 2.** Methodology process used.

The methodology process involved different stages. First, the coating materials were selected based on their main compounds, i.e., epoxy, asphalt, mineral, and water. Afterward, coating samples were used to test their mechanical and physical properties. Tensile strength was measured just for the mineral coating by preparing samples of (50 × 250) mm. For absorption tests, 20 samples of each coating were exposed to salt and regular water for 28 days.

To assess the pull-off adhesion strength, mineral (MI), epoxy (EP), solvent-base (BR), and water-soluble (BW) coating materials were placed in concrete slabs and divided into two groups: In the first group, the coating materials were air-dried for 28 days; in the second group, the coating materials were air-dried for 14 days, plus, 14 days in a drier at 70 °C. Both groups used water and oil to impregnate the concrete surface to assess the coating material's pull-off adhesion on contaminated surfaces. Figure 2 describes the stages used in this study.

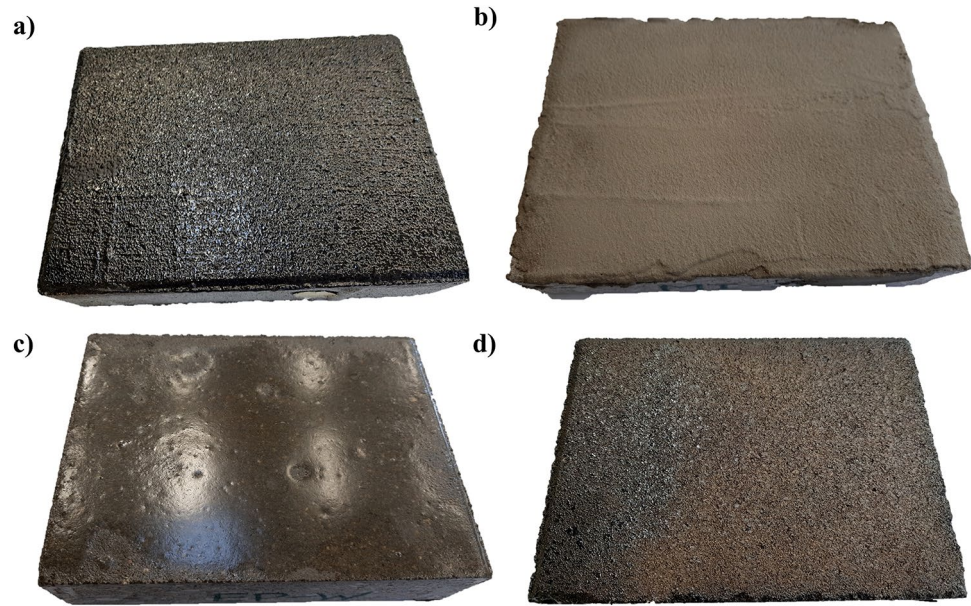
**Figure 3.** Coating materials applied in concrete slabs with wet substrate (a) BW (b) MI (c) EP (d) BR.

BW, MI, EP, and BR coating materials were applied according to the manufacturer's specifications. A total of 36 concrete specimens were used during the research. Figure 3 shows the coating materials applied to concrete slabs.

- **Application of coatings to the surface of the concrete slabs** The application varied according to the type of coating material.
  - **Epoxy coatings** After mixing the coating compounds, one layer of the mix was applied with a regular brush on the surface of each concrete sample.

- **Water-soluble and solvent-based coatings** According to the manufacturer's recommendations, three layers of the material were applied using a regular brush. The second and third layers were applied after the previous layer dried to touch, about 30 min for solvent-based coating and about 1 h for water-soluble coating.

- **Mineral coating** After mixing the material with water, two layers were applied with a spatula, distributing the material uniformly on the concrete slab's surface. The second layer was applied after the first layer had dried to touch after about 1.5 h.

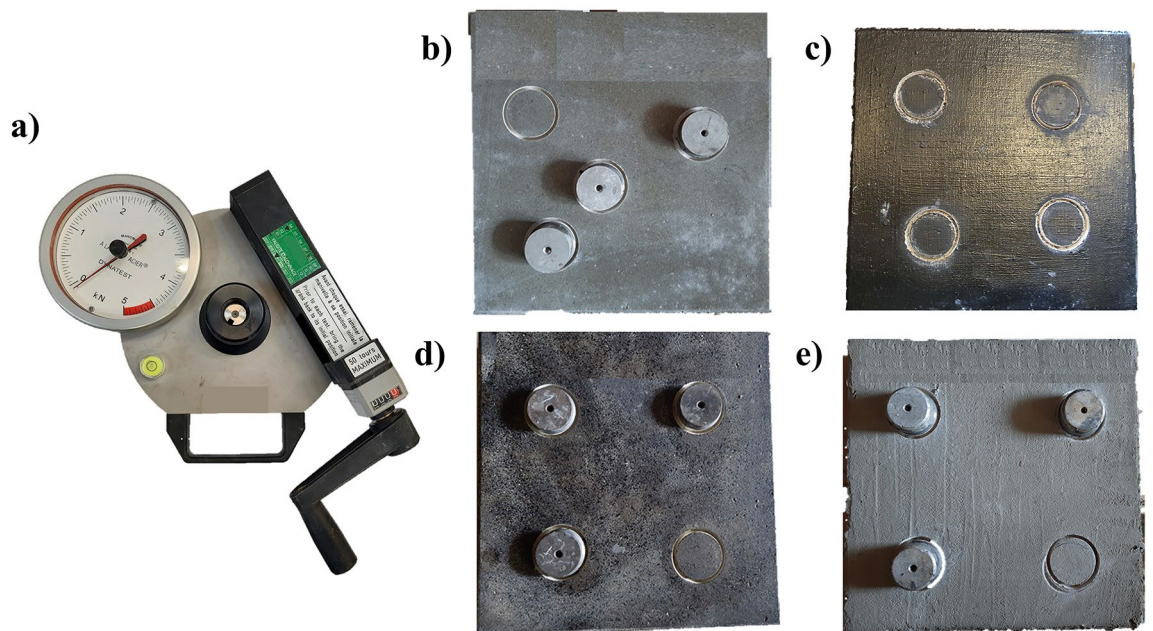
**Figure 4.** (a) Equipment used. Concrete slabs preparation for pull-off adhesion test: (b) EP (c) BW (d) BR (e) MI.

**Experimental tests.** *Pull-off adhesion strength of coating materials.* A traction dynamometer with a maximum tensile strength of 5 kN was used to perform the pull-off adhesion test. Before placing the metallic discs (dollies) on the concrete surface, it was necessary to drill a circular notch to define the measured surface accurately. Afterward, 50 mm-diameter/20 mm-height dollies were glued to the surface using a standard epoxy-based adhesive. Figure 4 shows the equipment used to perform the tests and some examples of concrete slabs with the dollies. A total of 70 pull-off tests were taken. The Pull-off strength test was performed according to PN-EN 14,891:2017 standard<sup>20</sup> and ASTM D 4541 standard<sup>24</sup>.

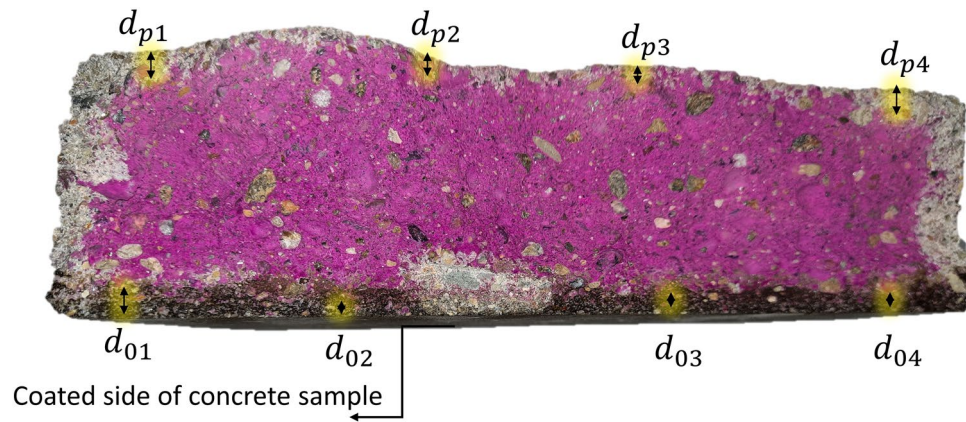
**Figure 5.** Carbonation measurement on both sides of concrete samples.

**Carbonation depth.** After applying the coating material, concrete samples were stored in an indoor controlled environment at  $20 \pm 2$  °C and  $75\% \pm 5\%$  relative humidity for 90 days. Next, phenolphthalein solution was sprayed onto the fresh broken concrete surface according to the CPC-18 RILEM<sup>23</sup>. This solution is characterized by being a colorless liquid commonly used as an acid-base indicator that changes to purple when the pH is higher than 9. As a result, the non-carbonated concrete surface, where the specimen is still alkaline, turns into a purple color, and the carbonated concrete surface remains colorless due to the reduction in the alkalinity of concrete.

According to Page et al.<sup>25</sup>, the performance of coating materials against corrosion can be measured by the carbonation suppression ratio ( $R_{cs}$ ) which compares the coated and the uncoated sides of concrete samples. Figure 5 shows the average depth  $d_0$  and  $d_p$ .

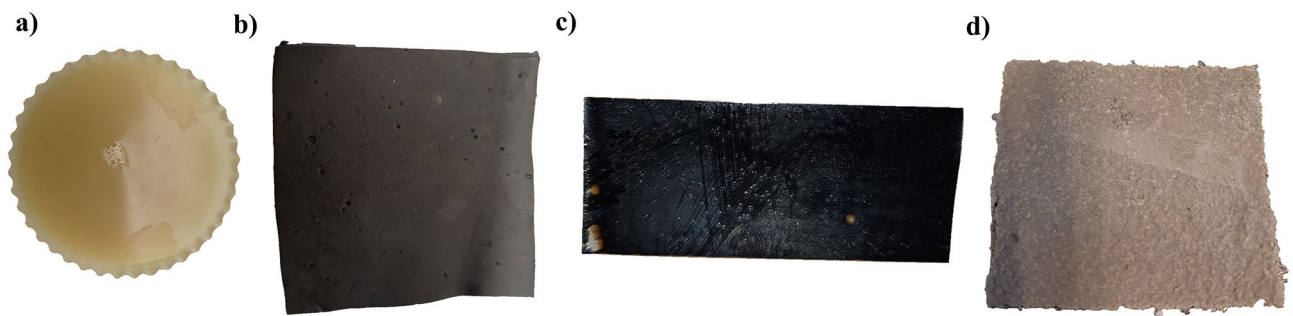
**Figure 6.** Coating materials samples. (a) EP (b) BW (c) BR (d) MI.

**Absorption test.** Absorption was measured by weighting the different coating samples after 28 days of exposition to salt and regular water. First, each coating was applied on silicone foils and was air-dried for seven days in a controlled environment at  $20 \pm 2$  °C and  $75\% \pm 5\%$  relative humidity. Then, mineral and water-soluble coatings were cut to size (30 mm × 30 mm), and some individual coating samples were made for epoxy and solvent-based types. Figure 6 shows the coating samples used to test absorption. Equations proposed by Almusallam et al.<sup>26</sup> were used to calculate the water absorption rate.

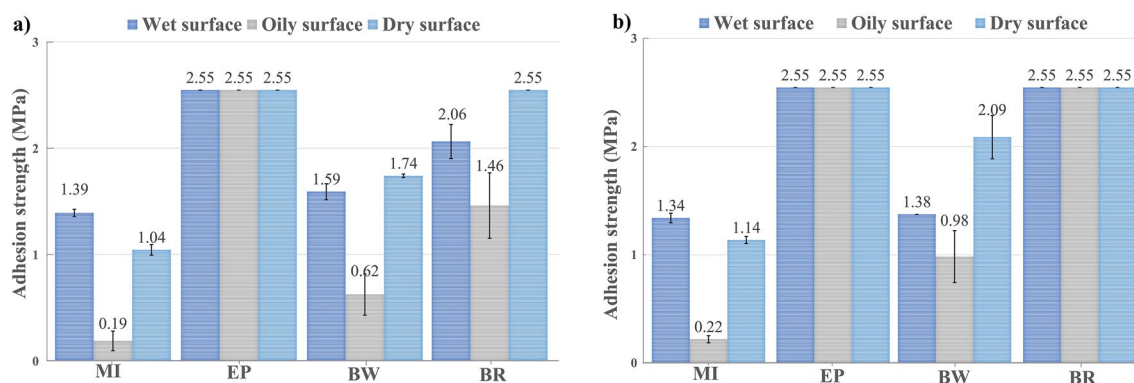
**Figure 7.** Average adhesion test in concrete slabs (a) Samples air-dried for 28 days (b) Samples air-dried for 14 days + oven-dried for 14 days.

**Pull-off adhesion strength of coating materials.** Figure 7 shows adhesion strength values for MI, EP, BW, and BR coatings applied on concrete slabs and dried in two conditions and on three surfaces. [Point 2.1.1.1].

The results indicate that epoxy materials presented the highest adhesion strength values in all scenarios by exceeding the maximum possible measure of the dynamometer (5 kN). These values follow the values given by the manufacturer. It is noteworthy that all EP samples presented substrate failure under the load, evidencing a

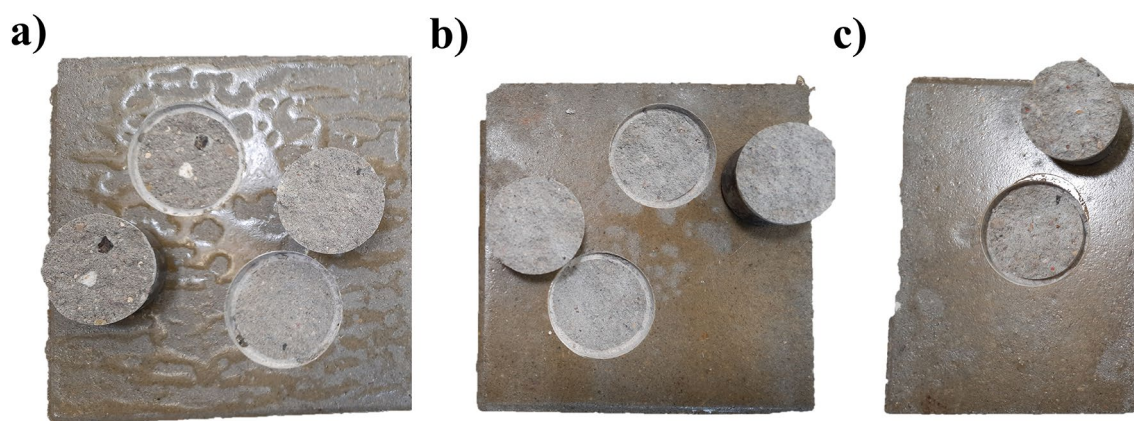
**Figure 8.** Adhesion tests in concrete samples with EP coating after 28 days of air-drying: (a) Oily substrate (b) Wet substrate (c) Dry substrate.

Only the EP coating products presented physical changes after applying the different coating materials on the concrete slabs. In the oily substrate, it was evidenced that epoxy coating could not interact with the oil molecules, making the coating repelling and leaving certain areas without coating material. In the case of wet and dry substrates, no physical changes were evidenced. Figure 9 shows the EP behavior after the application on oily, wet, and dry substrates.

concrete substrate strength weakness. Figure 8 shows concrete slabs painted with EP after being subjected to the pull-off test.

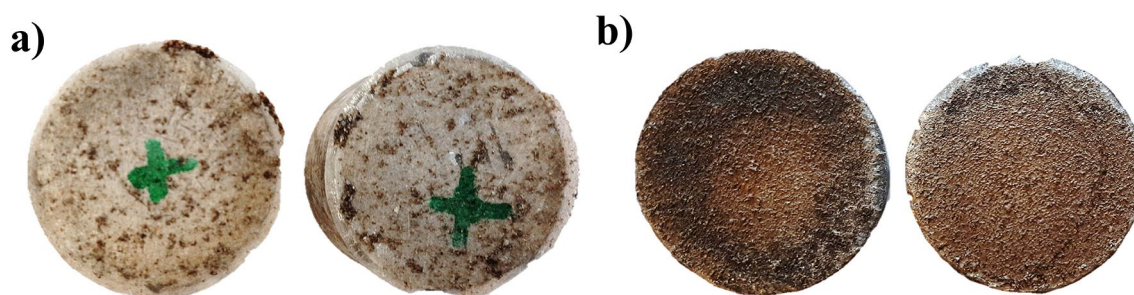
**Figure 9.** Dolly after pull-off adhesion test in the dry substrate: (a) BR samples exposed to air and oven drying (b) BR samples exposed to air drying.

For concrete slabs with BR Coating, the maximum pull-off adhesion strength values were observed in the samples dried for 14 days in the air plus 14 days in the oven by achieving the maximum pull force value (5 kN). However, according to the types of failures presented in the ASTM D 4541 standard and ISO 4264<sup>24,27</sup>, a glue failure was evidenced in all samples; this can be attributed to the drying process in the oven. The coating reduced its mechanical properties and did not chemically interact with the epoxy resin, leaving a weak joint. For samples exposed to air drying for 28 days, a reduction in the strength adhesion was evidenced; these specimens showed a decrease of 42% in samples saturated with oil and 19% in samples saturated with water. Even though there is a reduction in the strength values, the specimens presented a cohesive failure within the coating layer, which is considered the ideal type of failure in the pull-off test. Figure 9 shows examples of the types of failures mentioned for BR coatings.

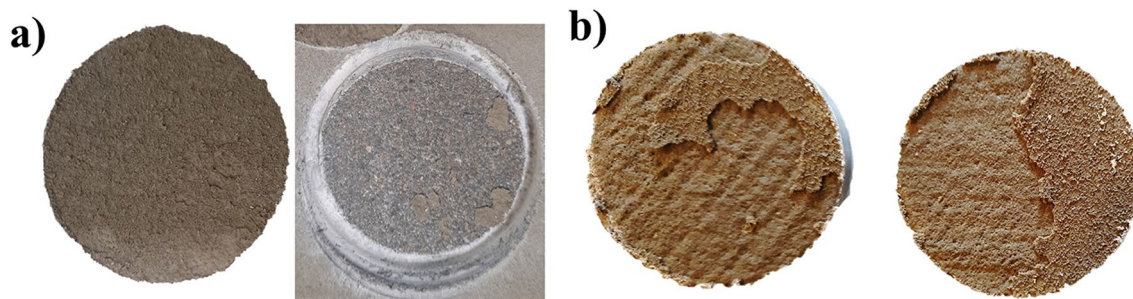
**Figure 10.** Mineral coating in the oily substrate: (a) MI samples exposed to air and oven drying (b) MI samples exposed to air drying.

The mineral coating was the only material where the presence of oil influenced the failure type. Samples exposed to air-drying presented 50% adhesive and 50% (Fig. 11b) cohesive failure, and samples exposed to oven drying showed 100% adhesive failure (Fig. 11a). For wet and dry surfaces, cohesive failure was evidenced in both types of drying, showing values aligned to those of the manufacturer. Figure 10 illustrates concrete specimens saturated with oil surface and protected with a mineral coating.

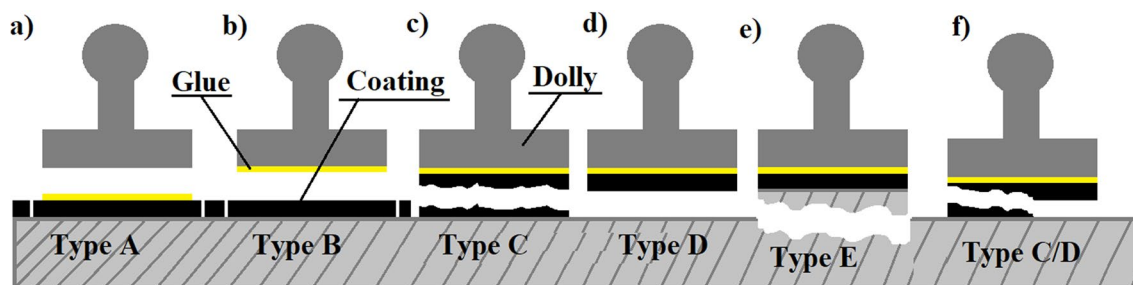
**Figure 11.** Types of fracture according to its nature: (a) Glue failure (b) Adhesive failure (between layers) (c) Cohesive failure (within a layer) (d) coating failure (e) Substrate failure (f) 50% cohesive failure and 50% coating failure.

ISO 4264<sup>27</sup> was used to assess the fracture type. Figure 11 describes the nature of the possible fractures.

According to Fig. 11, Table 5 summarizes the types of fracture obtained in all pull-off adhesion strength tests.

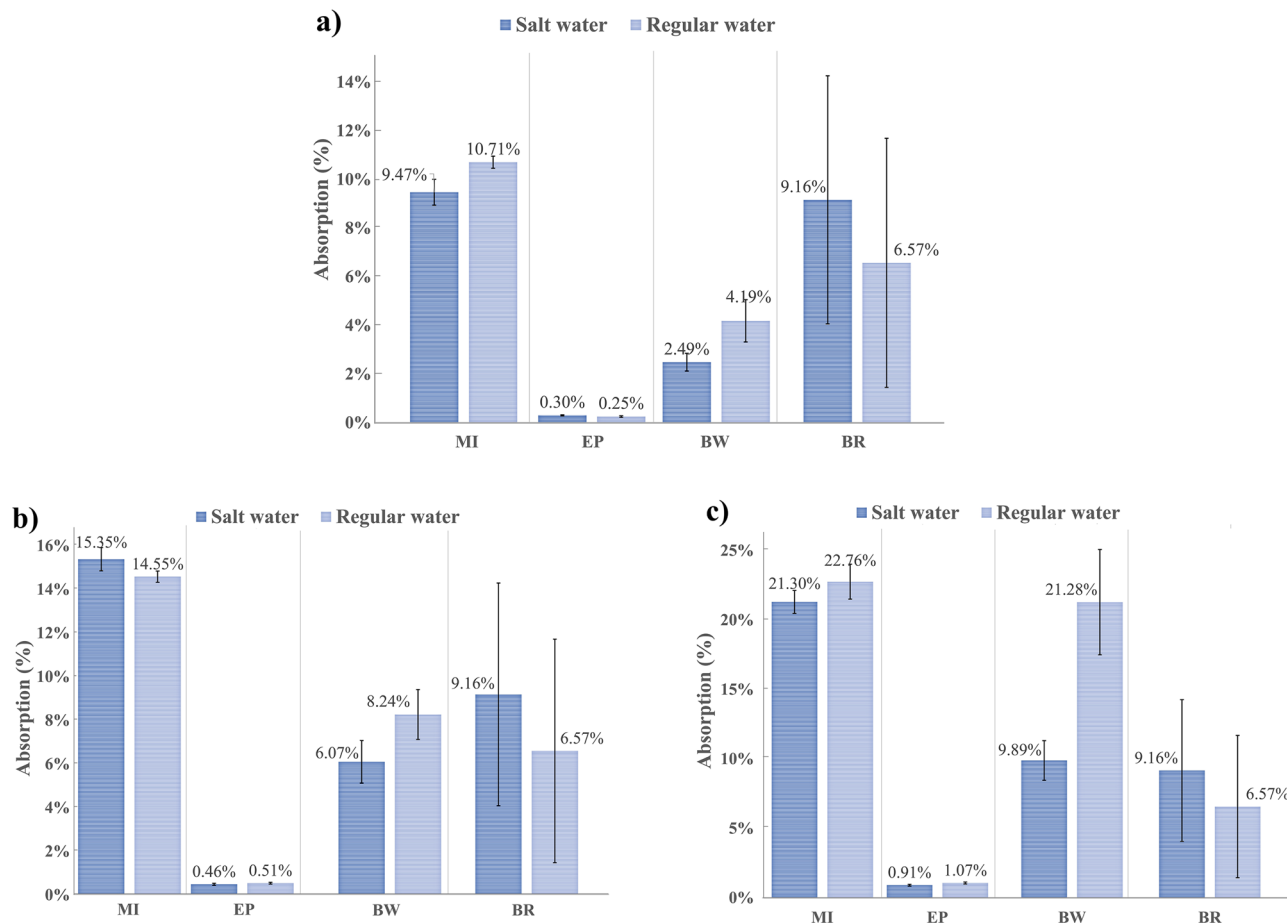
**Figure 12.** Average coating water absorption: (a) After 24 h (b) After 7 days (c) After 28 days.

**Absorption test.** Figure 12 shows the results of the water absorption test of the four coating materials at different stages, 24 h, 7 days, and 28 days. Table 7 describes the final weight gained by the different coating materials samples.

According to the results, MI, EP, and BR coatings presented similar absorption coefficients between each of them during the three stages when exposed to regular and saltwater. However, BW coating was widely affected by regular water, showing a total increment in the absorption coefficient after 28 days of exposition of around 21% in regular water, 10% more than in saltwater. According to Anderson et al.<sup>29</sup>, the low water absorption is caused by hydrocarbon constituents, showing a slight tendency to absorb water over the years. Additionally, physical changes were noticeable after seven days of contact. In the case of regular water, changes in the sample color were evident due to the chemical changes produced by the presence of oxygen that interacts with the basic components of the material, changing from black to brown color. For saltwater, some samples showed cracks in their surface, accelerating the corrosion of specimens. Figure 13 shows the changes in the color of the coating samples.

Data presented in Fig. 12 was used to calculate the water absorption rate, and Table 8 shows the results.

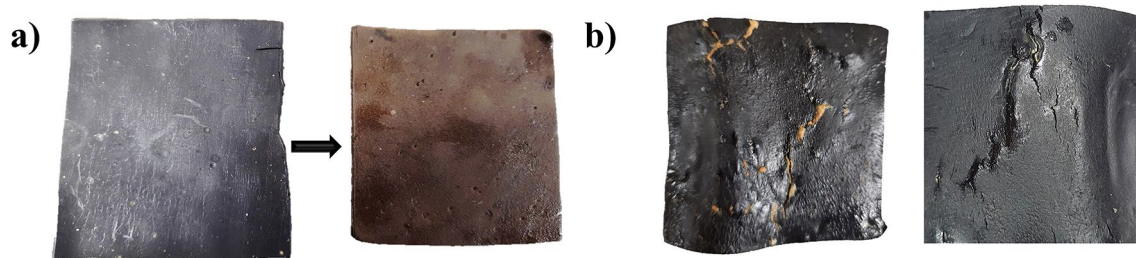
**Figure 13.** Physical changes in BW coating after 28 days of exposition (a) Produced by exposition to regular water (b) Produced by exposition to saltwater.

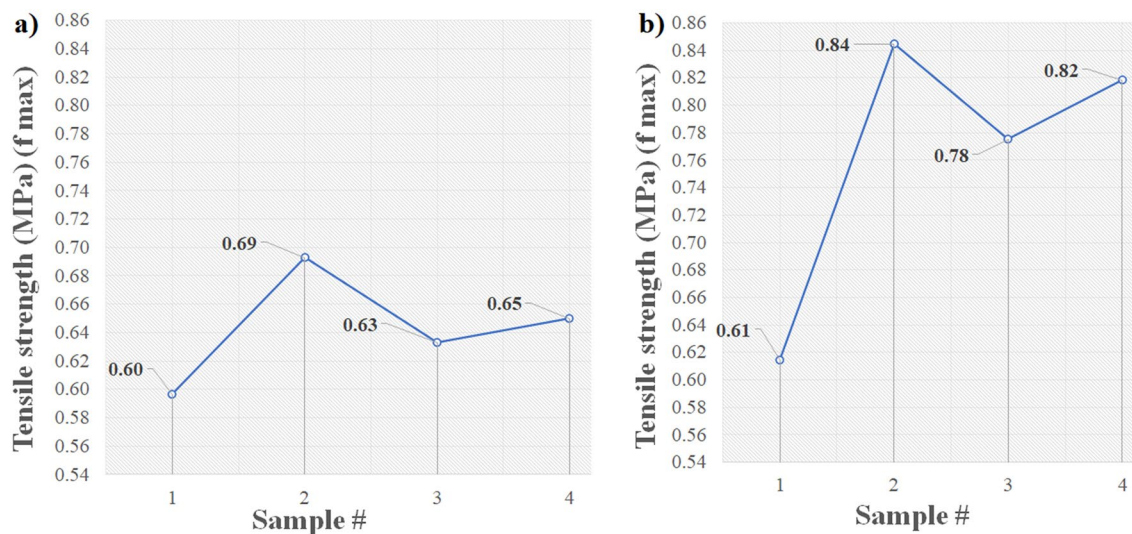
**Figure 14.** Tensile strength (a) after 14 days (b) after 28 days.

**Tensile test of the mineral coating.** Figure 14 shows the tensile strength results at 14 and 28 days of mineral coating. It shows an increment of around 25% in their strength value over time.

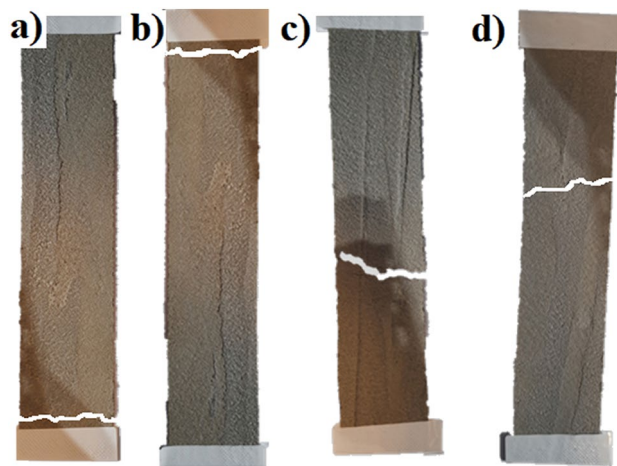
**Figure 15.** Detail failure mode and type: (a) Lateral at grip/tab Bottom (b) Lateral at grip/tab Top (c) Angled Gage Middle (d) Lateral Gage Middle.

After the test, samples were carefully photographed, and the failure type was determined according to the ASTM D 3039 standard. Figure 15 shows some examples of the typical failure modes obtained in this research.
