RESEARCH ARTICLE

Quality Assessment of Low Voltage Surge Arresters

INDEX TERMS MOV, leakage current, residual voltage, electrical aging, repeatability of production.

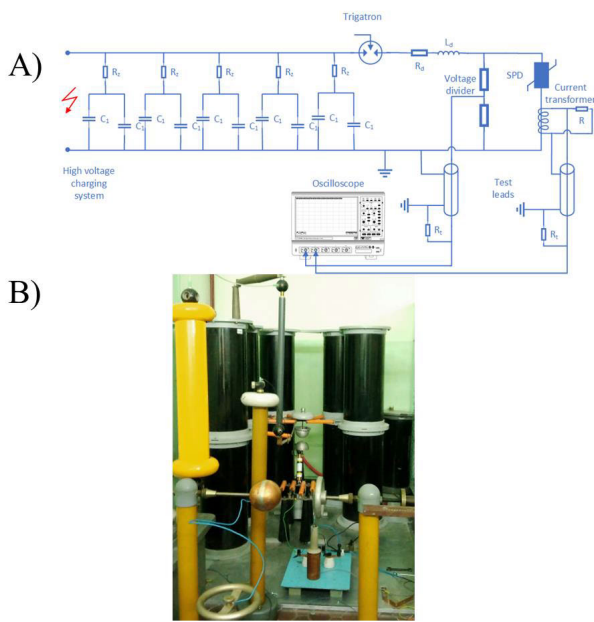
FIGURE 1. Measurement of the residual voltage of varistors with the nominal discharge current flow of $8 \mu\text{s}/20 \mu\text{s}$ with an amplitude of 5 kA, (a) layout scheme, (b) test stand.

- varistor voltage U_{1mA} of the LV limiter, the methodology according to the IEC 61643-331 standard was used, measuring the voltage U_{1mA} at the varistor terminals with a direct current flow of 1 mA - measurement before and after the applied surge,
- limiting voltage U_{res} (IEC 61643-11 standard) at rated discharge current (surge 8/20 μ s/ μ s) measured as it shown in Fig.1,

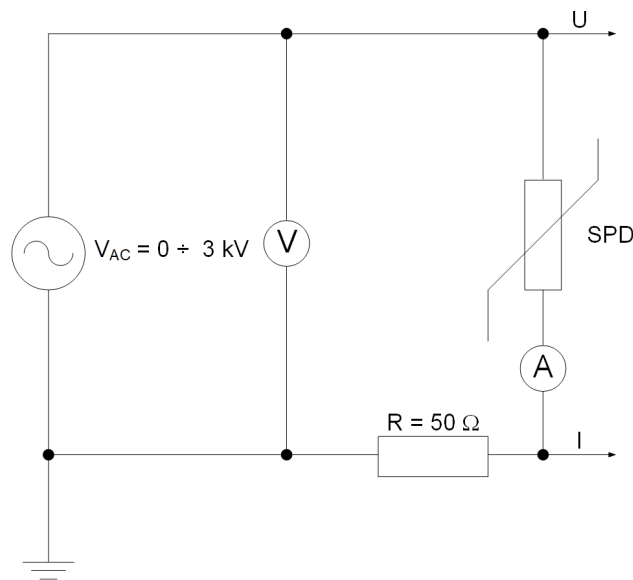
FIGURE 2. A scheme of test stand for leakage current measurements.

- total leakage current I_{LCT} and its resistive component (I_{LCR}) at the highest continuous operating voltage U_c according to Table 1 measured at test stand from Fig.2.

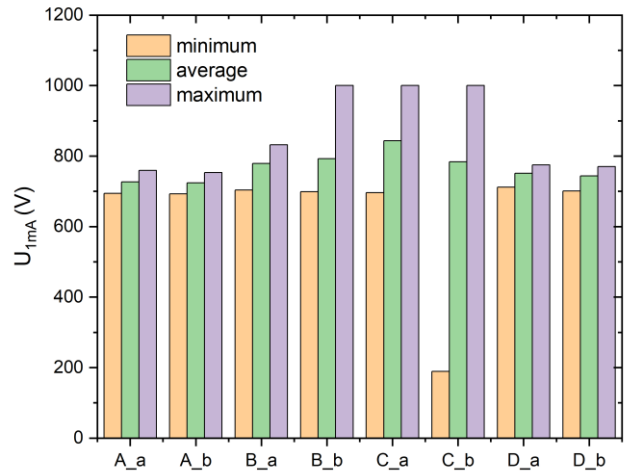
FIGURE 4. Statistical values of the varistor voltage U_{1mA} (minimum, average and maximum values) for a different samples of LV surge arresters (A, B, C, D) before (a) and after (b) an aging process.

Figure 4 shows the statistical parameters of the varistor voltage U_{1mA} of the population of investigated surge arresters. It can be observed that the A and D surge arresters are characterized by high repeatability, which remains even after an ageing process. An increase of U_{1mA} was observed for one sample of manufacturer B and a drastic decrease in this parameter for one of the varistors C, which means its complete damage. Moreover, the C-surge arresters are characterized by the greatest spread of the U_{1mA} for the investigated population.

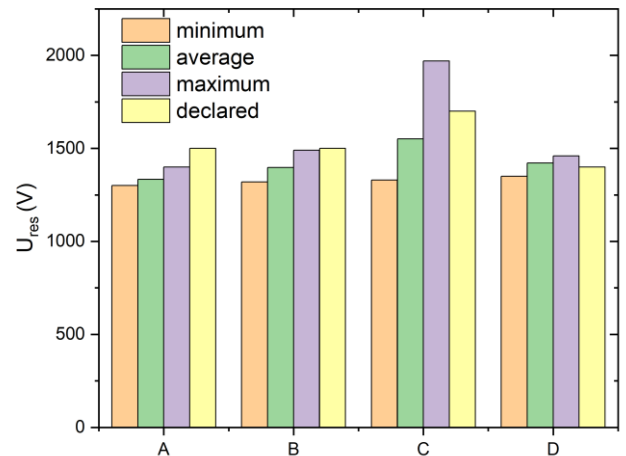
FIGURE 5. Statistical values of the threshold voltage (minimum, average and maximum values) for a different samples of LV surge arresters.

Figure 5 shows the results of U_{res} measurements. The largest dispersion of the maximum voltage values accompanying the discharge current flow can be observed again for the C- surge arresters. The remaining companies achieve similar spreads, however it is worth noting that the values obtained for C and D exceed the limits declared by the manufacturers. In this experiment, it can be concluded that manufacturer A obtained the reproducible and lowest residual voltage values. For the products of this manufacturer, the highest of the measured values of the limiting voltage is definitely below the voltage declared by the manufacturer. On the basis of

the above-mentioned test and analysis of other parameters, it can be assumed that in the case of LV surge arresters, the residual voltage test may be the basic method of checking the quality and durability of the surge arresters when performing, for example, a series of repeated current surges with specific parameters.

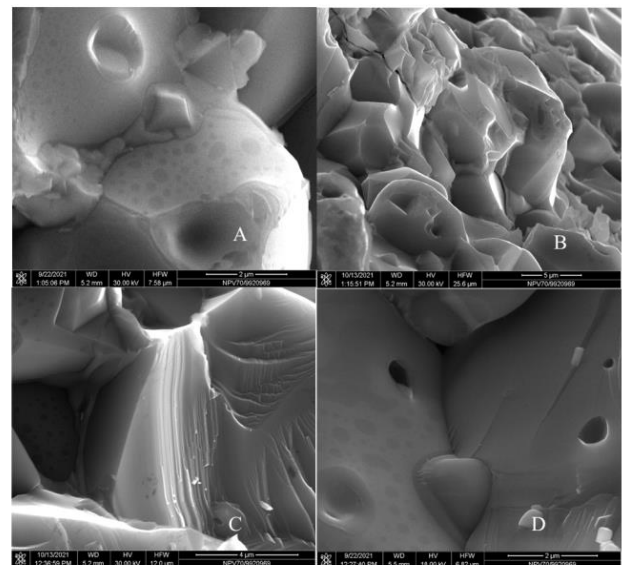
FIGURE 10. SEM images of varistors samples before ageing process.

The surface morphology of samples exhibit the presence of ZnO grains which have various sizes. Within the ZnO grain, submicron pores and traces of other phases can be observed (Fig S3 of the ESI). Images of varistors before an ageing process with higher magnification are presented in Fig. 10.

In each case ZnO grains with insertions of an additional phase are clearly visible. The most important differences between surge arresters can be seen in the interfaces, which are much broader for A and B varistors than for C and D samples. The non-ohmic properties of ZnO based varistors origin from grain boundaries between semiconducting zinc oxide grains [18]. For this reason varistors with broad interfaces may have a better ageing resistance, which was confirmed by electrical properties measurements. Moreover, in B varistor occur single crystalline inclusions with dimensions of approximately few micrometers. The shape of these

insertions suggest a $ZnSb_2O_4$ spinel-like formation. These observations are in line with conclusions from pXRD measurements. It is worth noting that interfaces in the A varistor are cracked, which may result from improper parameters of the sintering process and cause the I-U characteristics to deteriorate.
