RESEARCH ARTICLE

Quality Assessment of Low Voltage Surge Arresters

ABSTRACT Users expect reliable operation of the surge arrester during overvoltages, which may originate from a switching process or a lightning discharge. The necessary conditions to guarantee these expectations are: appropriate construction of the surge arrester, its production being maintained in accordance with technical standards, and a positive results of the type test (as well routine and acceptance tests). The recipient, especially when purchasing large quantities of the product, can check the final quality of the product through selective testing of samples from the market in order to find the best supplier. This manuscript specifies the basic parameters of low-voltage (LV) surge arresters of four manufacturers. Basic electrical parameters, i.e. leakage current and varistor voltage (U_{1mA}) before and after the nominal discharge current (I_n) of $8 \mu s/20 \mu s$, were determined for 10 randomly selected surge arresters of each manufacturer. Moreover one sample of each varistor batches was aged by fifty $8 \mu s/20 \mu s$ current impulses with I_n . The obtained results of structural analysis indicate th

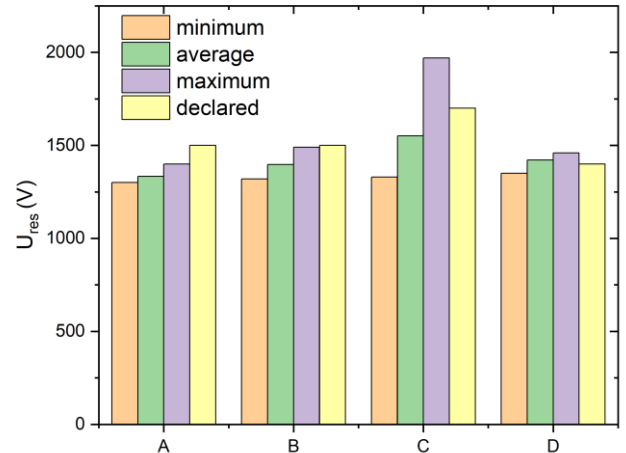
FIGURE 5. Statistical values of the threshold voltage (minimum, average and maximum values) for a different samples of LV surge arresters.

Figure 5 shows the results of U_{res} measurements. The largest dispersion of the maximum voltage values accompanying the discharge current flow can be observed again for the C- surge arresters. The remaining companies achieve similar spreads, however it is worth noting that the values obtained for C and D exceed the limits declared by the manufacturers. In this experiment, it can be concluded that manufacturer A obtained the reproducible and lowest residual voltage values. For the products of this manufacturer, the highest of the measured values of the limiting voltage is definitely below the voltage declared by the manufacturer. On the basis of

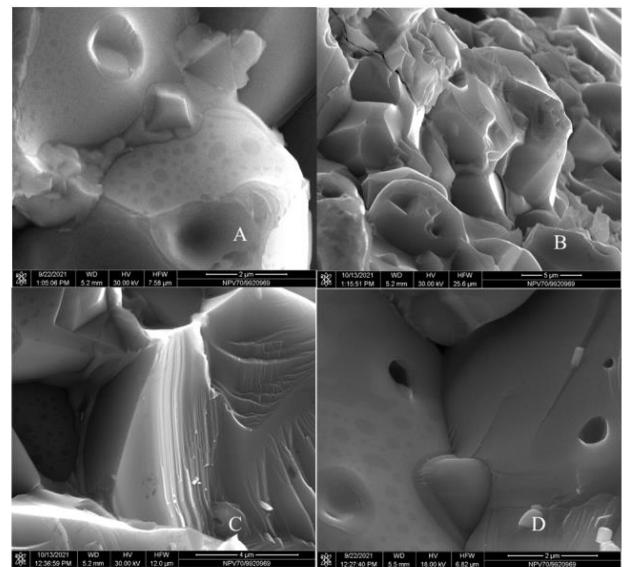
FIGURE 10. SEM images of varistors samples before ageing process.

The surface morphology of samples exhibit the presence of ZnO grains which have various sizes. Within the ZnO grain, submicron pores and traces of other phases can be observed (Fig S3 of the ESI). Images of varistors before an ageing process with higher magnification are presented in Fig. 10.

In each case ZnO grains with insertions of an additional phase are clearly visible. The most important differences between surge arresters can be seen in the interfaces, which are much broader for A and B varistors than for C and D samples. The non-ohmic properties of ZnO based varistors origin from grain boundaries between semiconducting zinc oxide grains [18]. For this reason varistors with broad interfaces may have a better ageing resistance, which was confirmed by electrical properties measurements. Moreover, in B varistor occur single crystalline inclusions with dimensions of approximately few micrometers. The shape of these

insertions suggest a ZnSb_2O_4 spinel-like formation. These observations are in line with conclusions from pXRD measurements. It is worth noting that interfaces in the A varistor are cracked, which may result from improper parameters of the sintering process and cause the I-U characteristics to deteriorate.

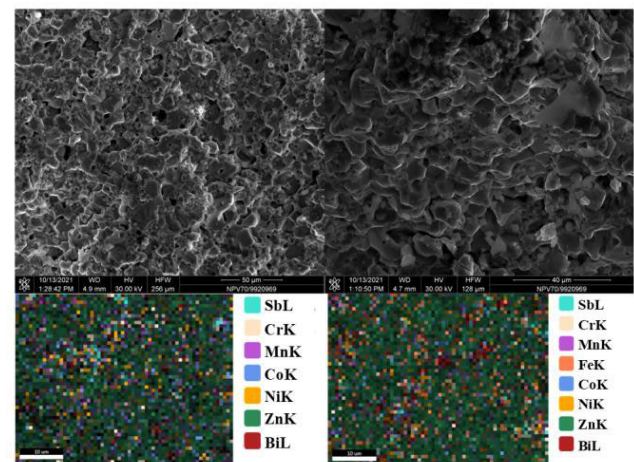
FIGURE 12. Comparison of SEM/EDX images before (left) and after (right) an ageing process for A varistors.
