Combination of terrestrial laser scanning and UAV photogrammetry for 3D modelling and degradation assessment of heritage building based on a lighting analysis: case study—St. Adalbert Church in Gdansk, Poland

Pawel Tysiac^{1*}, Anna Sieńska¹, Marta Tarnowska¹, Piotr Kedzierski² and Marcin Jagoda²

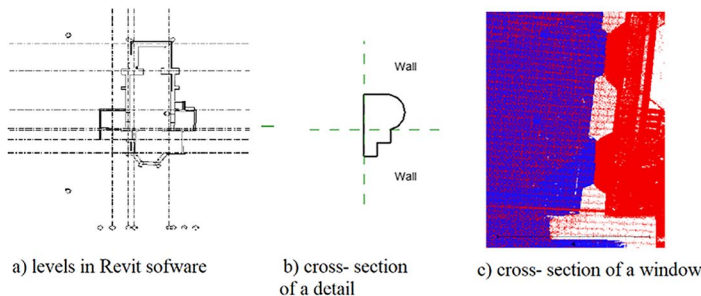
Fig. 7 The HBIM Model generation workflow

analysed. It should be noted, however, that the intensity of the beam reflection is affected not only by the type of material, but also by its colour, structure (roughness) and humidity. Therefore, the values presented by us helped us to classify the material of the church elements, but they cannot be used as reference values for other objects. For each measurement, a separate analysis should be made of the dependence of the material on the intensity of reflection due to variable humidity, structure and colour, e.g., of wood. The modelling workflow is shown in Fig. 7.

Step 1

Setting up levels, planes, vertical sections and cross sections

Step 2

Material Components Library

Step 3

Create Families and Individual Components

Step 4
Generate 3D model

The modelling phase was carried out with Autodesk Revit[®], a type of building information modelling software. After the point cloud has been properly imported, the church modelling stage in the Revit environment must start by adding levels to which the whole BIM work process must refer. Then, the added levels are automatically used to create a floor plan associated with them. The projection is a 2D view of the model display, forming the basis for placing the church's individual parts. In historic buildings, walls are often heterogeneous in thickness, lack horizontality, and show deviation. In most cases, therefore, individual elements are modelled manually. To save time and reduce the manual modelling for all

elements, some elements use rules derived from experience. For example, if the angle of the individual roof slope relative to the horizontal plane generated from the point cloud is measured, the end point of the roof slope curve can be predicted. In a specific level projection, a closed loop of the roof boundary was designed, and its slope was defined. Its value was then changed to reproduce the structural elements as faithfully as possible, depending on the ordering of points.

The technical elements obtained from the documentation were modelled in two ways. First, a large family library was built, making modelling faster. For example, a new family is created for windows that use the same family in multiple situations. One of the challenges in the modelling stage was the entrance to the church. Separately, the white decorative elements around the entrance were made along the same path as the muntin bars. A wooden door was inserted into the opening, and the size was determined by drawing the perimeter on the point cloud. We marked elements determining material differences by analysing the range of reflection spectra of the laser scanner and RGB colour ranges. The results of this review are shown in Table 2. There, the range of the reflection intensity for individual materials is quite large, but these are the extreme values that occurred in the measurements. Moreover, we noticed that each material had an average value, which occurred most often. Due to the significant tonal differences in the cloud of points, it was possible to adapt a specific material and precisely determine where a given element occurred, e.g., for walls that clearly differed in shade from the rest of the object. After registration, the actual surface of the object could be obtained, and the state of degradation could be
