HEALTH MONITORING OF A COMPRESSION IGNITION ENGINE FED WITH DIFFERENT LOW-SULPHUR MARINE FUELS BY ENDOSCOPIC IMAGE PROCESSING AND ANALYSIS

Zbigniew Korczewski*

Gdansk University of Technology, Poland

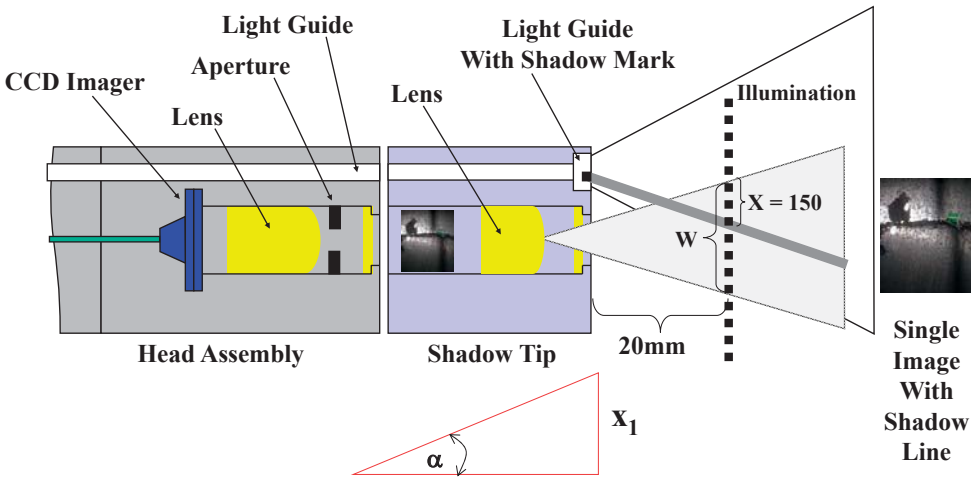
The tip of the video endoscope's 'Shadow' inspection head is equipped with specialized optics, generating a straight-line shadow in the luminous flux (like a projector) on the surface of the examined element. The projection of the shadow takes place at a known angle of the sighting head in relation to the observed surface and a known angle of the observation sector. The shadow generated near the detected defect is then located and recorded by a CCD camera placed in the assembly head. The closer the inspection head is to the observed surface, the closer the shadow line is to the left hand side of the monitor screen. Since the position of the shadow generating the image on the matrix of the LCD monitor screen is known, it is possible to easily calculate the magnification of this image and determine the linear dimension of the distance between individual pixels, as well as the actual dimensions of the detected surface defects, from dependencies (1) and (2) (Fig. 5).

The diagnostician confirms the position of the shadow line on the monitor matrix by superimposing the cursor line on the shadow (dashed line in Fig. 5). In this way, the digital coordinates of the shadow line are determined. In Fig. 5, the

digital position of the shadow line on the monitor matrix corresponds to $X=150$ pixels, counted from the left side of the screen. The calibration data of the applied measuring head, stored in the computer database of the video endoscope, show that this corresponds to the distance of the probe lens from the observed surface of (for this example) 20 mm.

Fig. 5. Schematic diagram of the 'Shadow' measurement method [19]

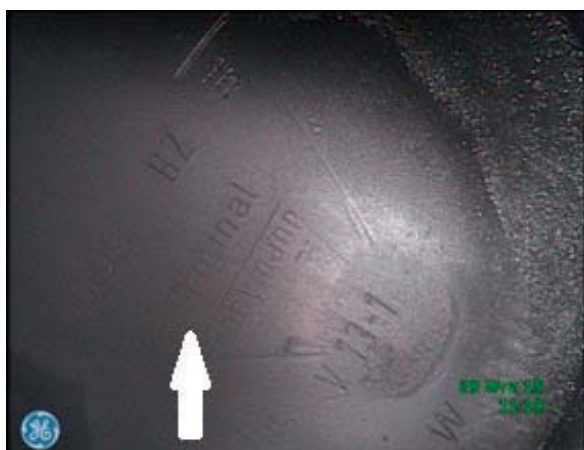
a) Piston head with visible identification number

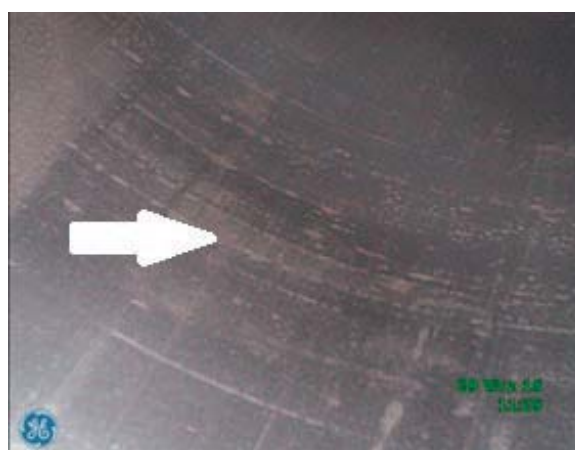
b) Cylinder sliding surface in the vicinity of BDC – traces of abrasive wear, no traces of the liner 'honing'

- the presence of longitudinal traces of slight abrasive wear of the cylinder liners
- (microslicings, scratchings, ploughings);
- the presence of small surface defects on the piston crown (mainly scratchings);
- slight deposits of impurities (mainly soot) on the bottom plate of the cylinder head, as well
- as on the surfaces of the cylinder's intake and exhaust valve heads.

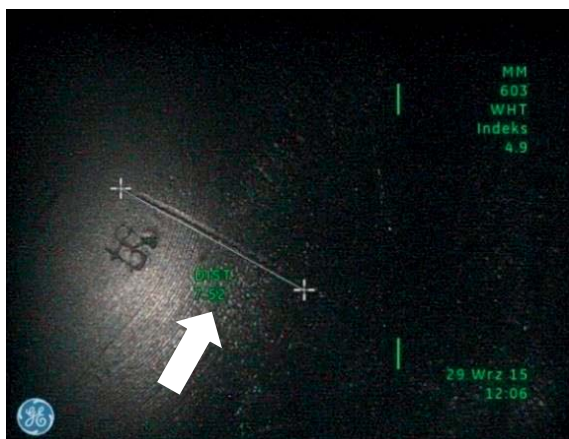
e) Measurement of the scratch length on the piston crown made by the 'Shadow' method – 7.52 mm, with an accuracy index of 4.9, corresponding to an absolute error of 0.3 mm

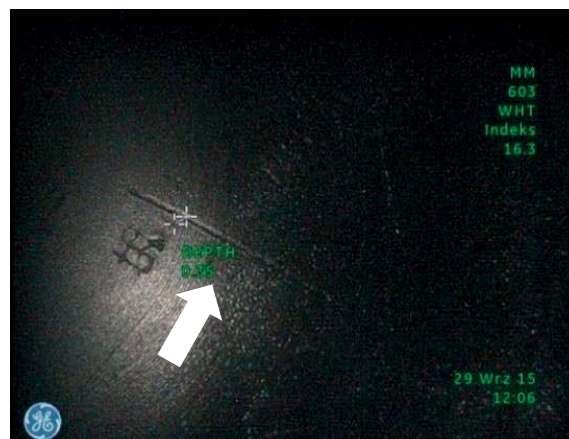
f) Measurement of the scratch depth on the piston crown made by the 'Shadow' method – 0.35 mm, with an accuracy index of 16.3, corresponding to an absolute error of 0.1 mm

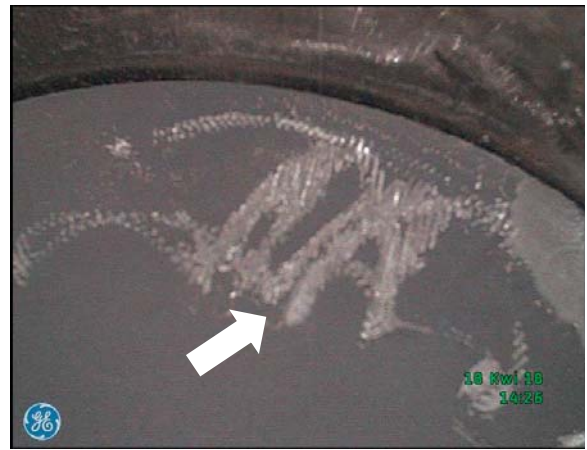
an increased amount of soot and ash is evident on the piston crown, bottom plate of the cylinder head and valve heads (Fig. 8). These are unambiguous symptoms of an incorrect fuel dose or injection advance angle, which indicate the need for engine adjustment. However, no additional surface defects were detected and earlier traces of abrasive, corrosive and erosive wear identified on the cylinder liner surface (i.e. at the beginning of the research engine operation) were conservative. Interestingly, the working space of the engine was self-cleaned of soot after switching to a different type of low-sulphur residual RMG380 marine fuel, with significantly lower chemical emissivity of exhaust gases [5] (Fig. 9). The registered results of the engine's endoscopic examinations were verified during direct inspection of its working space, after removal of the cylinder head at the end of the whole testing program for all marine fuels, see Fig. 10. The results confirmed the satisfactory technical condition of the engine, without any symptoms of destructive impacts on its structure from any of the tested low-sulphur marine fuels (apart from carbon deposits).

d) Piston crown – thick layer of soot, identification numbers not visible (visible trace after moving the video endoscope probe)

On the basis of the results recorded from the endoscopic examinations of the laboratory diesel engine after the completion of the entire testing program for low-sulphur marine fuels, it can be concluded that the technical condition of the available structural elements limiting its working space is satisfactory. The condition did not undergo significant changes under the influence of changes in the elemental composition of the fuel or the additives used to improve its lubricity. Also, changes in temperature and viscosity, during the implementation of transient processes in particular (e.g. rapid changes in a fuel dose during engine running), did not result in noticeable wear of the surface layers of the available structural elements of the working space. The detected surface defects, in the form of carbon deposits, indicate the need to adjust the fuel dose and the injection advance angle.
