GUIDED WAVES IN SHIP STRUCTURAL HEALTH MONITORING – A FEASIBILITY STUDY

¹ Gdańsk University of Technology, Poland

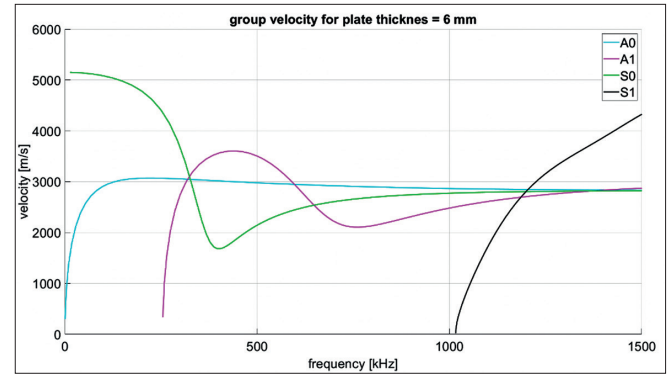
Fig. 5. Group velocity against frequency for 6 mm steel plate (A-antisymmetric, S-symmetric mode)

The parameters d and k indicate the plate thickness and the wavenumber, respectively, while q and p depend on longitudinal and transverse wave velocities in an infinite medium. Based on the equations, the curves illustrating the relationships between velocity and excitation frequency can be traced, as shown in Fig. 5.

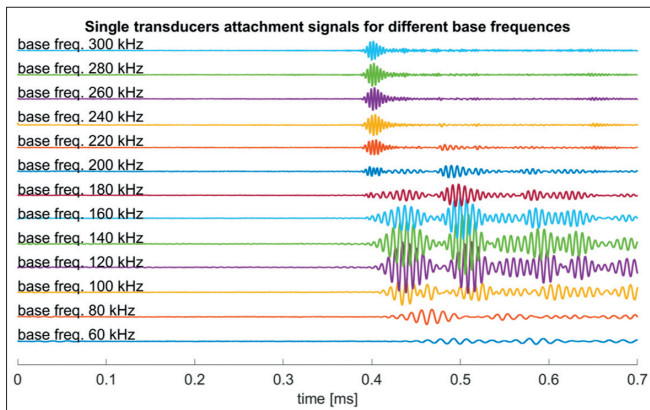
Fig. 12. Waterfall chart of signal received for different base frequencies.

In the first step, the sensitivity analysis aimed at determining the influence of excitation frequency on signal amplitude, was carried out to investigate corroded plates. A waterfall chart is presented in Fig. 12, registering signals for frequencies in the range 60-300 kHz, with a step of 20 kHz. It can be seen that the amplitude of the incident wave significantly decreases for a frequencies lower than 100 kHz and higher than 160 kHz.

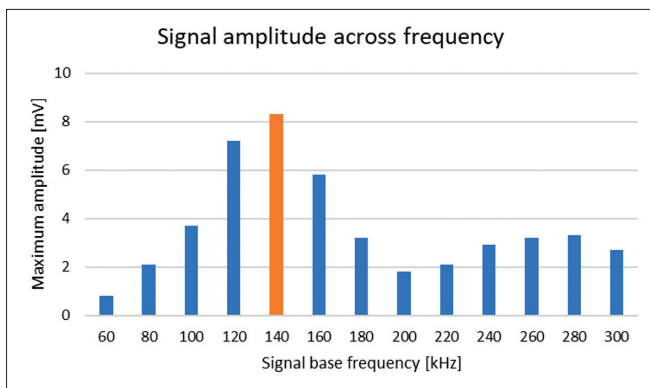
Fig. 13. Column chart of registered amplitudes for base frequencies.

Maximal amplitudes of the received signals were registered and are presented in Fig. 13. The highest amplitudes of the incident waves lead to the highest signal-to-noise ratios and were achieved for the frequency 140 kHz. The final data were only collected and analysed for this frequency because it provided the clearest and the most readable signals.

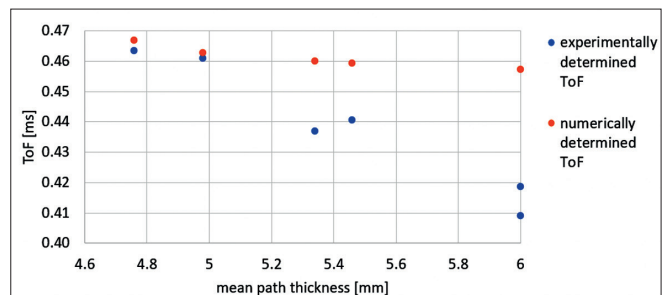
Fig. 20. Twenty FEM results compared with experimental results

Figure 20 presents the experimental and numerical ToFs. FEM values were calculated based on the mean thickness of the path from the micrometer. It can be seen that all ToFs for the FEM-tested plates are more significant than in the experimental plates. This can be explained by the fact that the constant average thickness was adopted in the numerical model, while the corroded surface was irregular in the real case. However, in both cases, the same decreasing trend is noted.

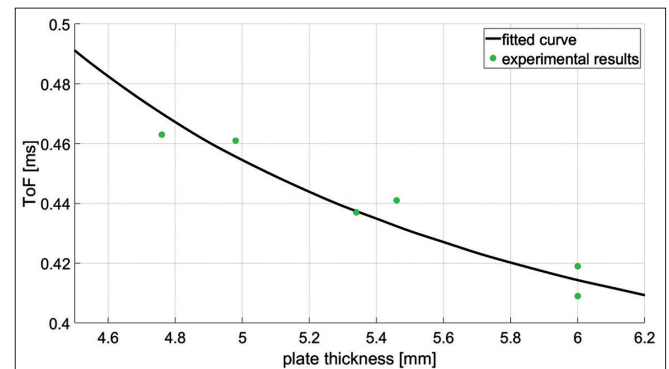
Fig. 22. Translated curve fitted to experimental results, non-translated curve for reference.

The results of the curve fitting (after considering the inaccuracies) that translates the curve by translation vector $[ToF; d] = [-0.036 \text{ ms}; 2.8 \text{ mm}]$, are presented in Fig. 22. The solid curve represents the theoretically determined thickness-ToF relationship, while experimental results are marked with green markers. It can be seen that the experimental and theoretical results coincide well with each other. The absolute average difference between experimental results and the fitted

curve equals 0.005 ms, and the maximum difference between observed ToF values equals 0.054 ms.
