GUIDED WAVES IN SHIP STRUCTURAL HEALTH MONITORING – A FEASIBILITY STUDY

ABSTRACT

Keywords: Corrosion, Guided Waves, Non-destructive Testing, Ship Structures

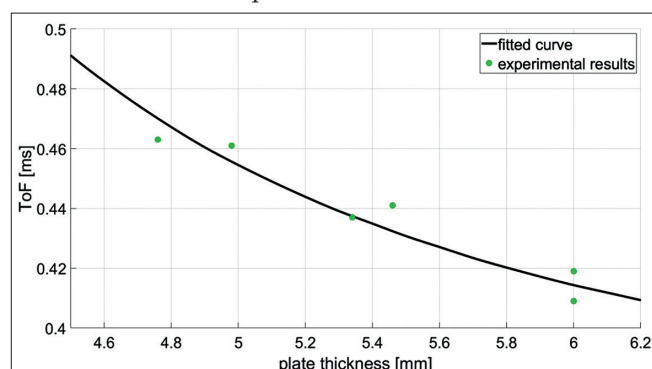
The results of the curve fitting (after considering the inaccuracies) that translates the curve by translation vector $[ToF; d] = [-0.036 \text{ ms}; 2.8 \text{ mm}]$, are presented in Fig. 22. The solid curve represents the theoretically determined thickness-ToF relationship, while experimental results are marked with green markers. It can be seen that the experimental and theoretical results coincide well with each other. The absolute average difference between experimental results and the fitted

curve equals 0.005 ms, and the maximum difference between observed ToF values equals 0.054 ms.

Fig. 22. Translated curve fitted to experimental results, non-translated curve for reference.

In the last stage, an algorithm was developed in the MATLAB environment, to fit the theoretical curve to the experimental results. The theoretical curve was calculated based on solving Eq. (2), using material parameters from the paragraph describing the numerical model. This was used to fit the dispersion curve based on the regression analysis, using the least square method. The algorithm considers plate thickness and the systematic error of the ToF measurements. Because several approaches for ToF determination give slightly different results, it was assumed that the results could be burdened with some systematic errors. Moreover, the delay resulting from signal transmission between the components of the experimental set-up might also affect the ToF values. Based on the regression analysis results, the error value was estimated at 0.036 ms.

The discrepancies between experimental and numerical results may also result from the differences between the material parameters determined using the fitting Lamb equation to the experimental results. The difference between the actual specimen's average thickness, alongside the propagation paths and the thickness obtained by solving the inverse problem using Lamb equations, was checked and calculated. The inverse calculation was based on the wave propagation velocity for a given average path thickness. The final inaccuracy was calculated as 2.8 mm. This means that, based on the non-destructive results and fitting curve procedure, the plate is thinner by 2.8 mm.
