## PROTECTION AND RENOVATION OF PUBLIC AREAS IN A MODERNIST CITY: THE CASE OF THREE STREETS IN THE HISTORIC CITY CENTRE OF GDYNIA

**ABSTRAKT:** This article concerns issues related to the preservation and restoration of public space in Gdynia's city centre, which was designed and built mainly in the 1920s and 1930s. In 2007, a major part of the city centre was entered into the register of monuments as a historic complex of urban architecture. Moreover, in 2015, the area was declared a Monument of History. Protection of a complex of urban architecture covers not only the renovation of historic buildings but also the protection of public spaces that comprise an integral part of the historic complex. Therefore, preservation of the historic shape and design of public space in the centre of Gdynia is one of the city's key conservation tasks. Since protection of urban space in relatively young historic centres (less than a hundred years old) is a novel issue from the perspective of conservation, it is therefore worth analysing. Issues connected with the protection and restoration of public space in the centre of Gdynia are exemplified by three historic streets, built in the late 1920s a

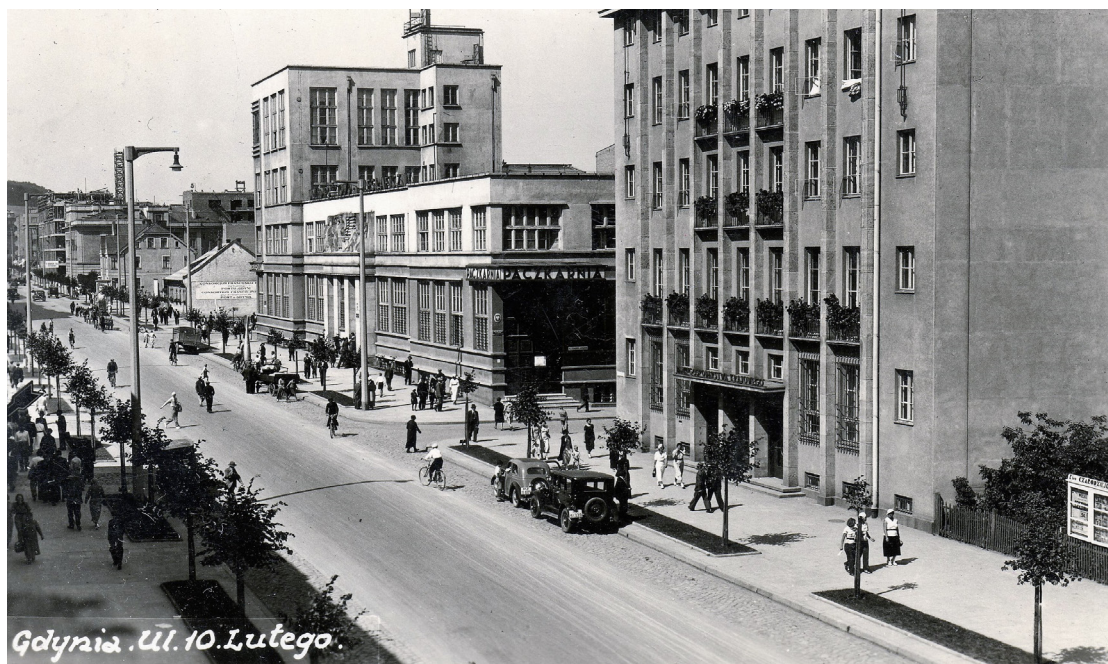
Fig. 1. Gdynia, 10 Lutego Street, the arrangement of the street in the second half of the 1930s; photo from private archives.

10 Lutego Street was arranged in place of Aleja Kuracyjna, which was planned at the beginning of the twentieth century to link the railway station and the beach. In the 1930s, 10 Lutego Street became one of the main compositional axes of the early modernist city centre (fig. 1). The width of the former avenue was then increased to 28 m. The street was laid out using a combination of modern bituminous surface and side lanes of cobblestones with curbs made of longitudinal basalt bricks. Cobblestone lanes were intended for the traffic of vehicles without tires, and as parking lanes (fig. 2). Rows of linden trees were introduced on both sides of the street. Encased in concrete enclosures, the trees were planted in twos, in regular square lawns.

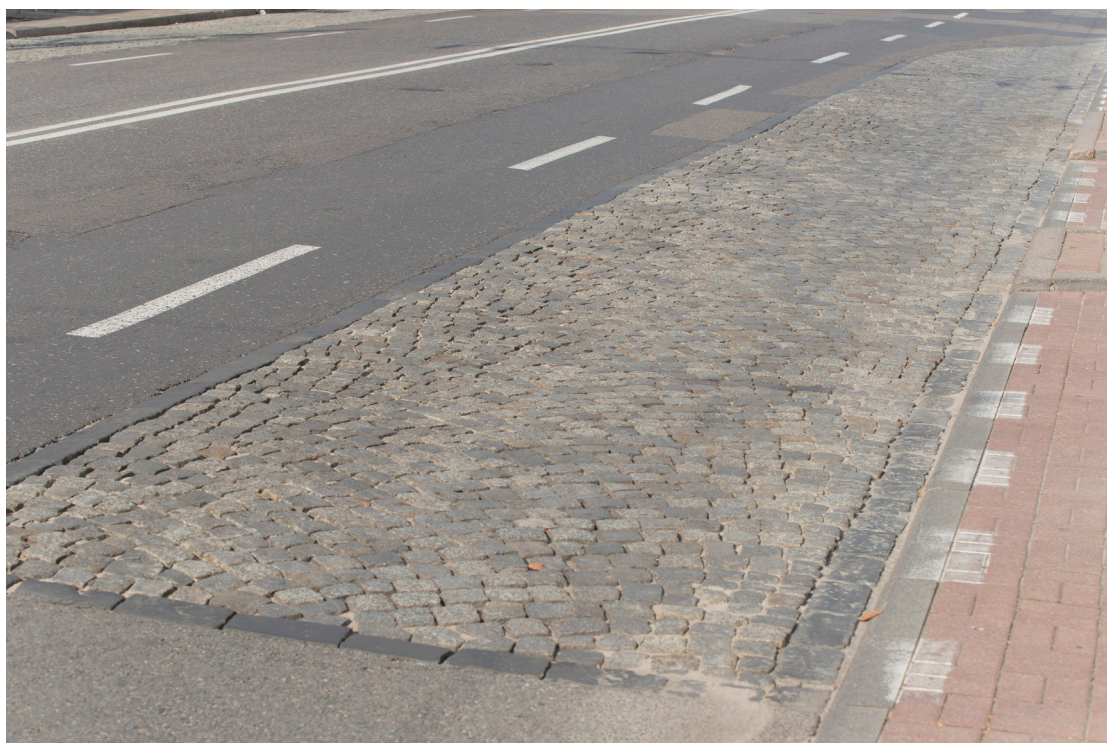
Fig. 2. Gdynia, 10 Lutego Street, historic road surface at the turn of the 1920s and 1930s, where asphalt was combined with cobbled side lanes; photo by B. Ponikiewski.

Apart from the main cobblestone lanes, which testify to the unique character of the street, no original pavement surface or other elements of the arrangement have been preserved.<sup>8</sup> No historic reinforced concrete lampposts have survived as these have been successively replaced throughout the city since the 1980s. At the beginning of the twenty-first century most of the trees were cut down to create parking bays.

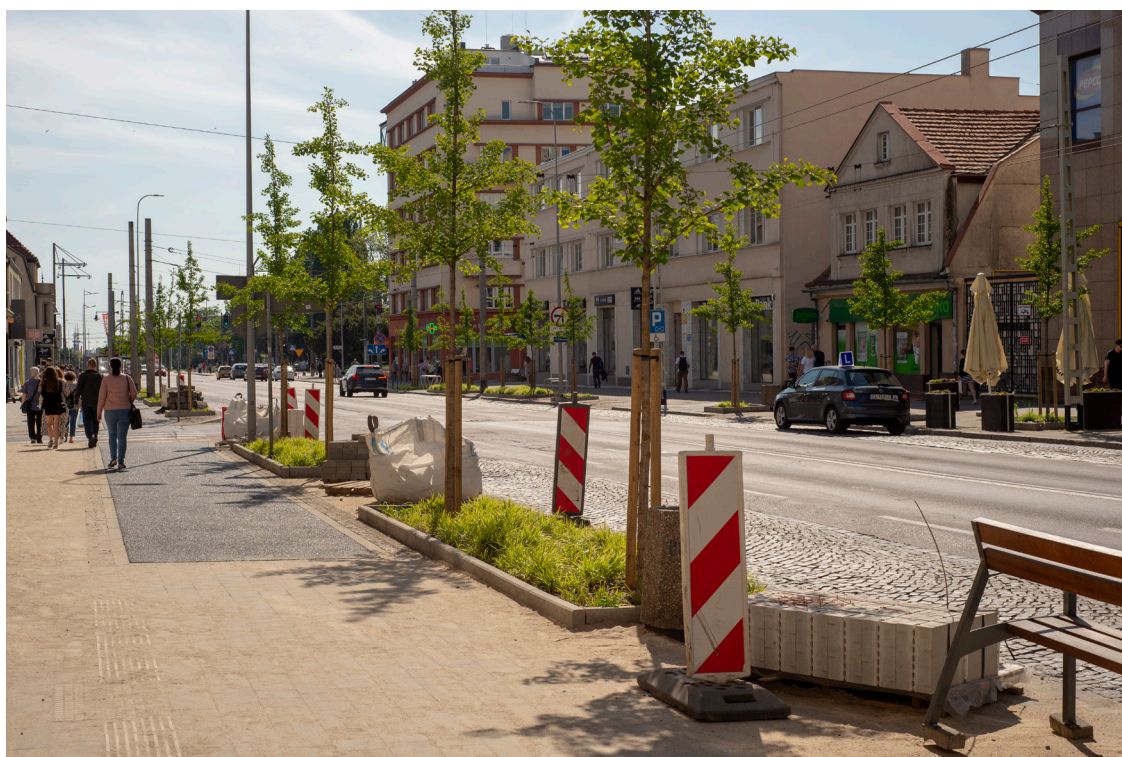
Fig. 3. Gdynia, 10 Lutego Street, after renovation works, which included the conversion of parking bays as well as the reintroduction of the historic width of pavements and the replanting of trees; photo by B. Ponikiewski.

out, including the elimination of a significant number of parking bays, and the restoration of the original width of pavements. Owing to the above, comprehensive reconstruction of the old arrangement of trees was made possible. Since the conditions for the growth of trees were unfavourable due to dense traffic and chemical measures against icing, it was decided in consultation with the conservator of monuments to introduce a foreign species of greater resilience (gingko tree) yet with features similar to the historical one (linden tree). Pavements were given a new surface made of concrete blocks of smaller format than in the original design, supplemented with textured slabs and directional markings for people with disabilities. A bicycle path was marked out in the northern part along the pedestrian lane (fig. 3).

The renovation of 10 Lutego Street aimed to restore the most characteristic elements of the historic composition from the interwar period. The former layout of the street, with wide pavements and rows of trees, was reconstructed and the side lanes of cobblestones on the roadway were repaired. Due to modern needs (concerning public transport stops, cyclists or people with disabilities) and the climate conditions that affect the city's greenery, comprehensive reconstruction of the original arrangement and of all its elements could not be pursued. Slight modifications to improve functionality and usability were accepted. In terms of conservation, they were assessed

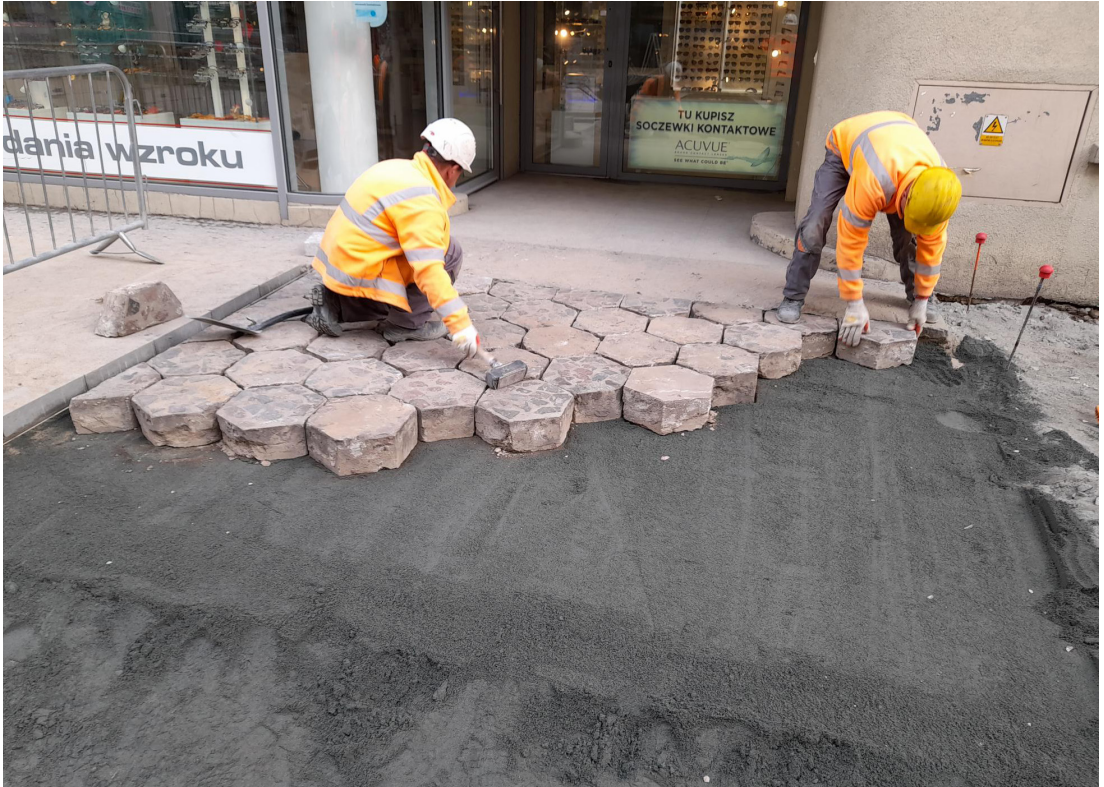
Fig. 4. Gdynia, Starowiejska Street during renovation works in 2022, which involved relocating the historic surface made of hexagonal blocks; photo by R. Hirsch.

of the existing width of the roadway with separate pavements, preservation of the historic road surface and stone curbs with local repairs, preservation of the historic surfaces of access roads to inner yards or former gates (fig. 4), and preservation of original materials, dimensions of stone elements, colours, types of joints as well as the brickwork of reused items. As for the degraded surface of pavements, it was decided to replace them on the provision that references be made to historical solutions, specifically concerning the square concrete slabs. Due to the varied style and time of construction of buildings along the street, some liberty was allowed for the newly designed street furniture, including street lamps, designed in a non-historical maroon colour to add diversity. Efforts to increase the area for pedestrians resulted in the creation of pedestrian zones with parklets, i.e. places to rest with seats and greenery, installed in a non-invasive and reversible way. At the degraded intersections, where asphalt had been reapplied, polished stone-block speed bumps were introduced to slow down the traffic. Finally, decisions were made to preserve existing trees and add seventy new ones owing to their value for both the entire city and the region, including rows of hawthorns that have lent Starowiejska Street a unique character.

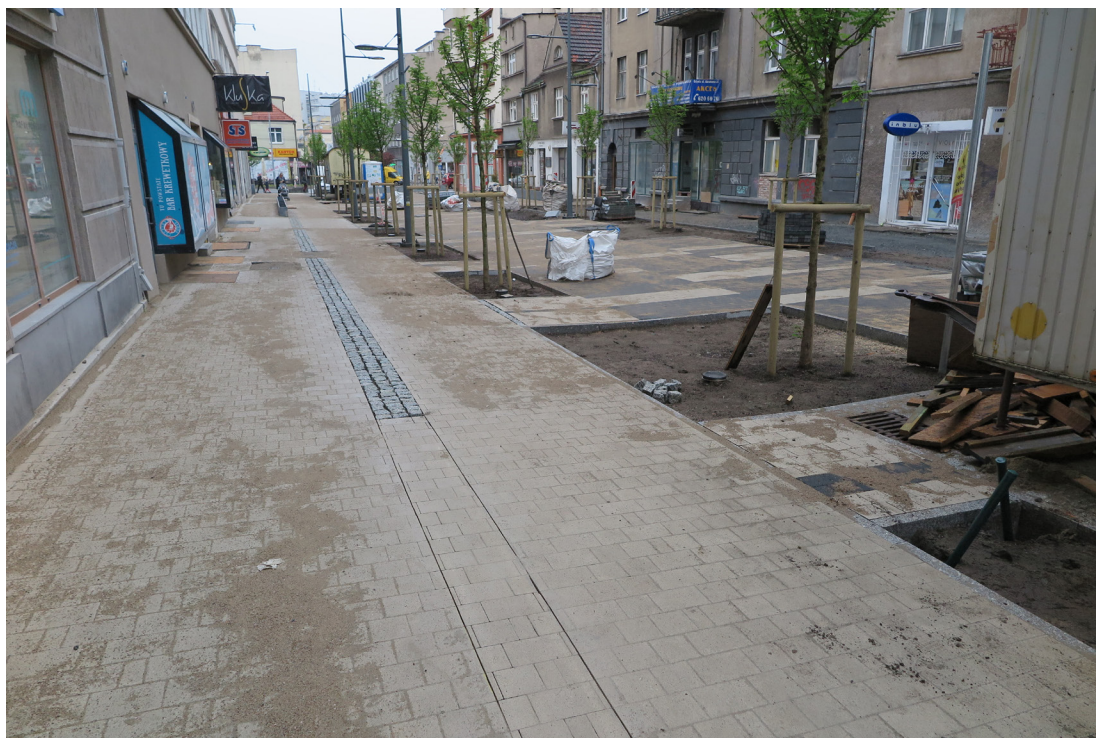
Fig. 5. Gdynia, Abraham Street, the section between Batorego Street and 10 Lutego Street, during the redevelopment into a so-called woonerf; photo from the archives of the Municipal Conservator's Office.

The described section of the street has been transformed to a high degree. No historical surfaces of roadways and pavements were preserved, and those that had been re-introduced were in poor technical condition. The road system was significantly changed due to the introduction of parking spaces. Moreover, since cars would park on the pavements, technical bollards of low aesthetic value were installed to prevent this. Lone trees in poor condition were the only remnants of the street's historic arrangement.

city authorities to cover, among others, the reconstruction of underground installations.<sup>13</sup> The project intended to create a so-called *woonerf*, i.e. the first shared space in Gdynia where priority would be given to pedestrians and cyclists. A new surface with geometric patterns, made of two-coloured concrete slabs of various size (fig. 6), replaced the separation of the roadway and pavements (fig. 5). Car traffic was limited to a narrow lane in the middle of the street, and the speed limit was reduced to 20 km/h. Such reorganization of space facilitated the introduction of much greenery and many outdoor catering facilities. Additional street furniture was installed, including benches, bicycle racks and modern lamps. The project had to meet the accessibility standards of the city of Gdynia (Wysocki, 2013). Accordingly, directional guiding and warning systems were added to the pavements, and either they were adjusted to the level of house thresholds or ramps were built allowing unrestricted use of commercial premises located on the ground floor.<sup>14</sup> The investment was commissioned in June 2019.

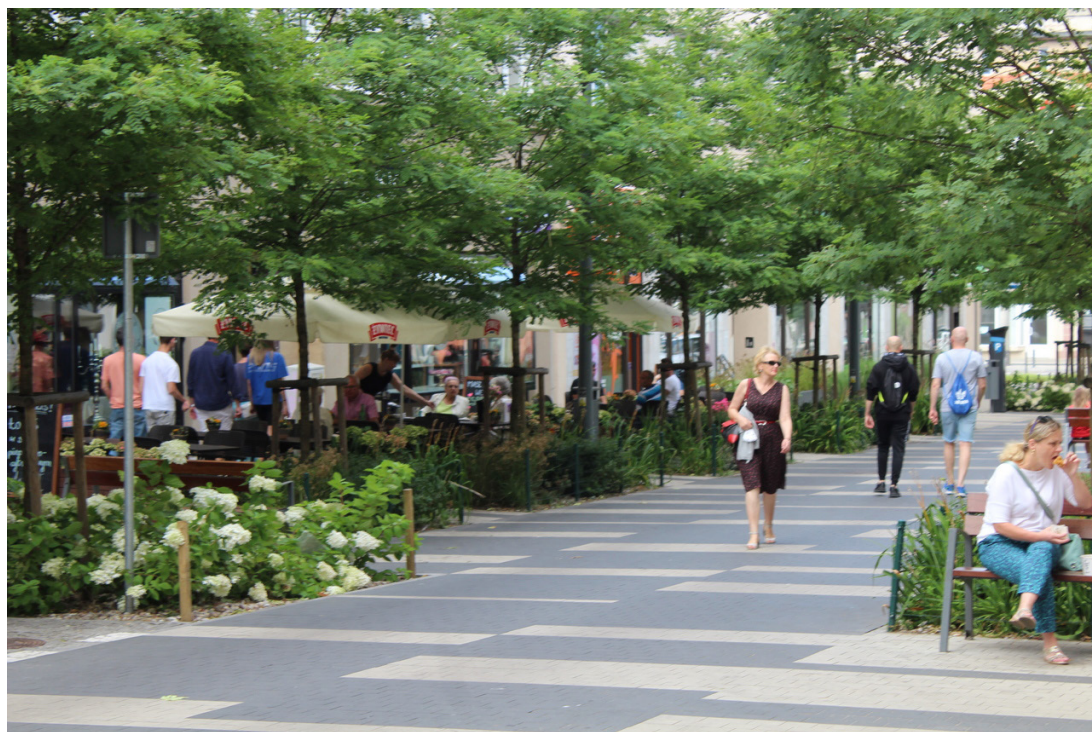
Fig.6. Gdynia, Abrahama Street, the section between Batorego Street and 10 Lutego Street after conversion into a so-called woonerf; photo by B. Ponikiewski.

The reconstruction of the section of Abrahama Street into the contemporary form of a *woonerf* is an example of current trends concerning utility and social expectations in modern European cities, where the idea of the so-called “shared space” has been implemented since the 1980s (Karlikowska & Kimic, 2017). However, not all such concepts may be compatible
