## Impact of spraying commercial Bentonite Nanoclay on fortification of the mortar as Nano Spraying Technique (NST) in heritages and historical buildings

Spraying Bentonite NanoClay as an innovative idea satisfied an urgent need for conservation of historical brick constructions. This research explores the application of Nanotechnology as a Nano-Geotechnics (NaG) and Nano Ground Improvement (NGI) techniques for fortifying the mortar between bricks in historical buildings against some environmental erosive factors. Bentonite Nanoparticles were selected because of their compatibility with mortar. They were applied via Nano Spray to mitigate holes and cracks caused by erosion. Various percentages of bentonite NanoClay (2–10%) Spray and the number of times to spray on the mortar were evaluated. Validation through field emission scanning electron microscopy imaging (FESEM/SEM), X-Ray diffraction and Fluorescence analyses (XRD/XRF), Inductively coupled plasma optical emission spectroscopy (ICP-OES), Brunauer–Emmett–Teller (BET), porosity tests, water absorption time measurement, and weathering tests confirmed the efficacy and long-term stability of this method. The result indicated that

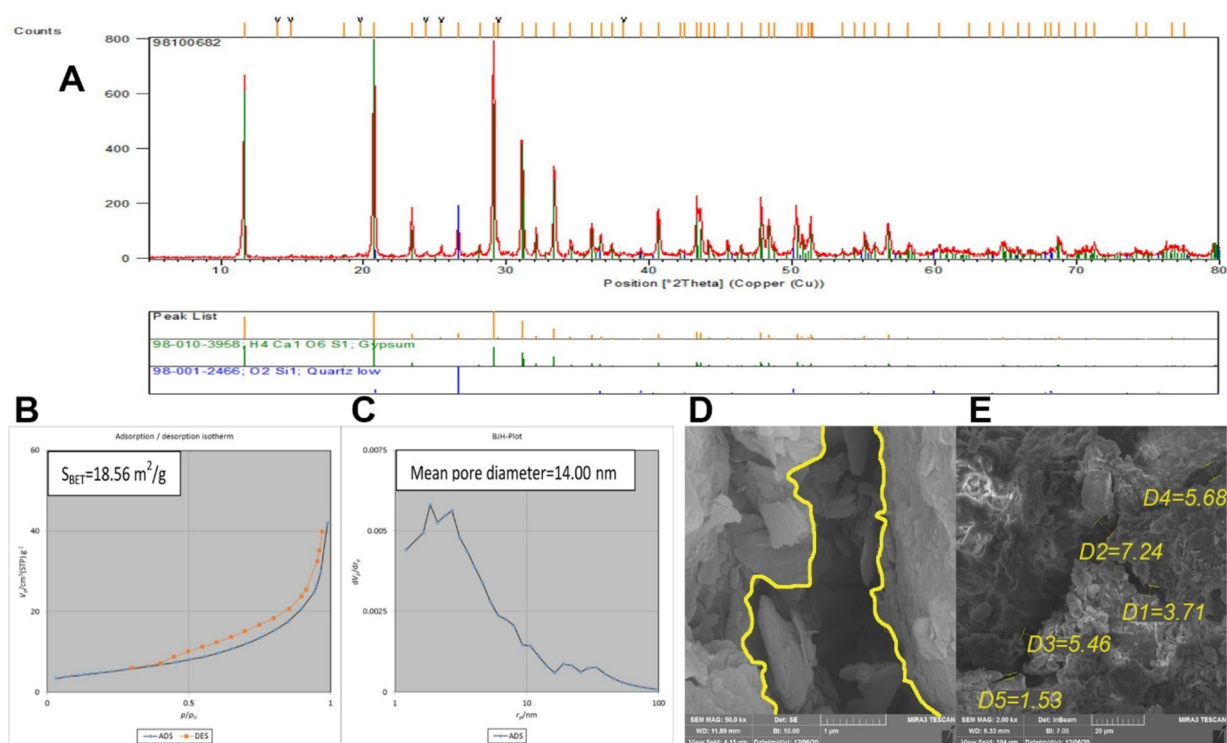
**Fig. 1.** Recognition of historical mortar. X-ray diffraction pattern of historical mortar (A), The nitrogen absorption and desorption curve (BET), and the pore size distribution (BJH) of the historical mortar sample (B and C), Scanning Electron Microscopy (SEM) displays the cracks and pores of the mortar with the magnification of 1 and 20  $\mu\text{m}$  (D and E).

X-Ray diffraction analysis (XRD) is employed to examine the the crystal structure of a substances<sup>23</sup>. Figure 1, A illustrates the XRD pattern of the mortar sample. According to the XRD pattern, quartz (Quartz Low SiO<sub>2</sub>) and gypsum (Gypsum H<sub>4</sub>Ca<sub>1</sub>O<sub>6</sub>S<sub>1</sub>) are observed in the sample. The results of the identified phases indicate that the gypsum phase is the largest component of this mortar. As seen by XRD analysis, the mortar has Calcium Sulfate and Silica in it, and the highest amount of Oxygen, Sulfur, and Calcium is for Calcium Sulfate, and Silicon and Oxygen are for Silica. In Fig. 1, B displays the Nitrogen absorption and desorption curve (BET), and C shows the pore size distribution (BJH) of the historical mortar sample. The results demonstrate that the surface area is equal to 18.56 square meters per gram, the volume of the holes is 0.064 cubic centimeters per gram, and the average size of the holes is equal to 14.00 nm. Based on the hole size distribution curve, most of the holes are less than 1.85 nm. Scanning electron microscopy (SEM) is a powerful imaging technique utilized to investigate the micro and nano scale structure and composition of materials<sup>23</sup>. In Fig. 1, SEM shows the mortar, according to which the surface erosion of the mortar can be seen in the form of pores and cracks. The magnification of images D and E are 1 and 20  $\mu\text{m}$  respectively. Covering the historical mortar with Nanoclay spray In this research, various

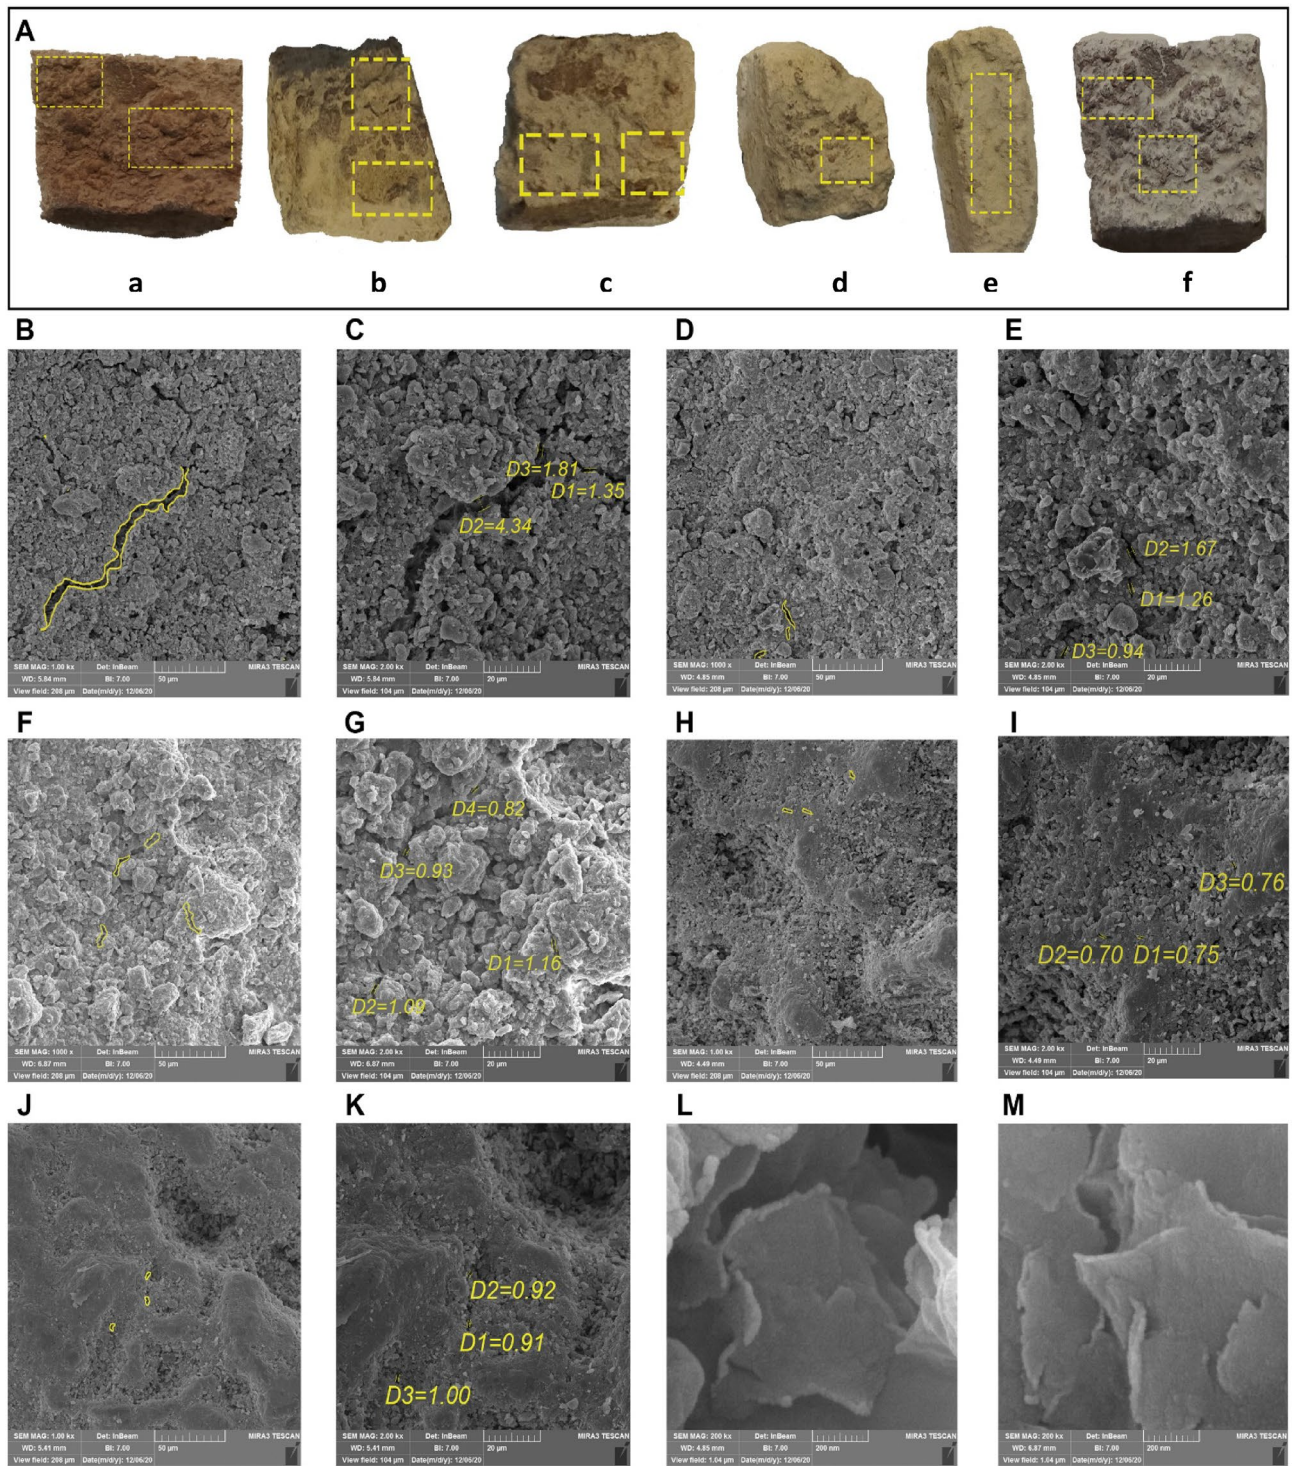
**Fig. 2.** A images of control and sprayed mortar samples. control and sprayed mortar samples with 2, 4, 6, and 10% nanoclay (A), The control sample of the mortar surface (a), covered with a 2% solution of nanoclay (b), a sample solution with 4% nanoclay in one spraying step (c), the sample sprayed with 4% nanoclay solution in two spraying stages (d), B–K SEM images of the sprayed samples, Covered with the 2% solution of Nanoclay NB2 (B, C). Covered with a 4% Nanoclay solution of one spray step NB4-1 (D–E). With a 4% solution of two-step Nanoclay spray NB4-2 (F–G). Covered with a 6% solution of Nanoclay NB6 (H–I). with a solution of 10% Nanoclay NB10 (J–K). images with 200 nm magnification were prepared from the one-stage and two-stage spray samples (L–M).

At first, to determine the optimal percentage of Nanoclay based on the filling rate of the holes, SEM was taken from the sprayed mortar samples. Figure 2A displays the images of control and sprayed mortar samples with 2, 4, 6, and 10% Nanoclay, and Fig. 2B–K shows the SEM images of the samples. Figure 2A shows the creation of a layer of Nanoclay coating on the mortar surface intuitively. The comparison of the pictures shows that in picture a, the control sample of the mortar surface has corrosion and small cracks in different parts. In picture b, for instance, with a 2% spray of Nanoclay, small cracks can still be seen in some places on the surface of the mortar. In picture c, the sample is covered with 4% Nanoclay spray in one step, the cracks are very hard to detect. In picture d, the sample is covered with 4% Nanoclay spray in two steps, it has a uniform surface without any cracks. In picture e, the sample is covered with 6% Nanoclay spray. It becomes difficult to detect cracks and the surface appears to be integrated and free of cracks but a cumulative coating of Nanoclay can be seen on the surface in some places. In picture f, with 10% Nanoclay spray on the surface of the mortar, the formation of new and hairy cracks can be seen, because the surface of the sample is covered with Nanoclay spray too much. consequently, it was avoided to spray the surface of the samples with a higher percentage.

From the comparison of the SEM images of the sprayed samples (Fig. 2B–K) with the control sample (Fig. 1D–E), it can be seen that in the microscopic images (B–C), although the surface of the Nanoclay coating is uniform in the sample, the cracks are not filled and still exist. Therefore, the 2% solution of Nanoclay (NB2) was rejected for further experiments. In the microscopic images (H–I) with an increase of 6% of Nanoclay (NB6), although it becomes difficult to detect cracks and the surface appears to be integrated and free of cracks, a cumulative coating of Nanoclay can be seen on.

the surface in some places. In this sense, this amount of Nanoclay is not a suitable percentage to solve the problem of cracks and holes in the primary mortar. In the microscopic images (J–K) with an increase of 10% Nanoclay (NB10), the formation of new and excess cracks on the surface of the mortar was observed compared to other samples. therefore, this amount of Nanoclay is not considered a suitable percentage. But the microscopic images (D–E) with a 4% Nanoclay solution of one spray step (NB4-1) show a better coverage of Nanoclay particles on the surface and the cracks are very hard to detect.

In the microscopic images (F–G) with a 4% solution of two-step Nanoclay spray (NB4-2), it can be seen that there is a single layer of Nanoclay coating and no cracks. At this stage, to obtain a more accurate result from these two samples NB4-1 and NB4-2, as seen in Fig. 2, microscopic images L and M with 200 nm magnification were prepared from the one-stage and two-stage spray samples. According to these images, the use of 4% Nanoclay

spray in two steps compared to the sample of 4% Nanoclay spray in one step, due to the lower thickness of the sprayed layer, the penetration of Nanoclay particles is better and it fills more holes and cracks in the mortar sample. So, it has a more complete and effective cover. Based on this, double spraying with 4% Bentonite Nanoclay was selected as the optimal percentage (opt).

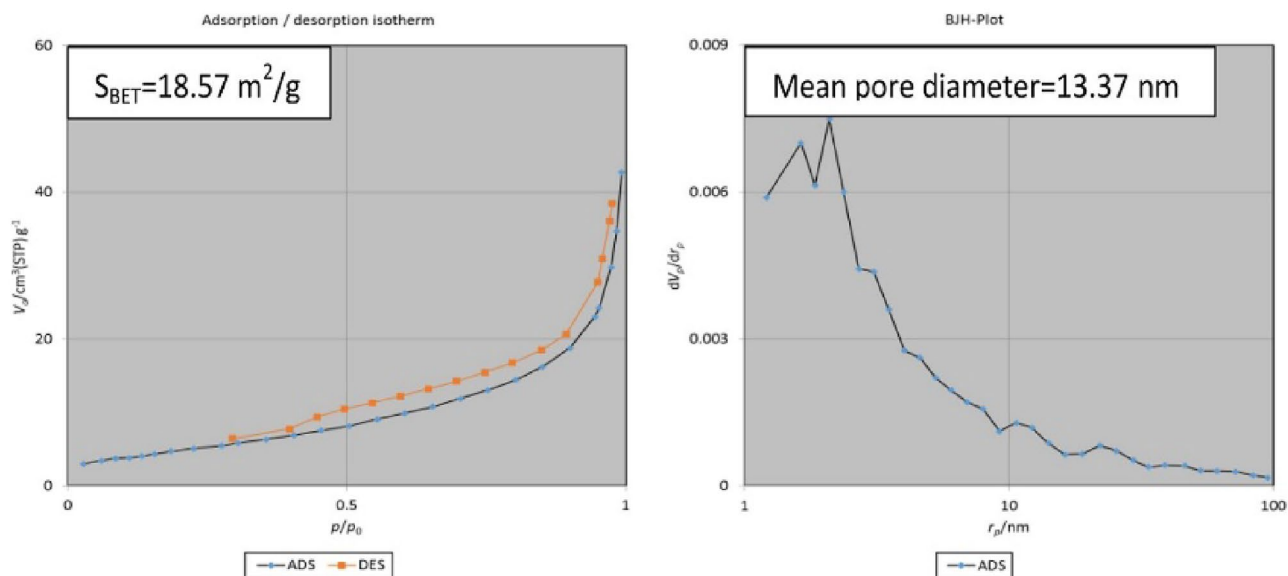
**Fig. 3.** The BET and BJH curves of the NB4-2 sprayed sample.

Considering Fig. 3, BET curve displays that the surface area of the sample covered with NB4-2 Nanoclay (double spray of 4% Nano-Bentonite solution) is equal to 18.57 square meters per gram, the volume of the holes is 0.062 cubic centimeters per gram, and the average size of the holes is equal to 13.37 nm. BJH curve also shows that most of the holes are less than 1.1 nm. While, Fig. 1 illustrates that the surface area of the control sample is equal to 18.56 square meters per gram, the volume of the holes is 0.064 cubic centimeters per gram, and the average size of the holes is equal to 14.00 nm. BJH curve also shows that the most holes are less than 1.85 nm. By examining and comparing the BJH and BET curves of the mortar samples in Fig. 1 with the NB4-2 sprayed sample, in Fig. 3, considering the number of filled holes and the surface porosity of the samples before and after spraying, conclude that the sample sprayed with Bentonite Nanoclay may have performed better in this test than the control sample. The reason for this increase in porosity can be considered to be very fine holes covered with Nanoclay.

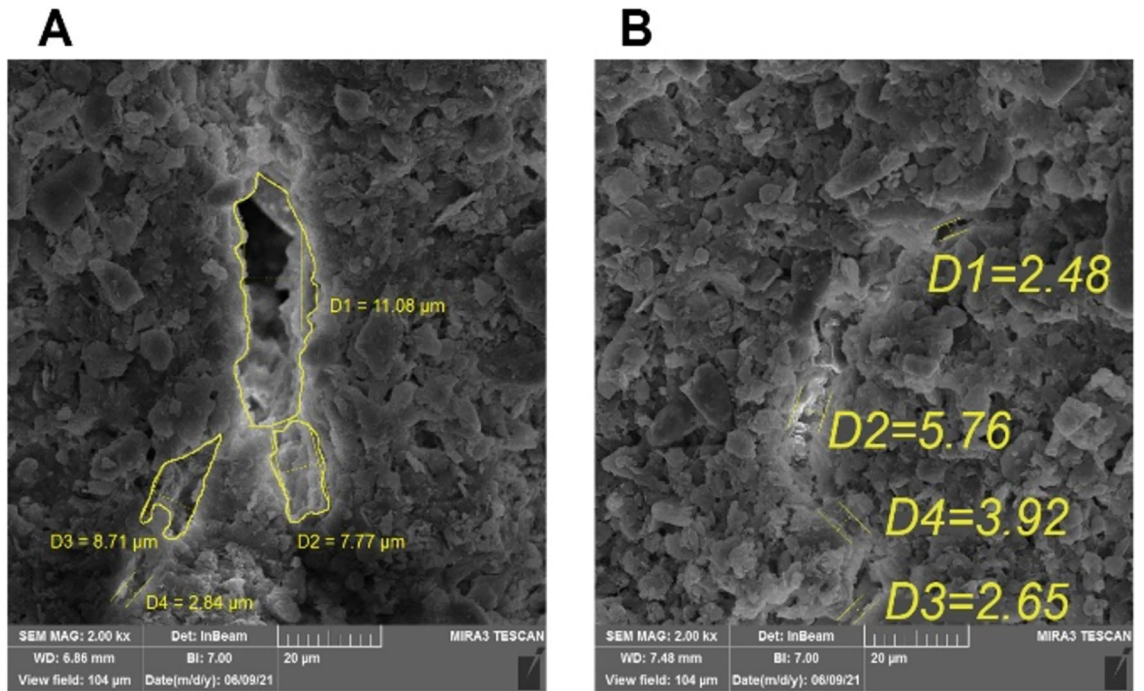
**Fig. 4.** SEM Images, the sample of mortar sprayed with the NB4-2 Nanoclay solution before and after performing the rain simulator test with a magnification of 20 μm (A, B).

Before and after the test (Table S2 (supplementary materials)), the control mortar sample and NB4-2 sample were weighed, then SEM images were prepared from them. By examining the samples according to Table S2, it was observed that the sample sprayed with Nanoclay had a lower erosion rate than the control sample. Also, from a comparison of Fig. 4A and B of the control mortar sample after performing the rain simulator test with the sample before performing this test, it is concluded that the size of the cracks has decreased. The sample sprayed with Bentonite Nanoclay still has more suitable conditions than the control sample, and according to the objectives of this research, it is more effective.

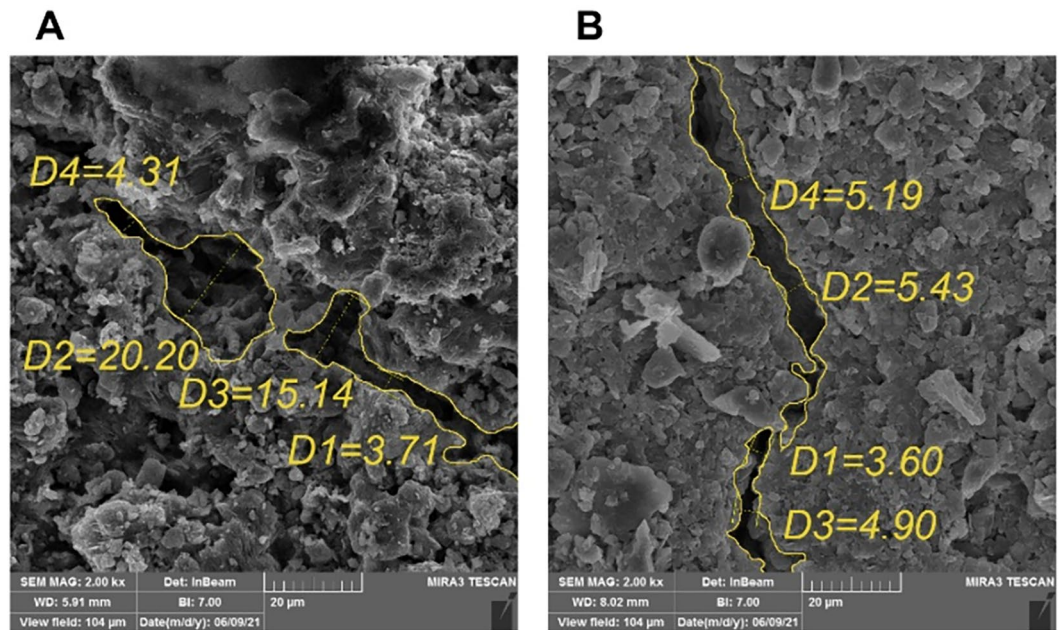
**Fig. 5.** The effect of freezing on samples. Control sample after performing the frost resistance test with a magnification of 20 μm. (A) sample sprayed with the optimal percentage of NB4-2 spray after the frost resistance test with a magnification of 20 μm. (B).

By weighing the samples before and after this test, the following results were obtained. According to Table S3 (Supplementary materials) the sample sprayed with NB4-2 has a lower erosion rate than the control sample. Then, they were compared with the control sample through the preparation of microscopic images, examination of the structure of the particles, and the amount of Bentonite Nanoclay spray coverage with the optimal percentage and its effects on the cracks and voids resulting from erosion on the surface of the samples before and after the frost resistance test. In Fig. 5A, FE-SEM obtained from the control sample with a magnification of 20  $\mu\text{m}$  shows the presence of holes and a porous surface in it and after performing the resistance test against frost, the texture

and size of the cracks compared to the control sample before performing this test (Fig. 2F–G) has been changed and the crack distance is less than 20.20 μm.

In the Fig. 5B samples of mortar sprayed with the optimal percentage of NB4-2 spray after performing the frost resistance test with a magnification of 20 μm can be seen that it still maintains its uniform surface after performing the frost resistance test. However, the size of the cracks has changed and the distance between them has reached less than 5.43 μm, the cover of the surface is still uniform.

By comparing these samples after performing the frost resistance test, with the conditions before performing this test, it can be concluded that: Although there is an incremental change in the size of the cracks and the distance between the pores of both samples of the mortars, the samples sprayed with Bentonite Nanoclay have more suitable conditions than the control sample and they have more effective performance.

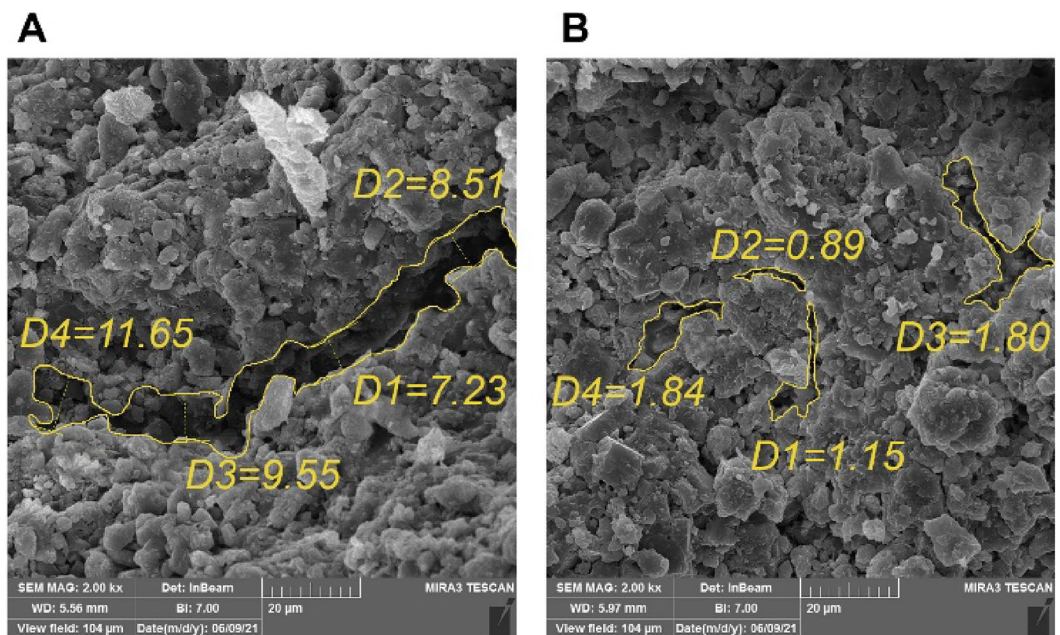
**Fig. 6.** The effect of accelerated aging Test. Control sample after performing the accelerated aging test with a magnification of 20  $\mu\text{m}$ . (A) The mortar sample sprayed with the optimal percentage of NB4-2 Nanoclay solution after performing the accelerated aging test with a magnification of 20  $\mu\text{m}$ . (B).

In the accelerated aging test, the control and optimal samples of NB4-2 were examined after 40 alternating periods of repetition during the cold-heat cycle for 480 h. Then, microscopic images with a magnification of 20  $\mu\text{m}$  were prepared for the control mortar samples and the NB4-2 sample after performing the accelerated aging test, which can be seen in Fig. 6. According to Fig. 6B, the mortar sample sprayed with the optimal percentage.

of NB4-2 spray still has a uniform surface of the Nanoclay coating after the aging test. In this experiment, better and more effective performance and cohesion of the optimal sample of NB4-2 can be observed in advancing the goals of this research.
