Finite Element Analysis of Occupant Risk in Vehicular Impacts into Cluster Mailboxes

Abstract: The deployment of cluster mailboxes (CMs) in the U.S. has raised safety concerns for passengers in potential vehicular crashes involving CMs. This study investigated the crashworthiness of two types of CMs through nonlinear finite element simulations. Two configurations of CM arrangements were considered: a single- and a dual-unit setup. These CM designs were tested on flat-road conditions with and without a curb. A 2010 Toyota Yaris and a 2006 Ford F250, both in compliance with the Manual for Assessing Safety Hardware (MASH), were employed in the analysis. The simulations incorporated airbag models, seatbelt restraint systems, and a Hybrid III 50th percentile adult male dummy. The investigations focused on evaluating the safety of vehicle occupants in 32 impact scenarios and under MASH Test Level 1 conditions (with an impact speed of 50 km/h). The simulation results provided insights into occupant risk and determined the primary failure mode of the CMs. No components of the mailboxes were found intruding into the vehicle's occupant compartment. For all considered cases, the safety facto

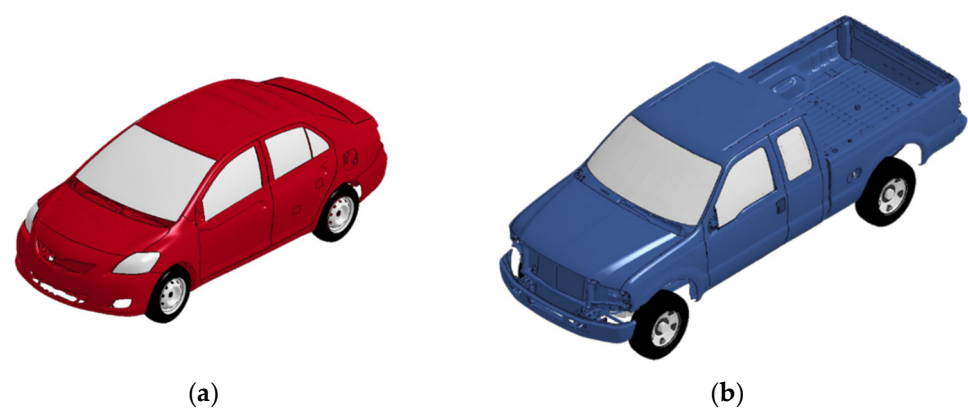
Figure 1. FE models of MASH-compliant test vehicles: (a) A 2010 Toyota Yaris passenger car (1100C) and (b) a 2006 Ford F250 pickup truck (2270P).

The two test vehicles used in the FE simulations of vehicular crashes into the CMs were a 2010 Toyota Yaris passenger car (1100C) and a 2006 Ford F250 pickup truck (2270P). The FE models of both test vehicles included seatbelts, airbags, and a Hybrid III crash test dummy to evaluate the risk of occupant injuries. The two test vehicle models are shown in Figure 1.

The Toyota Yaris model was originally developed and validated against full-frontal, offset-frontal, and side impact tests conducted at the National Crash Analysis Center (NCAC) [26,27]. These models were subsequently modified to improve their numerical accuracy and stability [28–30]. The FE model had a total of 926 components,

602,106 nodes, and 582,681 elements (including 15,156 solid, 562,821 shell, 4685 beam, and 19 discrete elements). The Ford F250 FE model was created at NCAC and validated against NHTSA's frontal-impact test (Test No. 5820) [31]. This model consisted of 746 components, 737,986 nodes, and 735,895 elements (including 25,905 solid, 707,656 shell, 2305 beam, and 29 discrete elements). The Ford F250 model was further improved by eliminating initial penetrations and updating contact definitions to increase model fidelity and numerical stability [32].

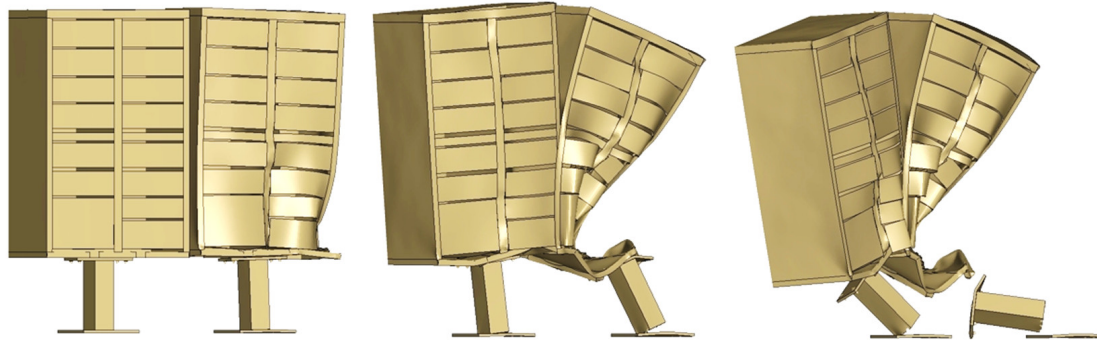
Figure 17. Sequential deformation of the dual-unit Type IV CM impacted by Toyota Yaris at 25° and at the nearest corner on a flat road. Time steps shown are 20, 80, and 120 ms.

Figure 17 shows the progressive structural deformation and damage of the dual-unit Type IV CM under impact of Toyota Yaris at a 25-degree angle at the nearest corner.

The initial phase of the impact generated high stress concentrations at the base of the pedestal columns and localized bending at the lower part of the CM upper unit. As the deformation progressed, the support columns underwent significant plastic deformation and failed at the base. This compromised the structural stability of the system and triggered a cascade of failures in the upper units. The main body of the CM experienced asymmetric crushing and folding, particularly in the regions directly under impact. Vertical panels displayed outward deformation due to axial compression, while horizontal panels exhibited bending and folding, forming localized plastic hinges.

The upper units of the CM exhibited progressive panel buckling and structural separation. The interaction between the vehicle and the CM caused a redistribution of forces, resulting in further deformation of the attachment points at the base and eventually rendering the unit detached from its foundation. Under impact by the Ford F250, the upper bodies of both units separated from the pedestals, and the vehicle ran over the second unit's pedestal while pushing the upper body forward, causing a large V-shaped dent on the hood of the Ford F250.
