TECHNOLOGICAL CONSIDERATIONS OF PERIODIC REPAIR WORKS OF CONCRETE INDUSTRIAL FLOORS

The paper presents a collection of practical information related to conducting periodic repair work on concrete industrial floors. The article is a case study and addresses specific situations related to the loss of serviceability of concrete industrial floors.

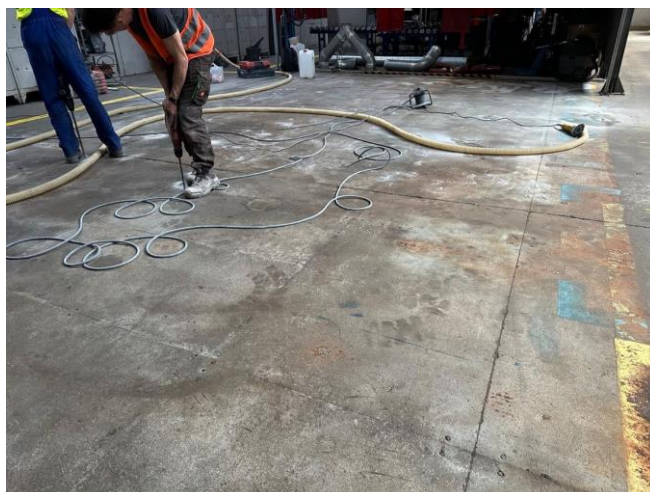
Fig. 3. Degraded concrete industrial floor (Example 1) during repair: damage inventory, removal of mounting anchors [38]

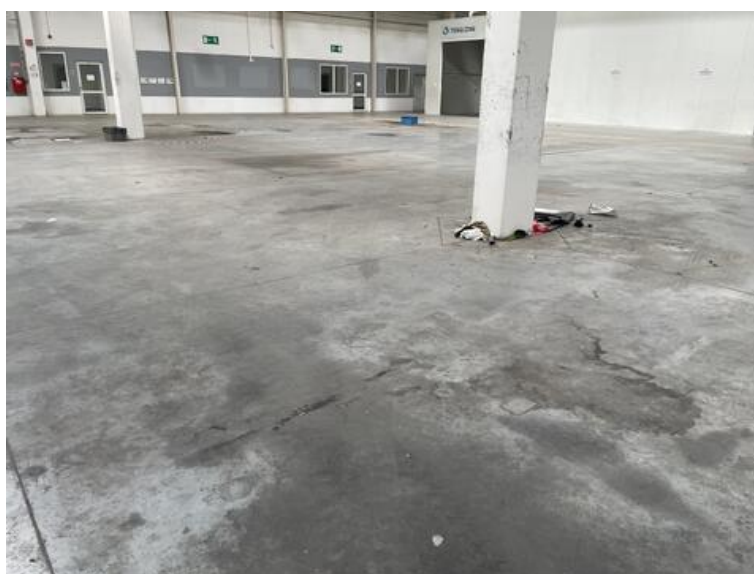
Fig. 14. Concrete industrial floor (Example 4) before renovation: damaged upper floor surface due to improper use of cleaning agents [38]

The ~6,800m² facility was in dry production, but leachate from machinery and equipment in the form of chemicals, oils and grease, permanently penetrated the floor structure (Fig.14). The floor required thorough washing and cleaning with specialized chemicals. Locally degraded parts required rough sanding, which took place on about 5% of the hall's surface. More than 6,000 anchors were removed from the floor, along with the repair of the areas after their removal. During the renovation work, it was found that all working expansion joints were subject to edge displacement and there was so-called slab keying associated with deformation and settlement of the substructure.

In the course of the work, a decision was made to repair the substructure and thus support the edges of the expansion joints by pressure injection, which was eventually carried out in the amount of ~1200 mb of expansion joints.
